Microstructure analysis in the creep process of a gas turbine blade of the turbine engine

The paper presents the results of microstructural tests of the turbine rotor blades made of nickel-based monocrystalline super alloys. The aim of these tests was to determine the consequences of impacting high exhaust gas temperature and stresses occurring during operation on the stability of the blade microstructure. The progress level of the blade microstructure changes in the post-operational stage for different sections towards the blade vertical axis and was compared with the blade microstructure on delivery made of the same super alloy. A varied degree of the microstructure degradation for different blade sections was shown. The changes typical of the high-temperature creep process – γ' phase directional growth (rafting), were observed only for the thinnest walls of the upper section of the turbine blade leaf.

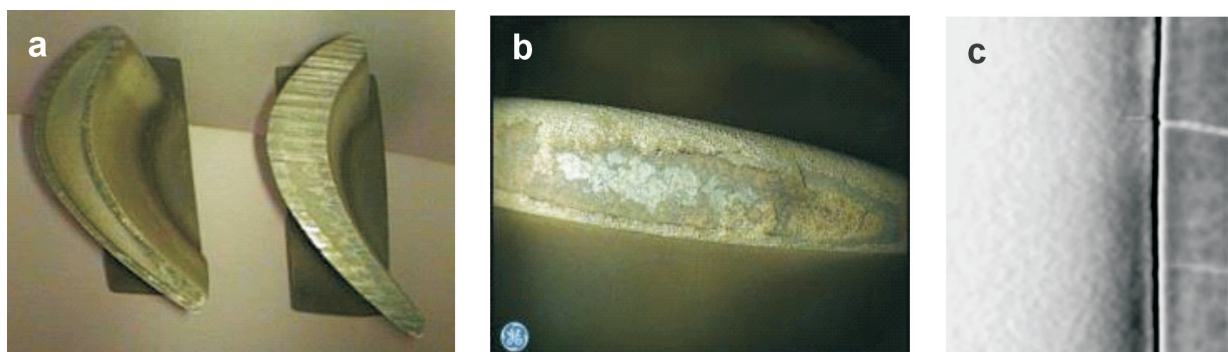
Fig. 1. Example forms of damage to gas turbine blades: a) the turbine blade tip chafing and its wear, b) total burn out of the coating until the leading edge alloy is revealed, c) the turbine blade leaf tomogram with a visible crack inside the leading edge [10]

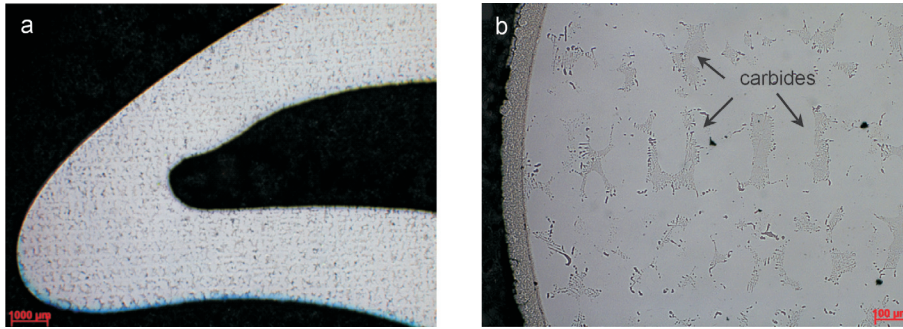
The microstructure of blade No. 1 observed with the use of light microscopy (LM) in the section of the blade locking was presented in Figures 2a and b. In the microstructure of blade No. 1, the dendritic structure, which was formed in the crystallisation process, Fig. 2a, and characteristic of the monocrystalline castings of the blades crystallized in the axis [001] was observed. The macroscopic examination was conducted within the area of the blade leading edge, and allowed to determine that the average distance of the primary dendrite arms is $348 \pm 29 \mu\text{m}$, however, the average length of the secondary dendrite arms is $173 \pm 28 \mu\text{m}$.

Fig. 2. The microstructure of the blade No. 1: a) cross-section by the blade locking, the dendritic structure, b) carbides particles with the "Chinese-script" morphology, LM

Within this microstructure, numerous carbides that have the "Chinese-script" morphology were also observed in the inter-dendritic areas, Fig. 2b.

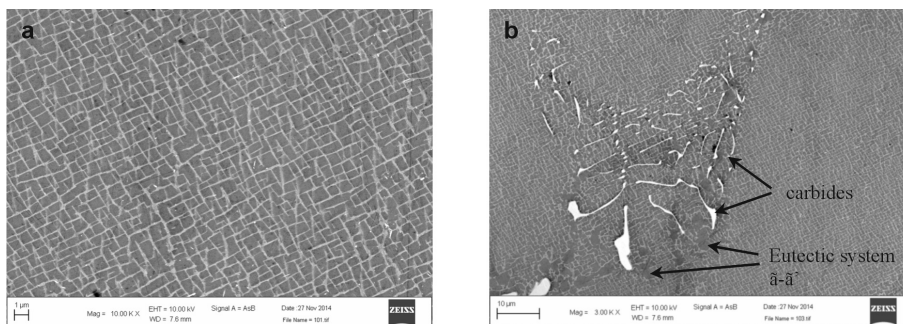
The microstructure within the leading edge observed with the use of the scanning electron microscope (SEM) was presented in Figures 3a and b. Within the dendritic areas, the cuboidal γ' phase particles separated by the γ phase matrix channels were determined, Fig. 3a. In the inter-dendritic areas, the γ - γ' eutectic system as well as a large number of carbides of the so-called "Chinese-script" morphology were observed, Fig. 3b. The average size of the γ' phase particles within the dendritic areas was measured and it equalled $0.33 \pm 0.75 \mu\text{m}^2$, however, the γ' phase surface fraction in these areas was established to be at the level of 66%.

Fig. 3. The microstructure of blade No. 1, cross-section at the locking: a) γ' phase particles separated by γ phase matrix channels, b) inter-dendritic area, γ - γ' eutectic system, carbides particles with the "Chinese-script" morphology, SEM

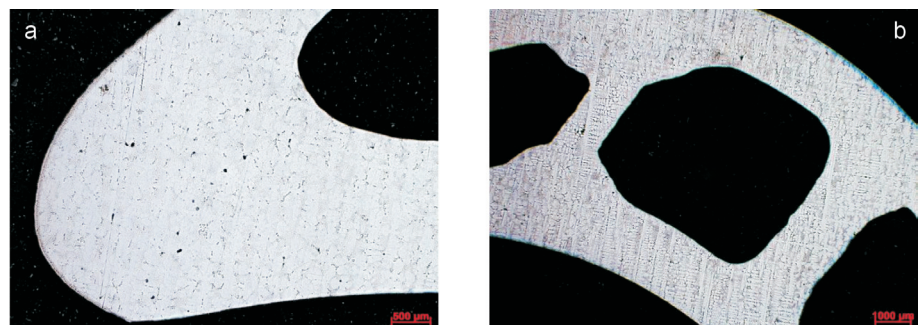
Fig. 4. The microstructure of blade No. 2: a) cross-section at the locking, dendritic structure, b) cross-section in the middle of the turbine blade leaf length, deviation from correct orientation of the crystallization direction, LM

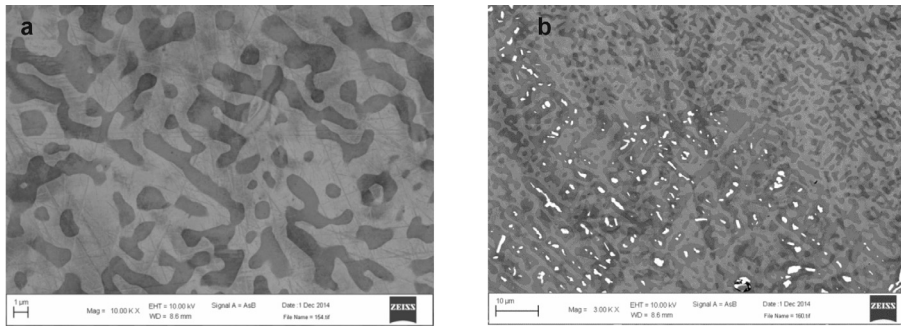
Within the cross-section dendritic areas at the locking, very small ordered cuboidal γ' phase particles separated by the γ phase matrix channels were noticed. Within the inter-dendritic areas, the occurrence of the γ - γ' eutectic system as well as a large number of carbides with the Chinese-script morphology, as in case of blade No. 1, were found. The average size of the γ' phase particles within the dendritic areas is $0.14 \pm 0.39 \mu\text{m}^2$, however, the γ' phase surface fraction at the level of 58% was established. In the dendritic areas in the middle of the blade length, the highly developed and connected to each other γ' phase particles, separated by the thickened γ phase matrix channels, were noticed, Fig. 5a. The microstructure changes of this type are characteristic of long-term exposure to high temperature. The γ - γ' eutectic system as well as many carbides were observed in the inter-dendritic area, Fig. 5b.

Fig. 5. The microstructure of blade No. 2: a) cross-section in the middle of the blade length, the developed and connected with each other γ' phase particles separated by the thickened γ phase matrix channels, b) inter-dendritic area, γ - γ' eutectic system, carbide particles, SEM

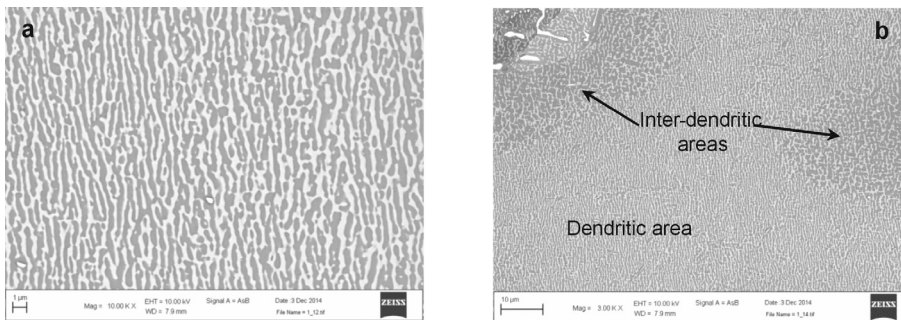
Fig. 6. The microstructure of blade No. 2, the upper longitudinal section: a) dendritic area, visible rafting phenomenon, b) dendritic and inter-dendritic area, SEM

The microstructure changes typical of the high-temperature creep process – γ' phase directional growth (the so-called rafting [17, 18]) at the uniaxial stress state, were noticed in the upper part of the longitudinal section of blade No. 2, Fig. 6a and b. The conducted research showed that the rafting phenomenon occurred only within the area, where the examined blade had the thinnest walls. The γ' phase particles orientation after

the γ' phase directional growth process shows the presence of the uniaxial tensile stress state related to the longitudinal blade axis within the examined area. In the inter-dendritic area, the γ' phase directional growth phenomenon was not observed because the initial microstructure within the inter-dendritic areas did not have the proper structuring to effect the necessary γ' phase directional growth, Fig. 6b.

stress state were observed only in case of the longitudinal section of the upper part of blade No. 2.

At the point, in which the blade has the thinnest walls of the section, which can affect the local increase of maximum temperature and stress. The γ' phase particles orientation after the γ' phase directional growth process shows the presence of the uniaxial tensile stress state related to the longitudinal blade axis within the examined area.

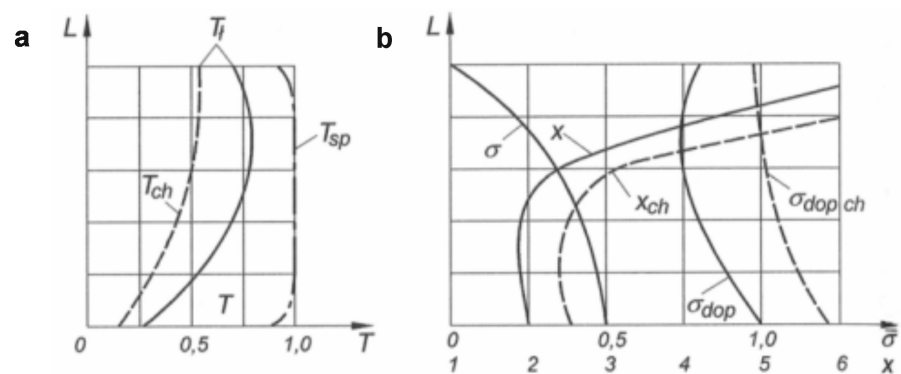
The super alloys used to operate at a temperature above the limit temperature T_g are called the heat-resistant ones. The T_g temperature for a given material is determined by the intersection point of the Re yield strength minimum value and the $R_z/t/T$ creep-rupture strength. The maximum exhaust gas temperature before the considered gas turbine is 1536 K [11], and its distribution along the length of the turbine blade leaf is uneven (Fig. 7a).

The usefulness criterion of the given material as a heat-resistant plastic can include the dependence of the stress value ratio to the Young's modulus σ/E , i.e. the so-called standardised stress of homological temperature T/T_l characteristic of deformation mechanisms of a given material. Along with an increase in the blade operating temperature above the norm and within a specified time of its impact, a significant decrease in the $R_{0.2}$ and R_m strength properties occurs. Therefore, mechanical properties, especially the long-term creep-rupture strength, decrease [1, 14]. The factor contributing to creep constituted the front turbine blade leaf construction, which influenced the increased normal stress σ in relation to the blade without a plate (Fig. 7b).

Fig. 7. The distribution of selected parameters along the L turbine blade leaf of the turbine rotor: a) T_{sp} exhaust gas temperature, T uncooled blade temperature and T_{ch} cooled blade temperature, b) normal stress in the turbine blade leaf without a plate σ and with a plate σ_p at its tip, allowable stress σ_{dop} and corresponding x and x_p safety coefficients [11]
