The analysis of temperature disintegration on the body of fuel injector during research on test bench

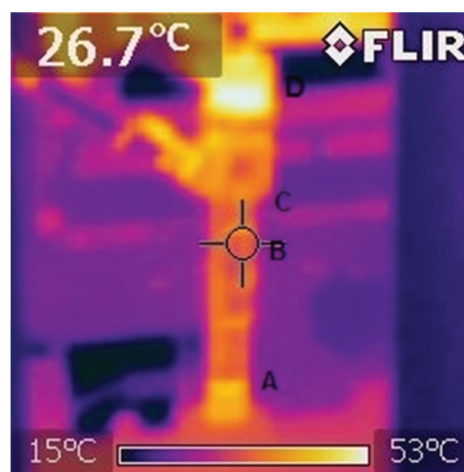
Figure 2 presents electromagnetic Bosch fuel injector researched infrared camera during test bench. There has been marked on the figure precision element on injector needle (A), fuel injector steering valve (B), valve sealer (C) and fuel injector coil (D). It is noticeable that higher temperature is on precision elements due to leaks and in the solenoid.

Fig. 2. Electromagnetic Bosch fuel injector on the infrared camera picture during test

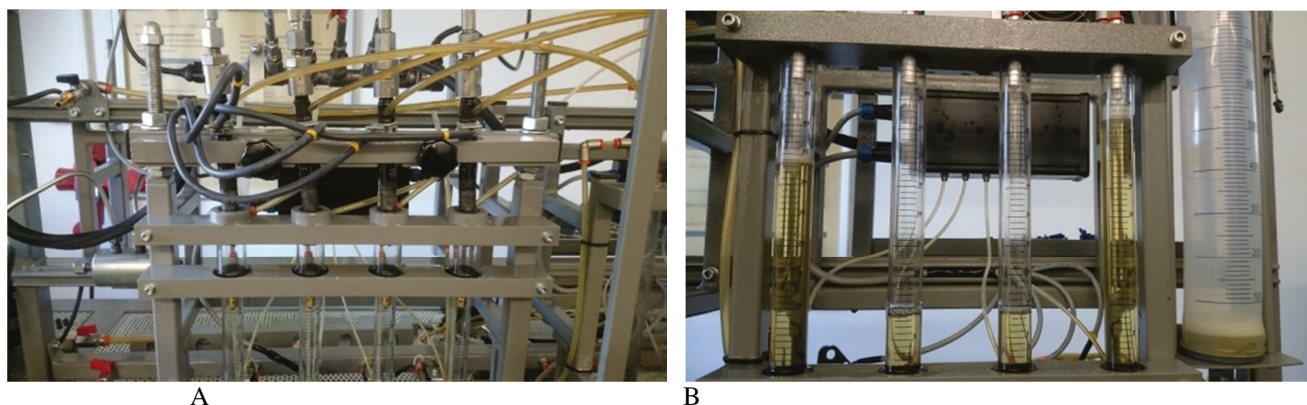
Table 1 shows standard test of researched fuel injectors. There is noticeable that injectors 1 and 4 are damage. There are huge return dosages what influence on their parameters. Figure 7 presents test bench STPiW 3 with researched Delphi injectors and magnitude of return dosage test. There was taken two injectors third and fourth during researches with infrared camera. Studies has been taken into consideration two areas of injectors body nozzle (Fig. 8, 9) and steering valve with coil (fig. 10, 11). Tests have been made with 50, 80, 110 and 140 MPa system pressures. Figure 12 presents measured return dosage by pressure 140 MPa for faulty and good working injectors. There is noticeable in all instances considerable difference temperatures between injectors. Figures 13 and 14 present damage fuel injector precision elements: needle and steering valve.

Fig. 7. A – researched fuel injectors on test bench STPiW 3, B – the magnitudes of return dosages researched fuel injectors

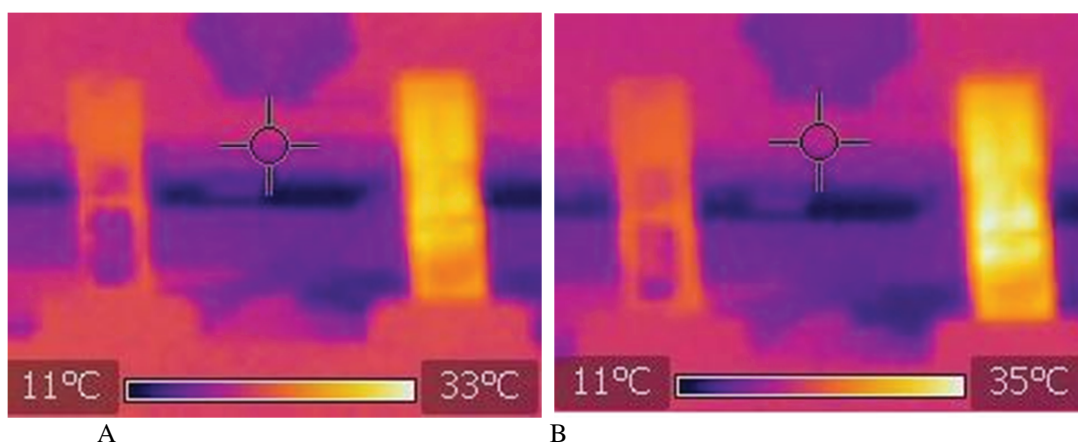
Fig. 8. Pictures of nozzle areas from infrared camera for third and fourth injectors: A – fuel pressure 50 MPa, B – fuel pressure 80 MPa

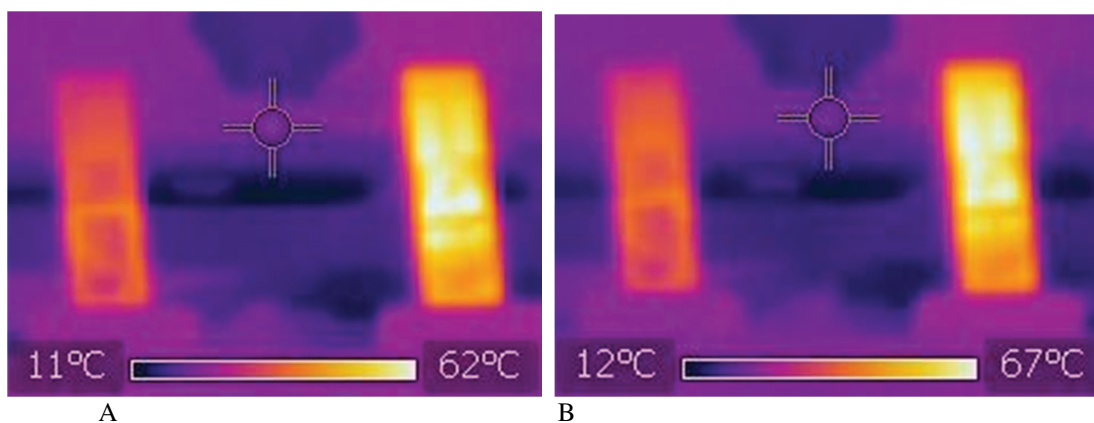
Fig. 9. Pictures of nozzle areas from infrared camera for third and fourth injectors: A – fuel pressure 110 MPa, B – fuel pressure 150 MPa

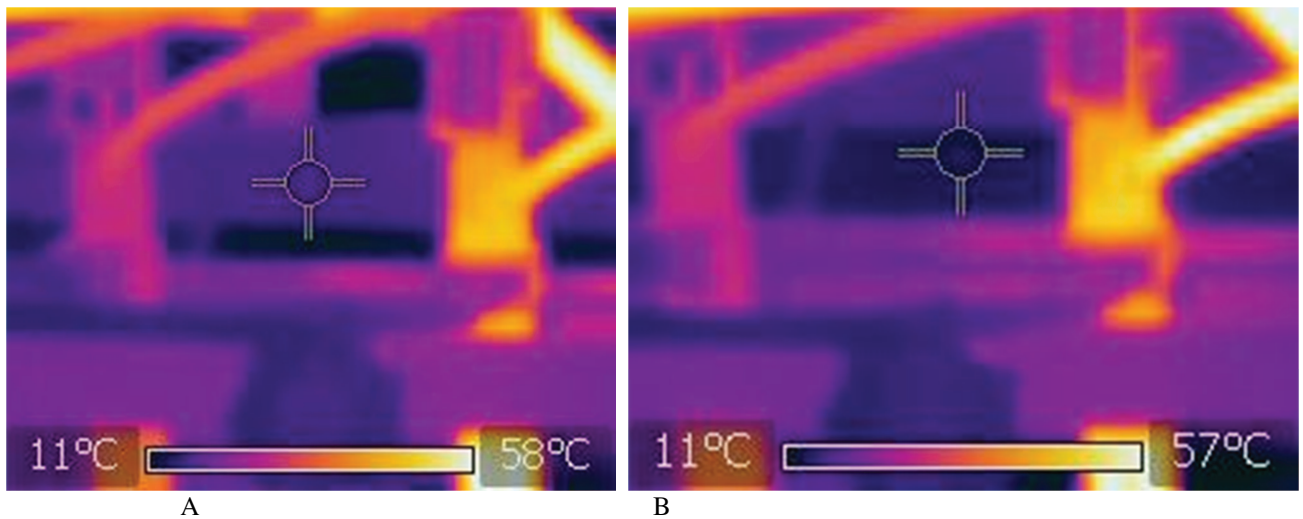
Fig. 10. Pictures of steering valve and electromagnetic coil areas from infrared camera for third and fourth injectors: A – fuel pressure 50 MPa, B – fuel pressure 80 MPa

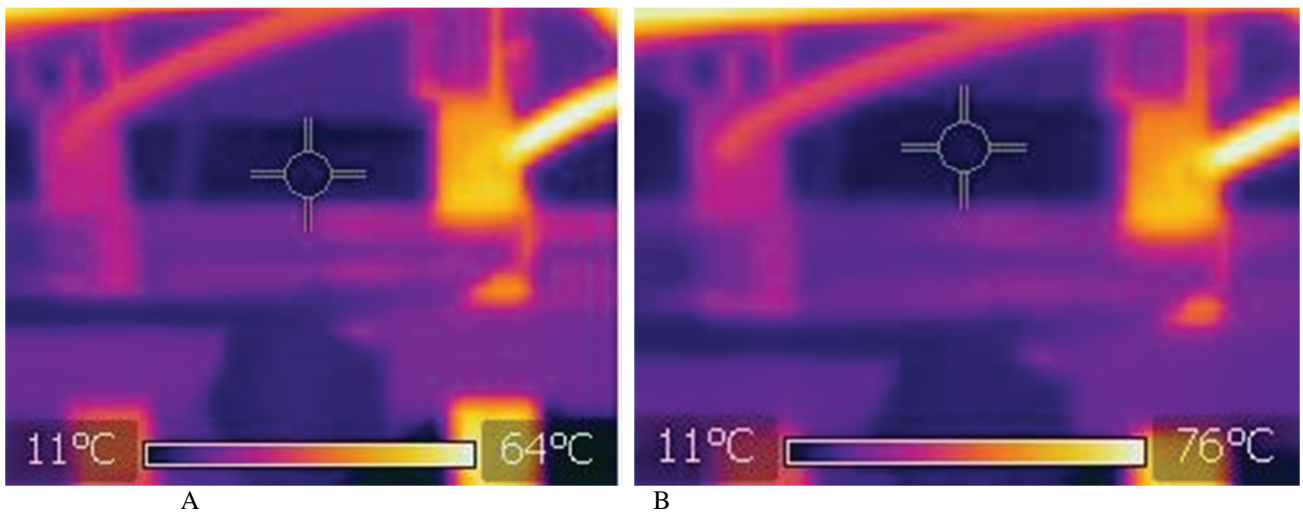
Fig. 11. Pictures of steering valve and electromagnetic coil areas from infrared camera for third and fourth injectors: A – fuel pressure 110 MPa, B – fuel pressure 140 MPa

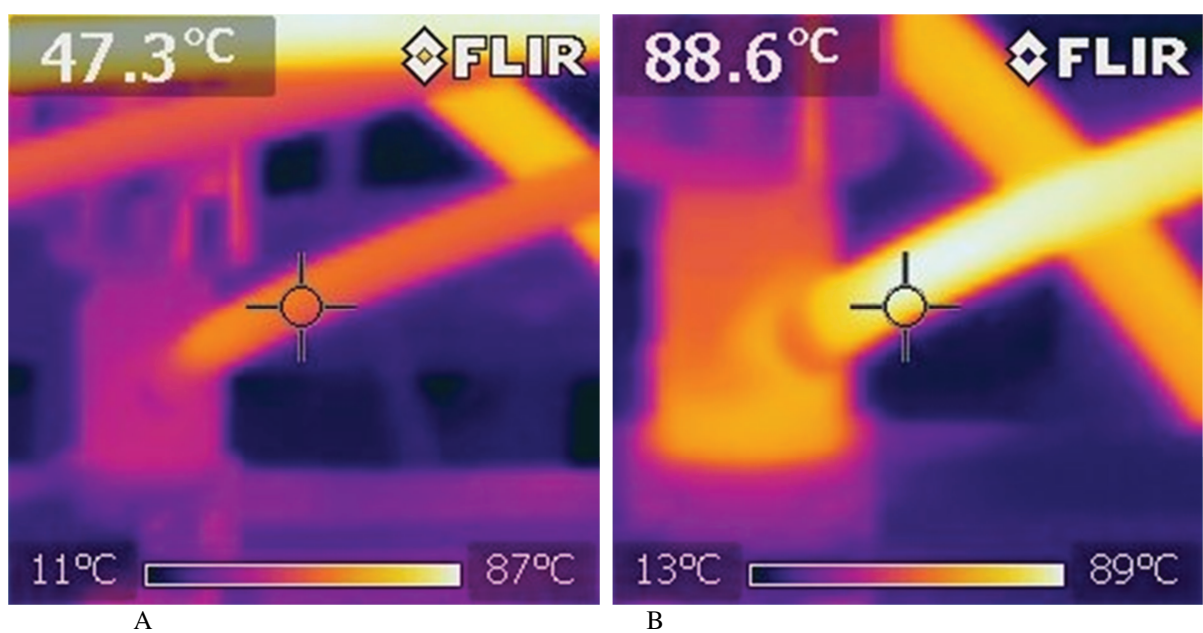
Fig. 12. Temperature of return dosage: A – correct fuel injector, B – faulty fuel injector

It is possible to state during analysis of research results that infrared camera could be useful during researches fuel injectors on the test bench. There happen very often that fuel injector is researched and the standard test shows its damage but engineer don't know where it occur. Fuel injector has few areas: nozzle with needle, steering valve with sealer and coil. When return dosage is too high it is hard to determine where the fault occurs. There is possibility to disassemble injector and use microscope to check precision elements but sometimes it is hard to find where the leaks are. It is easy to change all elements but then repair costs increase. Using infrared camera is very effective method without invasion of diagnostic during researches. There have been researched two areas of injectors during test. The first area was injector nozzle area. If the precision element on the injector needle is damaged it will increase leaks. Temperature would be higher there (Fig. 8, 9). Infrared camera registers it. The same situation is with steering valve. Figure 12 presents the temperature difference between good working and faulty injectors. Return dosages amount $119.40 \text{ mm}^3/\text{H}$ for faulty fuel injector and $38.26 \text{ mm}^3/\text{H}$ for good working by 160 MPa test pressure. This difference is visible on infrared camera because the faulty injector has temperature of returning fuel 88°C (361 K) and

good working 47°C (320 K). This is the result of internal leaks caused damages precision elements. The return dosage temperature increased about 87% by system pressure 160 MPa. For lower pressures 80 MPa temperature increased about 40%.

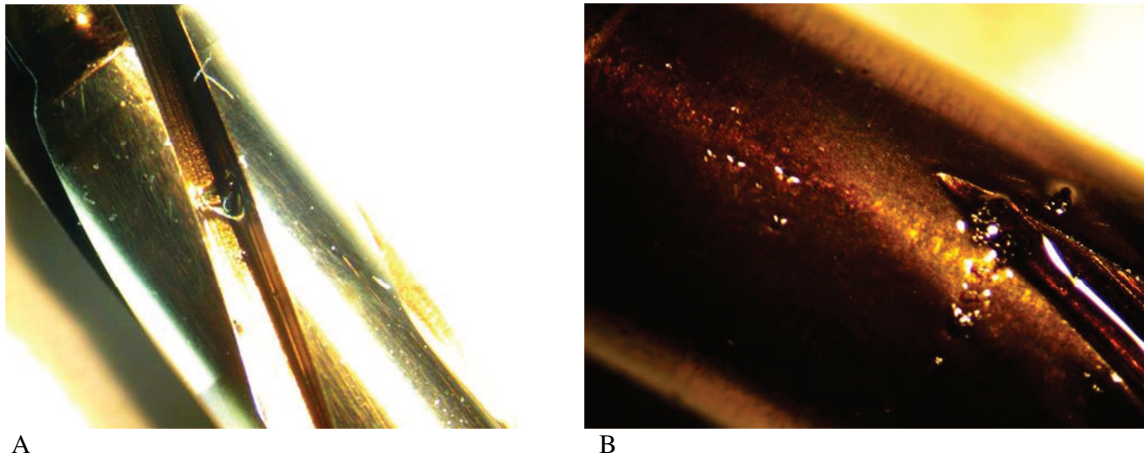
Fig. 13. A, B Precision elements on damage injector needle

Figure 13 and 14 show damages precision elements. There are noticeable a lot of pollutants, metal filings, corrosion, temperature damages and pieces of fuel filter. Metal fillings come from fuel injection pump. In this case diagnostic process was very easy. Everything were visible. But sometimes there are instances where theoretical all elements are in norms but injector leaks. Using infrared camera to find this area is very helpful. There were researched injection fuel temperature on the test bench and fuel return dosages temperature for good working and faulty injectors. Injection temperatures were similar for both but return various due to leaks. The measurements have been carried starting through 40°C intake fuel to injectors. Then has been made one fuel injectors standard test to stabilize the temperature inside. After the test is it possible to make researches by using infrared camera. There is possibility to use this method to all modern fuel injectors. Every electromagnetic and piezoelectric fuel injectors start to heat during inner leaks.
