Multifaceted diagnostic inference process for identifying the causes of self-ignition engine faults resulting from PM sediments

Key words: VGT turbocharger, PM particulates, diagnostic tester, spectral analysis, error codes

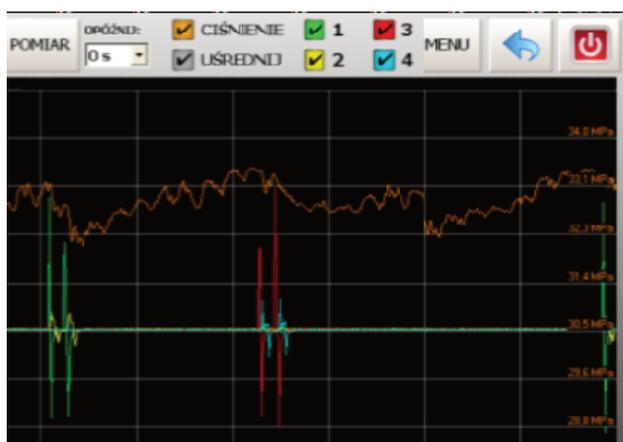
The recorded characteristics show the high pressure maintenance conditions for the 3rd cylinder injector over the extended periods of time, suggesting the possibility of "clogging the atomizer openings". In this case, one aspect is worth noting of the injector damage condition in the absence of fault indications generated by the MIL indicator [15]. Contaminated fuel and improper filtering quality lead to permanent defects of the injector's ball control valve,

which cannot close the cross-channel leakage despite the EDC controller's failure to control the valve. The lower pressure in the control chamber of the injector causes an uncontrolled fuel injection. In this case, the controller will not register any fault, and the excess fuel contributes to the exhaust smoke increase. Despite such a serious fault in the system – the MIL indicator on the instrument cluster [14] will not be activated.

Fig. 6. Current characteristics of injector coils and pressure in the fuel rail.

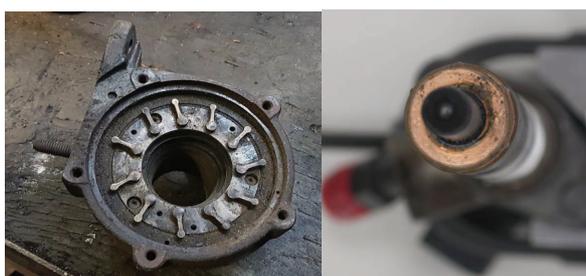
The last step is to erase the errors recorded in the controller's memory. This is an action that must always be performed after a repair or replacement of damaged components. Disassembly of the turbocharger confirmed the expected excess of the sediment in the lever and steering vanes area, and also the excessive deposits were found in the injector outlet zone (Fig. 7). After error deletion and a test run, the tester record showed no error codes.

Fig. 7. Residual sediments in the area of the levers positioning the exhaust nozzle blades and in the zone of injector outer openings

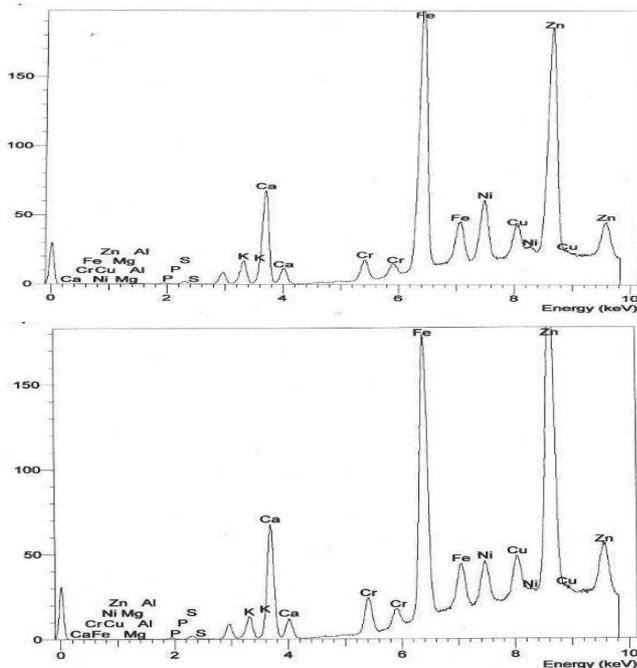
XRF (X-ray fluorescence) method was applied in the qualitative analysis and the sample of the sediments was taken after washing the analyzed zones with hexane (Fig. 9). On the basis of the assessment of band intensity changes for the identified elements, a qualitative assessment of the sedimentation was conducted. The presence of metals such as iron, zinc, chromium, nickel, and copper was found in the analyzed sediments. In addition, the presence of such elements as calcium and phosphorus and sulfur was noted. The presence of zinc, calcium and phosphorus results from the engine oil degradation, including the additive package. In addition, depressants also contain iron ions [8]. In the XRF spectrum for the sediments taken from the levers, a high intensity of iron bands was recorded. These impurities are mainly due to the corrosion processes of steel elements, whose structure is more susceptible to corrosive FAME. The relatively high intensity of the calcium and zinc bands was noted, indicating engine oil contamination as well as a significant share of the spectrum indicating nickel.

Fig. 8. XRF spectrum for sediments from the injector openings and nozzle levers

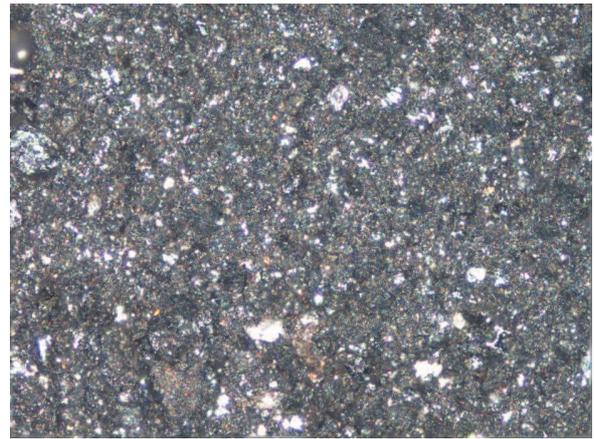
In the microscopic analysis of the deposit collected from the levers (Fig. 8), the sediment grains were observed, which were stained with a tarry substance. The sediment from the injection zone of the 3rd cylinder injector was characterized by a finer and "dry" structure with a visible fraction of the mineral material. The XRF ED X-ray fluorescence spectra were taken from the Oxford Instruments ED 2000 recorder, while the infrared IR spectra (FTIR) were recorded on the BIO-RAD FTS 175.

Fig. 9. Microscope image (magnification 100 ×, reflected light) of the sediment collected from the exhaust nozzle levers

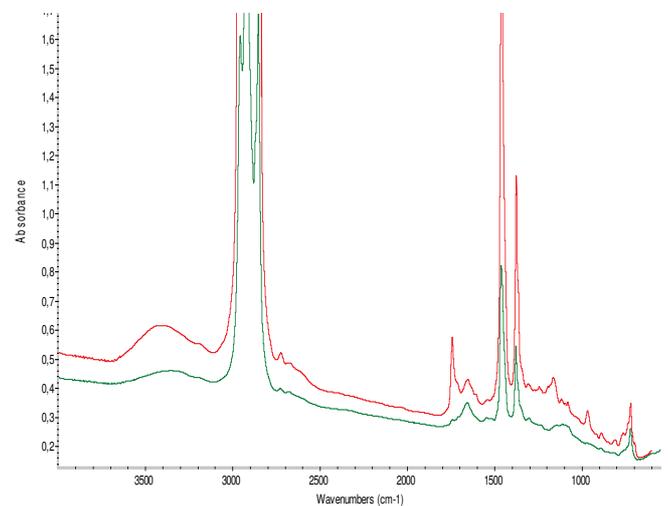
After the sediments from the outer surface of the analyzed zones were washed with chloroform, the sample was analyzed in the infrared spectrum. The fuel residue and the engine oil residue were observed, as well as degradation products. The IR spectrum for the substances isolated in the 3rd opening of the injector is poorer (Fig. 10). At first a comparative analysis was conducted of hydrocarbon bands, i.e. the range of wave numbers: $2850\text{--}3000\text{ cm}^{-1}$, 1464 cm^{-1} , 1377 cm^{-1} , 722 cm^{-1} [10]. In both cases, the background was more raised, which is related to the presence of soot. In addition, vibration bands typical for hydroxyl groups (about 3400 cm^{-1}) are present, which may be derived from the absorbed water, and also from the alcohol and carboxylic acids structures [10].

Fig. 9. Infrared spectrum of the soluble sediment from the injector openings (green) and nozzle levers (red)

The band in the range of about 1655 cm^{-1} in the diagnostic area of $2000\text{--}1600\text{ cm}^{-1}$ is also intensive, which indicates the presence of oxidation processes of organic compounds to carbonyl and carboxylic structures. The effects of these compounds on nitrogen oxides are related to the presence of hydrated carboxylic acid salts. These substances may also be derived from the oxidation and degr-

dation processes of the basic additives present in the engine oil.

The approx. 1630 cm^{-1} band is derived from other compounds containing C-O-NO₂ bonds, resulting from nitro-oxidation of engine oil components and fuel in contact with nitrogen oxides. The observed intense 1747 cm^{-1} band is related to the presence of esters, for which the representative ones are the relations of C=O (aliphatic) carbonyl groups with the bands in the $1750\text{--}1735\text{ cm}^{-1}$ range [5].
