## Comparative study of aftermarket and OEM DPFs for Periodic Technical Inspections (PTI) compliance with new PN emission limits

*This study evaluates the performance of aftermarket and OEM diesel particulate filters (DPFs) using a particle number counter (PNC) during stationary Periodic Technical Inspection (PN-PTI) tests. Several European countries have already implemented regulations requiring this test to ensure that vehicles equipped with DPFs meet the stringent particle number (PN) emission limits. In this work, measurements were conducted on various vehicles with new and conditioned DPFs. The results revealed significant variability in PN emissions, with some filters failing to meet the required limits. Key contributors to elevated PN levels were identified, including filter aging and inadequate conditioning procedures. Based on the findings, the paper proposes practical recommendations and diagnostic approaches to support compliance with PN-PTI test requirements.*

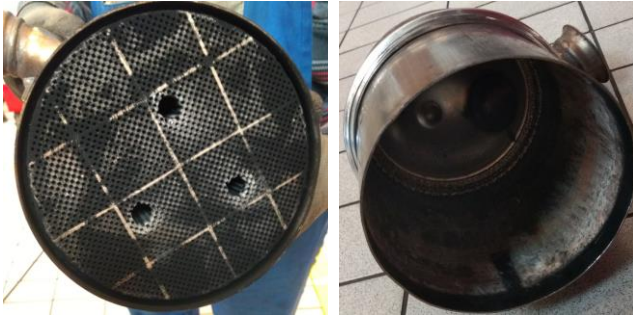
Fig. 4. Tested DPF filters with 3 holes and empty

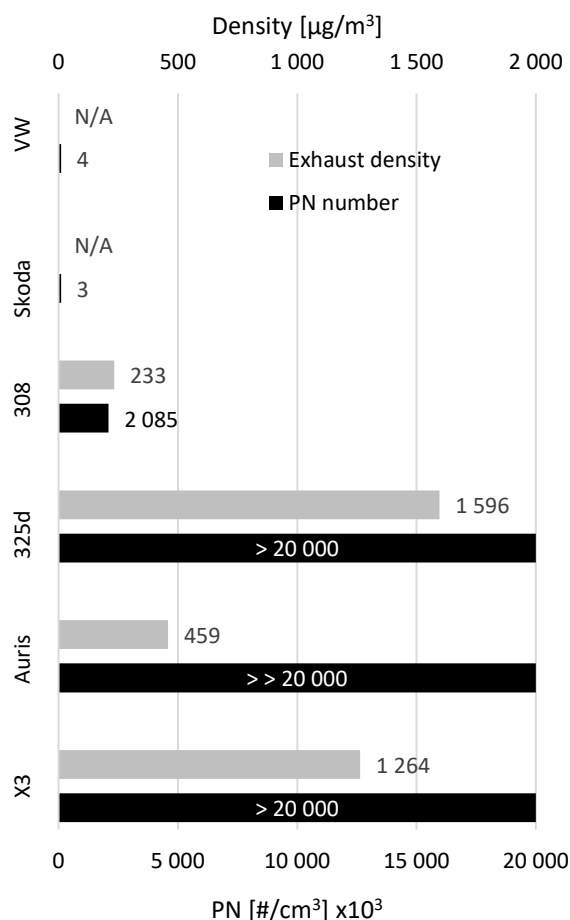
Fig. 10. DPFs assessment depending on PN emissions for different cars

As shown in Fig. 10, vehicles that were not originally equipped with a diesel particulate filter (BMW X3, BMW 325d, and Toyota Auris) exhibited PN emissions that exceeded the measurement range of the particle number counter, with values exceeding 20 million  $\#/cm^3$ . In terms of PM emissions, the BMW vehicles recorded “poor” results, according to the DPF100 tester. Interestingly, the Toyota Auris, despite also lacking a DPF, showed a “good” PM result, with a value below 500  $\mu g/m^3$ . This unexpected outcome for the Toyota may be attributed to the engine being fully warmed up at the time of testing. This suggests that the DPF100 PM tester may not be reliable as a standalone tool for verifying the presence or functionality of a DPF part, as thermal conditions can significantly influence the readings. For the Peugeot 308, the PN measurement exceeded 2 million  $\#/cm^3$ , which clearly indicates a malfunction of the DPF. However, the PM tester reported a “good” result of 233  $\mu g/m^3$ , again highlighting the limited diagnostic reliability of the DPF100 PM tester. Only the Skoda and Volkswagen vehicles produced PN results within the acceptable range, indicating that their DPF parts were functioning properly.

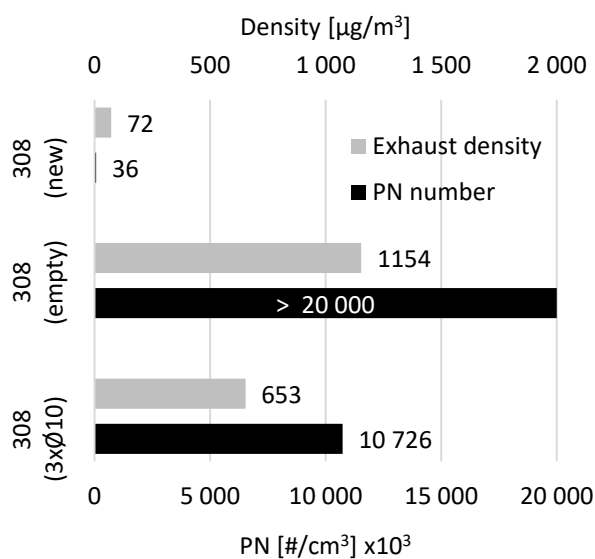
Fig. 11. PN emission results for damaged and new DPF in a Peugeot 308

Figure 11 presents the results obtained from a series of controlled modifications performed on the DPF of a Peugeot 308. Initially, three 10 mm diameter holes were drilled into the existing DPF. In this configuration, the PNC immediately detected abnormally high PN emissions exceeding 10 million  $\#/cm^3$ , indicating severe filter damage. However, the DPF100 PM tester reported a “marginal” result of 653  $\mu g/m^3$ , suggesting that the filter was not in optimal condition.

In the next stage, the DPF core was completely removed. This resulted in an even higher PN reading from the PNC (over 20 million  $\#/cm^3$ ) and notably higher PM emis-

sions measured by the DPF100 to  $1154 \mu\text{g}/\text{m}^3$ , classified as a “poor” result. At this point, both devices correctly indicated the lack of DPF functionality.

Finally, after installing a new aftermarket DPF, both instruments recorded values consistent with proper filter opera-

tion. The PN count dropped dramatically to  $36,000 \#/\text{cm}^3$ , and the PM tester showed a “good” result of  $72 \mu\text{g}/\text{m}^3$ . These results confirm that while both devices can detect a fully removed or replaced filter, only the PNC counter reliably identifies partial damage (e.g., drilled holes), highlighting its superior sensitivity to even minimal damage to the DPF.

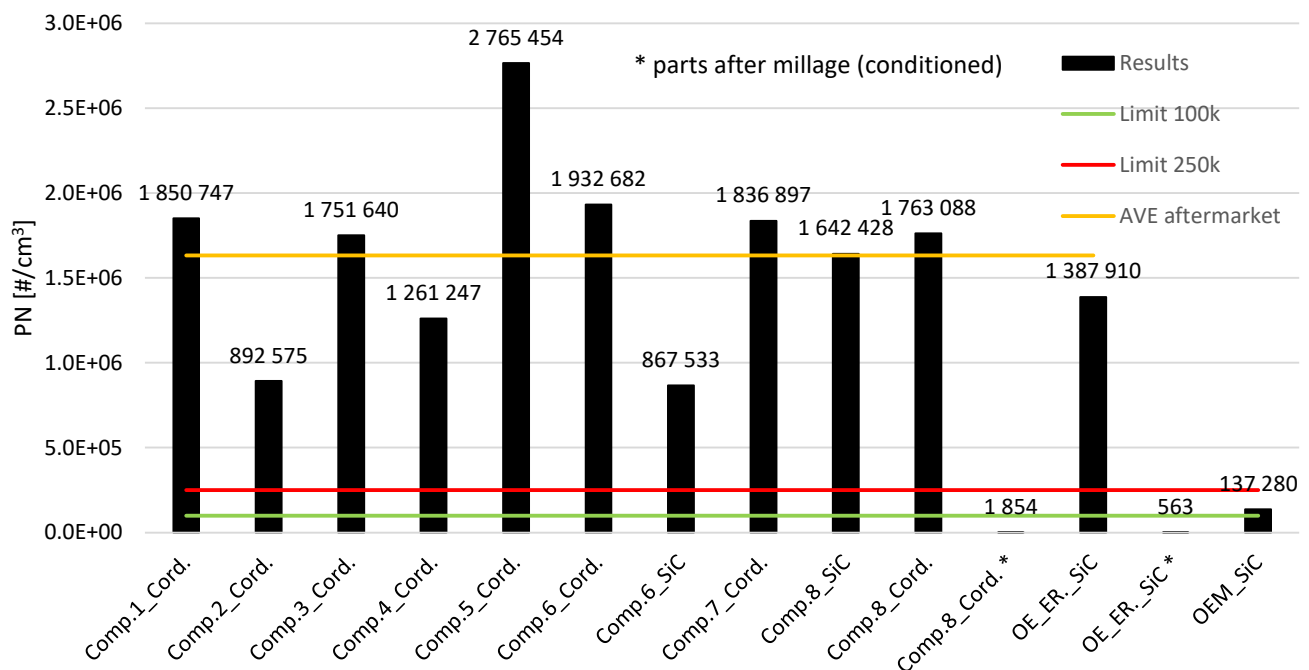
Fig. 14. PN emission results in a Peugeot 308 for different DPF filters from the aftermarket and original equipment

Referring to the results shown in Fig. 14, none of the aftermarket DPFs tested (representing eight different competitors) passed the particle number emission tests, regardless of substrate type (SiC or cordierite). The average particle number for these aftermarket parts was significantly high, reaching approximately 1.6 million  $\#/\text{cm}^3$ . Only the OEM DPF remained within the acceptable upper limit, achieving a value of 137,280  $\#/\text{cm}^3$ .

Interestingly, the OE Eurorepar filter ("OE\_ER\_SiC") also failed the test, clearly exceeding the regulatory limits. Although labeled as OE, this filter had been sourced through an aftermarket supplier, which was evident from its physical construction and manufacturer markings.

Additionally, after the initial testing, the OE Eurorepar part remained installed in the vehicle and was driven for approximately 1,000 km. A follow-up measurement then showed a dramatic improvement in performance, with a result of just 563  $\#/\text{cm}^3$ . Subsequently, a competitor 8 cordierite DPF ("Comp.8\_Cord.") was installed, driven for about 200 km, and also delivered very good results (1854  $\#/\text{cm}^3$ ). These road test results clearly indicate that aftermarket DPFs may require a period of conditioning before reaching their optimal filtration efficiency.

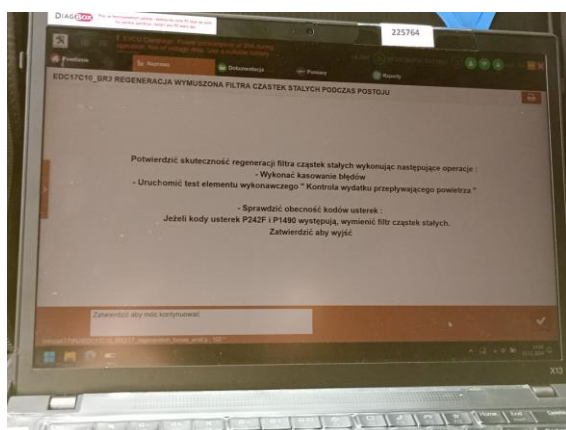
Fig. 15. Forced and stationary DPF filter regeneration by an authorized service

The final test conducted on the Peugeot 308 involved a forced regeneration of the DPF. After installing one of the aftermarket cordierite DPF filters, the particle number emissions were measured using the PNC device, resulting in a high value of 2 205 387  $\#/\text{cm}^3$ .

Subsequently, a forced regeneration procedure was performed at an authorized service. According to the manufacturer's diagnostic software, the regeneration process (Fig. 15) lasted approximately 1.5 hours and consisted of three identical cycles:

Immediately after the regeneration process, a follow-up PNC measurement showed that PN emissions had dropped below the 250,000  $\#/\text{cm}^3$  limit, with a result of 173,172  $\#/\text{cm}^3$ . This demonstrates that forced regeneration has a measurable positive effect on the functional performance of the DPF.

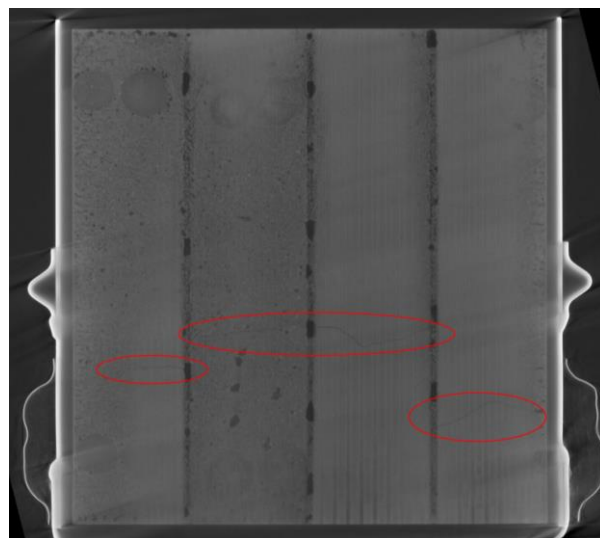
Fig. 16. Computer tomography of the DPF filter in the housing

Computed tomography of the DPF revealed multiple transverse cracks in the lower part of the DPF filter (Fig. 16), a characteristic sign of “ring-off cracks”, which commonly occur in diesel particulate filters [11, 19].

This type of damage usually happens when the DPF regeneration process doesn't occur properly. If the filter is clogged and the exhaust gases aren't hot enough, regeneration starts only at the front (inlet) of the filter. A heat wave then slowly moves toward the outlet. Because the rear part of the filter is still blocked with soot, it gets very hot. After some time, the high temperature at the outlet can also trigger regeneration from the rear side. Now, two heat waves travel toward each other – one from the front and one from the outlet. Meanwhile, the front of the filter stays relatively cool due to the incoming exhaust gases. This creates a strong temperature difference inside the filter. When the two heat zones meet (approximately one-third of the filter length from the rear), the thermal stress is so high that it causes the ceramic filter to crack – a failure known as “ring-off cracks”.

The primary cause appears to be thermal stress generated during uncontrolled or interrupted regeneration processes. This typically occurs when the filter is heavily loaded with soot and regeneration initiates irregularly, creating intense localized heating. The resulting thermal gradients induce mechanical stress within the ceramic structure, leading to transverse cracks (ring-off cracks). Additional contributing factors may include:

The cracks likely resulted from a combination of excessive soot accumulation, irregular regeneration, and extended thermal gradients, all of which contributed to structural damage of the ceramic DPF filter.

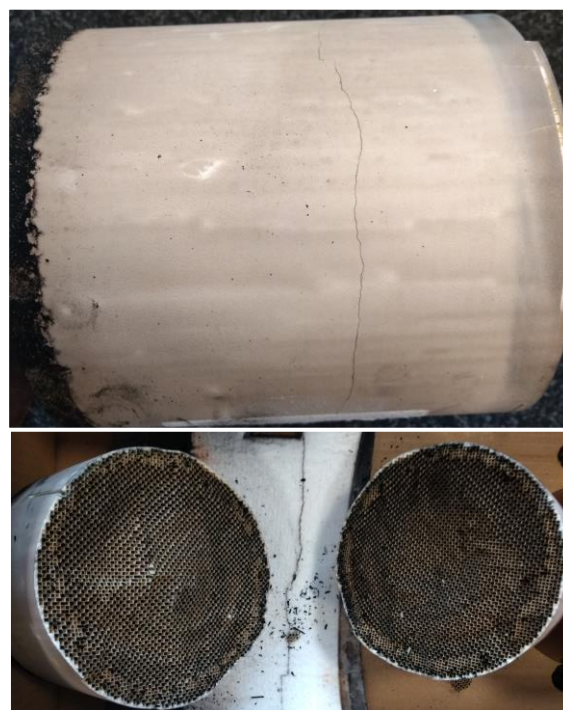
Fig. 17. The filter after removing it from the housing

After performing the CT scan of the DPF, the filter housing was cut for visual inspection of the internal damage. As shown in Fig. 17, a full circumferential crack was

confirmed, and the filter unexpectedly split into two separate parts upon removal from the surrounding support mat.

The vehicle owner reported that the car was mainly driven on very short trips, typically around 3 km and occasionally up to 10 km. Additionally, the driver was unaware of when DPF regeneration cycles occurred. This strongly suggests that regeneration processes were either unsuccessful or early interrupted, which is a known cause of ring-off cracks.

In this case, the increased particulate number emissions recorded by the PNC device were caused by structural cracks in the DPF, which were confirmed both through computed tomography scanning and after cutting the filter housing. In addition to the high emissions, visual inspection showed significant smoke, a dirty exhaust outlet, and a noticeable unpleasant odor coming from the tailpipe.

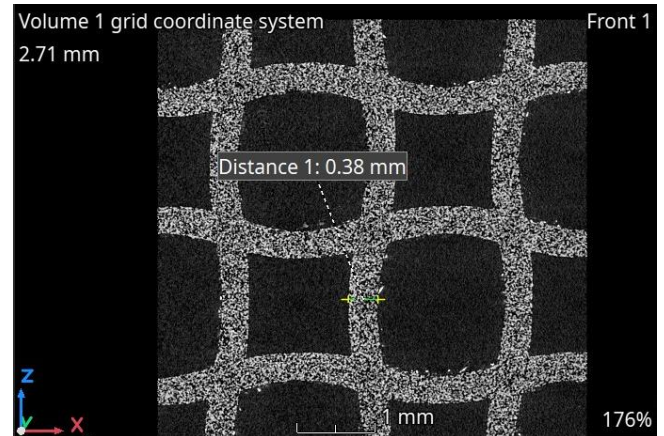
Fig. 20. Structure and wall thickness for OEM DPF SiC filter

Figure 20 shows the honeycomb structure of the OEM SiC filter, which features a relatively uncommon channel

geometry. In contrast, Fig. 21 presents the more typical honeycomb structure of an aftermarket cordierite filter. A comparison of both structures indicates that the wall thickness of the OEM filter is 0.38 mm, while the aftermarket filter has a thinner wall of 0.31 mm – approximately 18% thinner. This reduced wall thickness likely contributes to lower particle filtration efficiency.

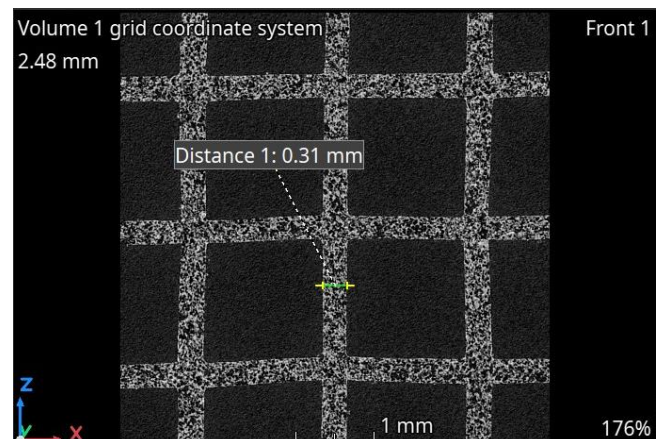
Fig. 21. Structure and wall thickness for Aftermarket DPF Cordierite filter

Additionally, the OEM filter walls appear denser, with smaller pore sizes, whereas the aftermarket filter shows greater porosity (higher percentage of open space within the porous wall structure). This increased porosity improves the flow of exhaust gases and, consequently, allows more solid particles to pass through the filter wall.
