## Comparative study of aftermarket and OEM DPFs for Periodic Technical Inspections (PTI) compliance with new PN emission limits

**Key words:** Periodic Technical Inspections, particle number counter, PN-PTI test, DPF

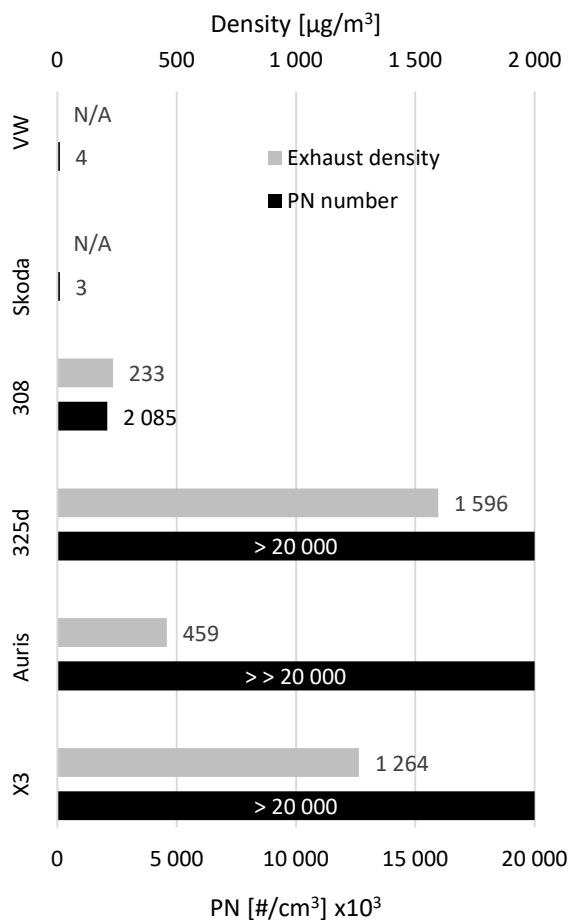
Fig. 10. DPFs assessment depending on PN emissions for different cars

As shown in Fig. 10, vehicles that were not originally equipped with a diesel particulate filter (BMW X3, BMW 325d, and Toyota Auris) exhibited PN emissions that exceeded the measurement range of the particle number counter, with values exceeding 20 million  $\#/cm^3$ . In terms of PM emissions, the BMW vehicles recorded “poor” results, according to the DPF100 tester. Interestingly, the Toyota Auris, despite also lacking a DPF, showed a “good” PM result, with a value below 500  $\mu g/m^3$ . This unexpected outcome for the Toyota may be attributed to the engine being fully warmed up at the time of testing. This suggests that the DPF100 PM tester may not be reliable as a standalone tool for verifying the presence or functionality of a DPF part, as thermal conditions can significantly influence the readings. For the Peugeot 308, the PN measurement exceeded 2 million  $\#/cm^3$ , which clearly indicates a malfunction of the DPF. However, the PM tester reported a “good” result of 233  $\mu g/m^3$ , again highlighting the limited diagnostic reliability of the DPF100 PM tester. Only the Skoda and Volkswagen vehicles produced PN results within the acceptable range, indicating that their DPF parts were functioning properly.

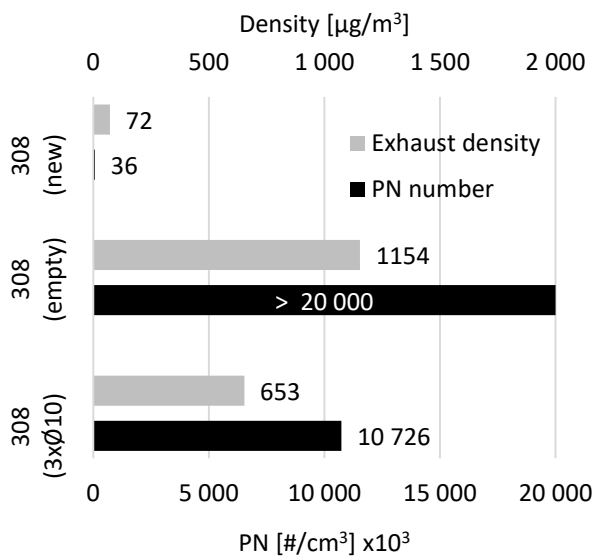
Fig. 11. PN emission results for damaged and new DPF in a Peugeot 308

Figure 11 presents the results obtained from a series of controlled modifications performed on the DPF of a Peugeot 308. Initially, three 10 mm diameter holes were drilled into the existing DPF. In this configuration, the PNC immediately detected abnormally high PN emissions exceeding 10 million  $\#/cm^3$ , indicating severe filter damage. However, the DPF100 PM tester reported a “marginal” result of 653  $\mu g/m^3$ , suggesting that the filter was not in optimal condition.

In the next stage, the DPF core was completely removed. This resulted in an even higher PN reading from the PNC (over 20 million  $\#/cm^3$ ) and notably higher PM emis-

sions measured by the DPF100 to  $1154 \mu\text{g}/\text{m}^3$ , classified as a “poor” result. At this point, both devices correctly indicated the lack of DPF functionality.

tion. The PN count dropped dramatically to  $36,000 \#/\text{cm}^3$ , and the PM tester showed a “good” result of  $72 \mu\text{g}/\text{m}^3$ . These results confirm that while both devices can detect a fully removed or replaced filter, only the PNC counter reliably identifies partial damage (e.g., drilled holes), highlighting its superior sensitivity to even minimal damage to the DPF.

Finally, after installing a new aftermarket DPF, both instruments recorded values consistent with proper filter opera-

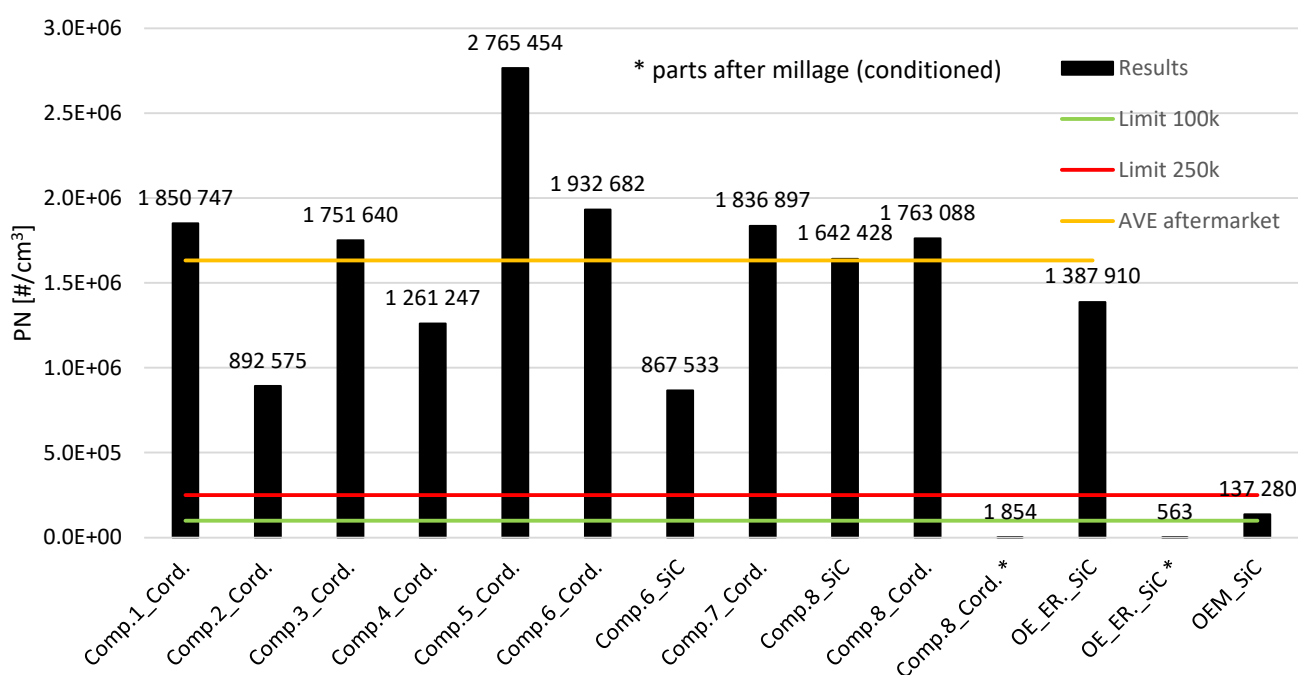
Fig. 14. PN emission results in a Peugeot 308 for different DPF filters from the aftermarket and original equipment

Referring to the results shown in Fig. 14, none of the aftermarket DPFs tested (representing eight different competitors) passed the particle number emission tests, regardless of substrate type (SiC or cordierite). The average particle number for these aftermarket parts was significantly high, reaching approximately 1.6 million  $\#/\text{cm}^3$ . Only the OEM DPF remained within the acceptable upper limit, achieving a value of 137,280  $\#/\text{cm}^3$ .

Interestingly, the OE Eurorepar filter ("OE\_ER\_SiC") also failed the test, clearly exceeding the regulatory limits. Although labeled as OE, this filter had been sourced through an aftermarket supplier, which was evident from its physical construction and manufacturer markings.

Additionally, after the initial testing, the OE Eurorepar part remained installed in the vehicle and was driven for approximately 1,000 km. A follow-up measurement then showed a dramatic improvement in performance, with a result of just 563  $\#/\text{cm}^3$ . Subsequently, a competitor 8 cordierite DPF ("Comp.8 Cord.") was installed, driven for about 200 km, and also delivered very good results (1854  $\#/\text{cm}^3$ ). These road test results clearly indicate that aftermarket DPFs may require a period of conditioning before reaching their optimal filtration efficiency.

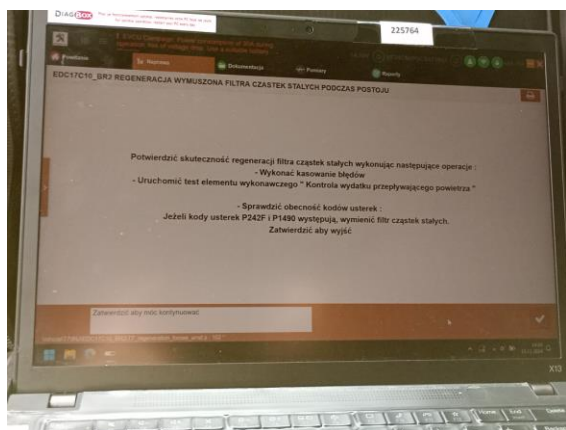
Fig. 15. Forced and stationary DPF filter regeneration by an authorized service

The final test conducted on the Peugeot 308 involved a forced regeneration of the DPF. After installing one of the aftermarket cordierite DPF filters, the particle number emissions were measured using the PNC device, resulting in a high value of 2 205 387  $\#/\text{cm}^3$ .

Subsequently, a forced regeneration procedure was performed at an authorized service. According to the manufacturer's diagnostic software, the regeneration process (Fig. 15) lasted approximately 1.5 hours and consisted of three identical cycles:

Immediately after the regeneration process, a follow-up PNC measurement showed that PN emissions had dropped below the 250,000  $\#/\text{cm}^3$  limit, with a result of 173,172  $\#/\text{cm}^3$ . This demonstrates that forced regeneration has a measurable positive effect on the functional performance of the DPF.

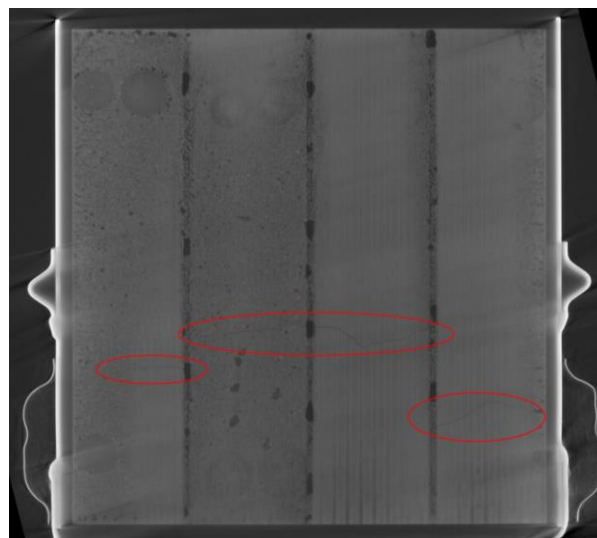
Fig. 16. Computer tomography of the DPF filter in the housing

Computed tomography of the DPF revealed multiple transverse cracks in the lower part of the DPF filter (Fig. 16), a characteristic sign of “ring-off cracks”, which commonly occur in diesel particulate filters [11, 19].

This type of damage usually happens when the DPF regeneration process doesn't occur properly. If the filter is clogged and the exhaust gases aren't hot enough, regeneration starts only at the front (inlet) of the filter. A heat wave then slowly moves toward the outlet. Because the rear part of the filter is still blocked with soot, it gets very hot. After some time, the high temperature at the outlet can also trigger regeneration from the rear side. Now, two heat waves travel toward each other – one from the front and one from the outlet. Meanwhile, the front of the filter stays relatively cool due to the incoming exhaust gases. This creates a strong temperature difference inside the filter. When the two heat zones meet (approximately one-third of the filter length from the rear), the thermal stress is so high that it causes the ceramic filter to crack – a failure known as “ring-off cracks”.

The primary cause appears to be thermal stress generated during uncontrolled or interrupted regeneration processes. This typically occurs when the filter is heavily loaded with soot and regeneration initiates irregularly, creating intense localized heating. The resulting thermal gradients induce mechanical stress within the ceramic structure, leading to transverse cracks (ring-off cracks). Additional contributing factors may include:

The cracks likely resulted from a combination of excessive soot accumulation, irregular regeneration, and extended thermal gradients, all of which contributed to structural damage of the ceramic DPF filter.

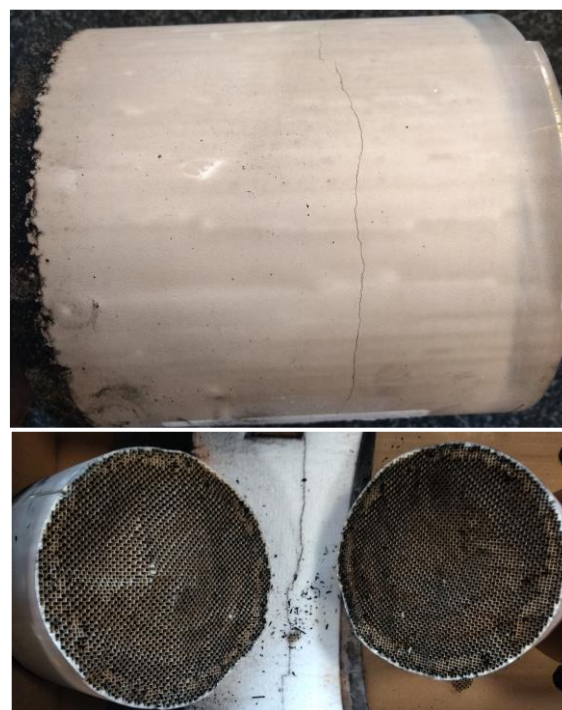
Fig. 17. The filter after removing it from the housing

After performing the CT scan of the DPF, the filter housing was cut for visual inspection of the internal damage. As shown in Fig. 17, a full circumferential crack was

confirmed, and the filter unexpectedly split into two separate parts upon removal from the surrounding support mat.

The vehicle owner reported that the car was mainly driven on very short trips, typically around 3 km and occasionally up to 10 km. Additionally, the driver was unaware of when DPF regeneration cycles occurred. This strongly suggests that regeneration processes were either unsuccessful or early interrupted, which is a known cause of ring-off cracks.

In this case, the increased particulate number emissions recorded by the PNC device were caused by structural cracks in the DPF, which were confirmed both through computed tomography scanning and after cutting the filter housing. In addition to the high emissions, visual inspection showed significant smoke, a dirty exhaust outlet, and a noticeable unpleasant odor coming from the tailpipe.

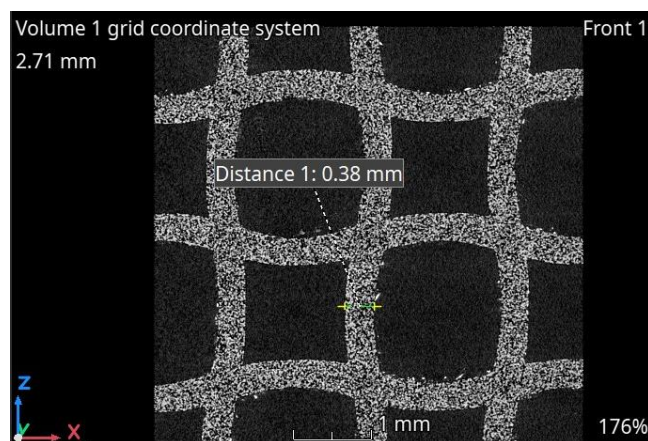
Fig. 20. Structure and wall thickness for OEM DPF SiC filter

Figure 20 shows the honeycomb structure of the OEM SiC filter, which features a relatively uncommon channel

geometry. In contrast, Fig. 21 presents the more typical honeycomb structure of an aftermarket cordierite filter. A comparison of both structures indicates that the wall thickness of the OEM filter is 0.38 mm, while the aftermarket filter has a thinner wall of 0.31 mm – approximately 18% thinner. This reduced wall thickness likely contributes to lower particle filtration efficiency.

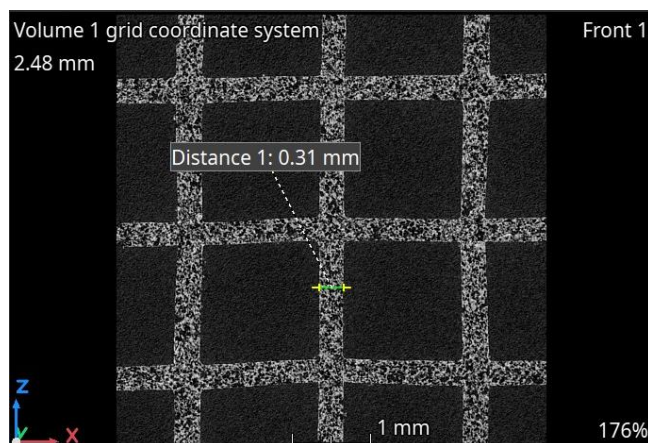
Fig. 21. Structure and wall thickness for Aftermarket DPF Cordierite filter

Additionally, the OEM filter walls appear denser, with smaller pore sizes, whereas the aftermarket filter shows greater porosity (higher percentage of open space within the porous wall structure). This increased porosity improves the flow of exhaust gases and, consequently, allows more solid particles to pass through the filter wall.

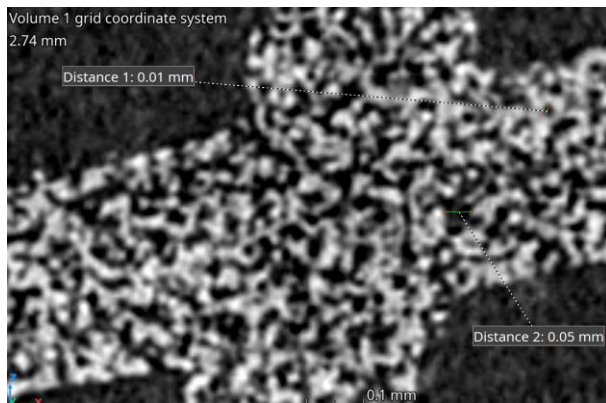
Fig. 22. OEM filter wall – magnified pore structure

Figure 22 (OEM filter) and Fig. 23 (aftermarket filter) show magnified CT scan images of the filter walls and their pores. Several representative pore diameters are indicated, ranging from small pores of approximately 0.01 mm to larger ones around 0.06 mm. A visual comparison shows that the OEM filter contains a greater number of smaller pores, whereas the aftermarket filter exhibits larger pores.

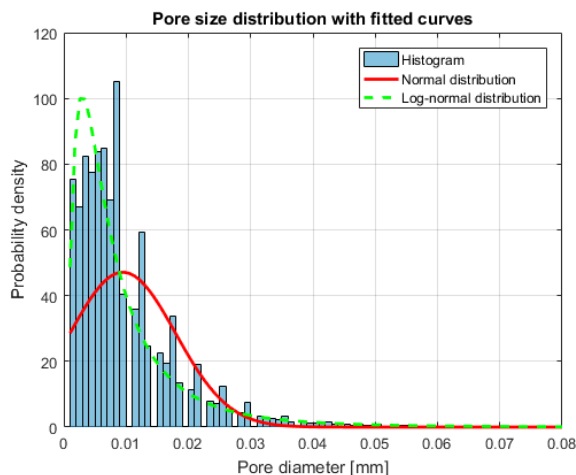
Fig. 24. Pore size distribution – OEM filter section

The OEM filter exhibits a more homogeneous pore structure, characterized by a narrower pore size distribution and reduced variability in pore diameters. In contrast, the aftermarket filter shows a broader pore size distribution, including a noticeable presence of larger pores. Such characteristics may suggest reduced efficiency in capturing fine particulate matter, although they could also result in lower flow resistance (i.e., lower pressure drop) across the filter.

Based on this analysis, the mean pore diameter was calculated to be  $9.5\ \mu\text{m}$  for the OEM filter and  $11.1\ \mu\text{m}$  for the aftermarket filter. The porosity of each filter was determined by calculating the ratio of total pore volume to total sample volume, expressed as a percentage. According to this approach, the OEM filter exhibited a porosity of 39.5%, while the aftermarket filter showed a higher porosity of 45.5%.

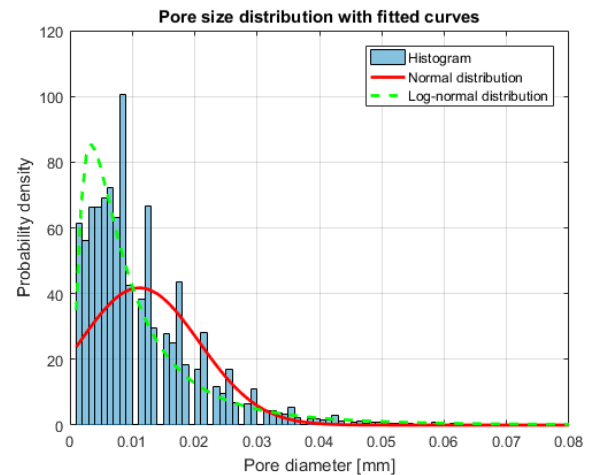
Fig. 25. Pore size distribution – aftermarket filter section

As a result, the new aftermarket filter shows higher PN emissions during the initial phase. However, after a short conditioning period, the larger pores begin to fill with particulate matter, which enhances the filter's ability to trap particles and reduces emissions to levels compliant with regulatory limits.
