## Investigation of the effect of engine running time on the material characteristics of a piston

Regardless of the class of passenger car, manufacturer, or type of internal combustion engine, vehicle owners strive to ensure the longest possible period of reliable engine operation. The reliability and performance of an internal combustion engine are key indicators of its quality and prestige. Numerous research and development studies have focused on optimizing piston design and identifying the causes of piston failure. However, to better understand degradation mechanisms and trends in modern piston design, it is necessary to investigate the phenomena affecting the piston during typical engine service life. Thermomechanical stresses, friction, elevated and fluctuating temperatures, and contaminants all contribute to piston wear and reduce its service life. In this study, a new aluminum piston was compared with a piston extracted from an engine after approximately 200,000 kilometers of operation. The influence of engine operating time on piston surface condition, hardness, microstructure, and surface quality was analyzed. These parameters provide insight into the impact of friction

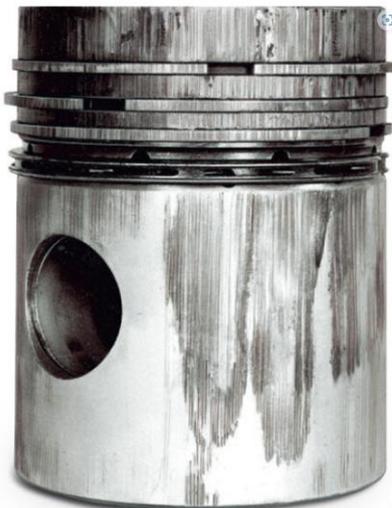
However, a more functional and diagnostically useful classification is based on the underlying cause of the failure. One of the most common and severe types is piston seizure due to overheating, as illustrated in Fig. 2. There are four primary causes of such failures: delayed combustion-induced overheating, incorrect piston installation (wrong piston type), blocked oil injection, and cooling system malfunction [21].

Fig. 2. Photograph of a piston damaged by seizure [21]

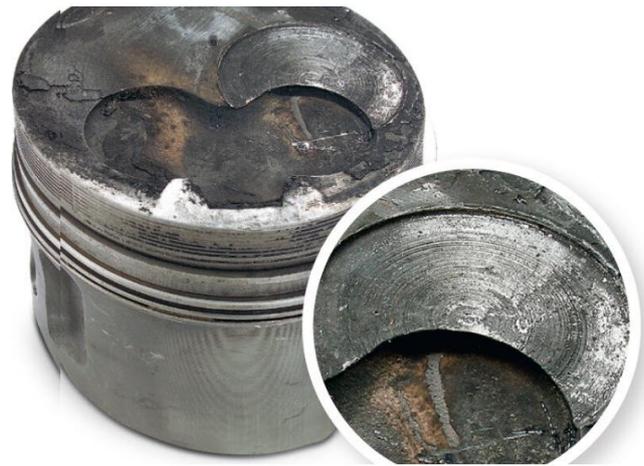
Another common type of piston failure in internal combustion engines is damage to the piston crown. This type of failure may have multiple causes, including: incorrect valve recess depth, excessive piston protrusion above the cylinder deck, carbon deposits on the piston crown, excessive machining of the cylinder head sealing surfaces, improper cylinder head sealing, insufficient valve clearance, and incorrect valve timing [21]. An example of piston crown damage is shown in Fig. 3.

Fig. 3. Photograph of a piston with a damaged crown [21]

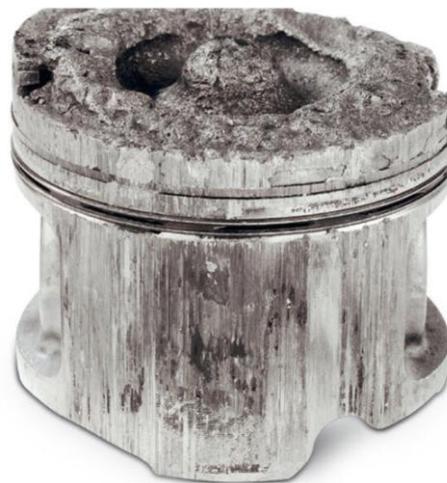
A more dramatic form of piston failure in internal combustion engines is piston material melting. An example of a piston exhibiting material melting is shown in Fig. 4. According to the literature, there are six primary causes of piston melting:

- incorrect fuel injection quantity
- improper injection timing
- faulty or damaged injector nozzles
- delayed ignition
- insufficient compression
- oscillations in the fuel injection lines.

Fig. 4. Photograph of a piston damaged by crown melting [21]

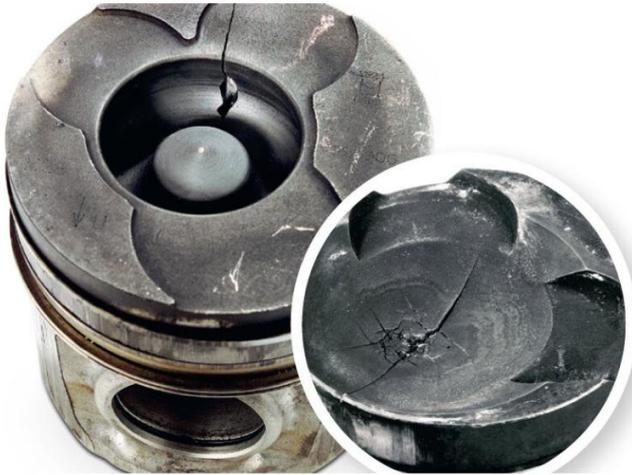
Another common type of piston failure is cracking of the piston crown and combustion chamber area [19, 21]. This type of damage is particularly frequent in older-generation diesel engines. An example of such failure is shown in Fig. 5. The most common causes include:

- incorrect fuel injection timing
- damaged or unsuitable injector nozzle
- improper fuel injection quantity
- lack of piston cooling
- chip tuning (increasing engine power without accounting for thermal limits)

- installation of pistons with improper combustion bowl geometry
- insufficient compression.

Fig. 5. Photograph of a piston damaged by cracking in the combustion chamber [21]

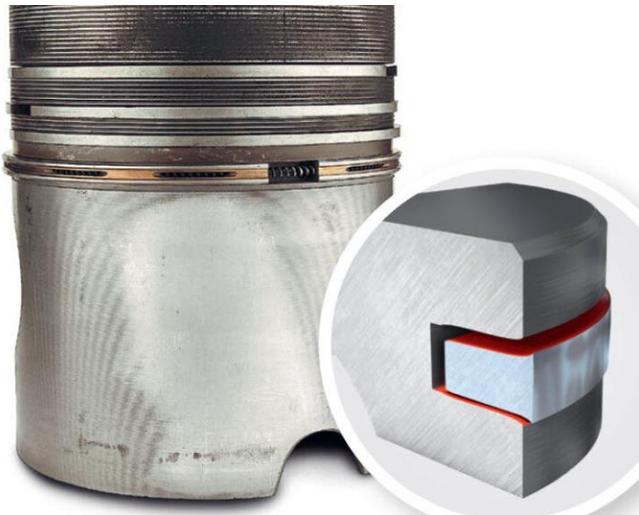
Axial wear caused by contamination is shown in Figure 6. Dirt and other impurities that enter the engine oil form an abrasive mixture that acts like sandpaper, leading to wear of the piston skirt. Infrequent oil and filter changes can significantly accelerate piston degradation and may ultimately result in critical engine failure.

Fig. 6. Photograph of a piston damaged by dirt intrusion [21]

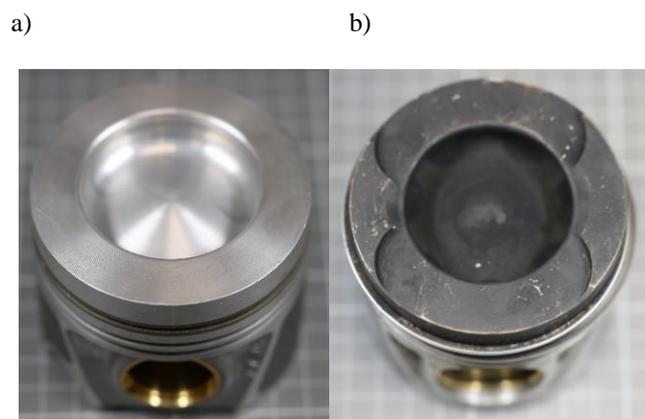
Figure 8 presents a comparison of the piston crown and combustion chamber area between a new and a used internal combustion engine piston. On the surface of the used piston crown, residual soot is visible in the form of a black deposit. Minor scratches were also observed, likely caused during disassembly or handling. No cracks, melting, or material loss were identified. The crown edges remain smooth, with no visible deformation. The piston crown and combustion chamber surfaces show no wear beyond what

would be expected from the normal combustion process of the air-fuel mixture during engine operation.

Fig. 8. Piston crown with combustion chamber: a) new diesel engine piston, b) piston after approximately 200,000 kilometers of operation

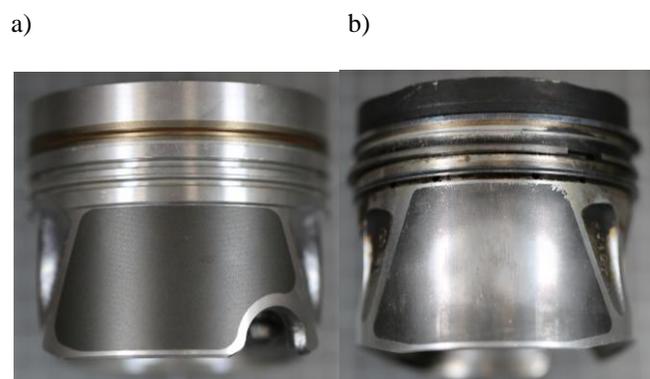
Figure 9 presents a comparison of the skirt and ring land areas of a new piston and a used piston from an internal combustion engine with approximately 200,000 kilometers of service. The comparison reveals noticeable wear on the piston's lateral surface. The graphite-based coating on the load-bearing surface has worn off, with no longitudinal scratches observed. The wear pattern corresponds to the contact zone between the piston and the cylinder wall. A significant accumulation of carbon deposits is visible on the fire land, forming a thick layer. Discoloration is also apparent on the ring land surfaces.

Fig. 9. View of the piston skirts from internal combustion engines: a) unused piston, b) used piston

- Reinforcement of the combustion chamber, e.g., by applying Durablow® technology or protective coatings on the piston crown
- Enhancement of heat dissipation efficiency through optimization of the cooling channel geometry
- Reduction of frictional wear on the piston skirt by applying advanced graphite-based coatings.

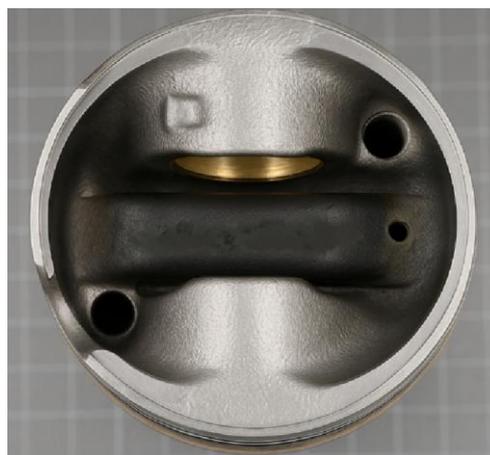
The final area showing visible changes compared to the new piston is the underside of the piston crown in the combustion chamber region, as shown in Fig. 10. Despite the presence of an internal cooling channel, this surface was exposed to significant thermal stress. No surface damage or cracking was observed on the inner side of the piston. However, the area exhibits signs of overheating, likely due to localized exceedance of thermal limits.

Fig. 10. View of the overheated internal area of a used internal combustion engine piston

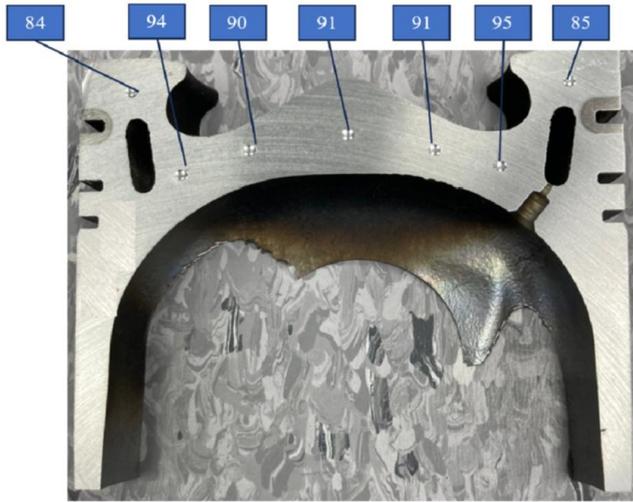
The hardness measurement points for the used piston are shown in Fig. 14. Measurements were taken at seven locations. The highest recorded hardness was 94 HB, while the lowest was 84 HB. The average hardness of the used piston was 90 HB, with a spread of 11 HB. The lowest hardness values were observed near the piston crown, whereas the highest values occurred near the oil gallery on the combustion chamber side.

Fig. 14. Used diesel engine piston with marked hardness measurement points and HB values

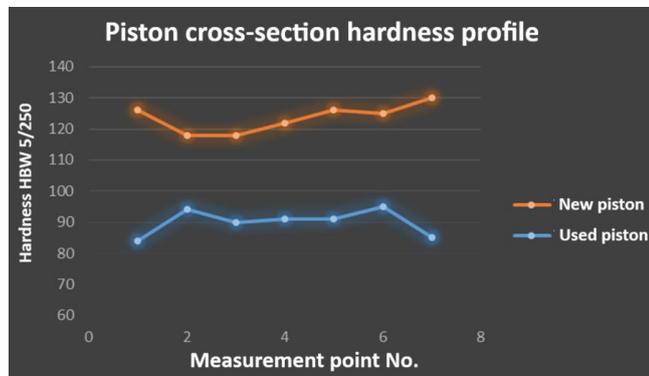
Figure 15 compares the hardness profiles of a new diesel engine piston and a piston with 200,000 kilometers of service. The new piston exhibits consistently higher hardness across the entire cross-section, on average approximately 28% greater than that of the used piston. The most significant reduction in hardness was observed near the piston crown, amounting to approximately 34%.

Fig. 15. Comparison of hardness profiles of new and used pistons in cross-section

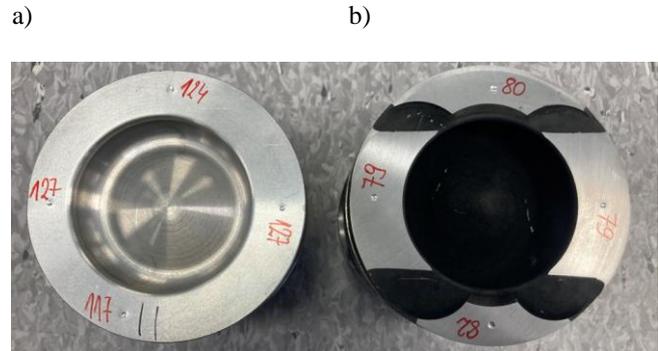
The measured hardness values on the crown of the new piston were: 124, 127, 117, and 127 HBW. For the used piston, the corresponding values were: 80, 79, 82, and 79 HBW. The hardness reduction along the piston pin bore axis was approximately 33%, while along the skirt axis it

was about 38%. This significant decrease in hardness on the piston crown is likely due to prolonged exposure to elevated temperatures during engine operation. Such a substantial loss of hardness adversely affects the fatigue strength and overall durability of the piston, increasing the risk of premature wear or mechanical failure.

Fig. 16. Hardness measurement of the piston crown: a) new piston, b) used piston

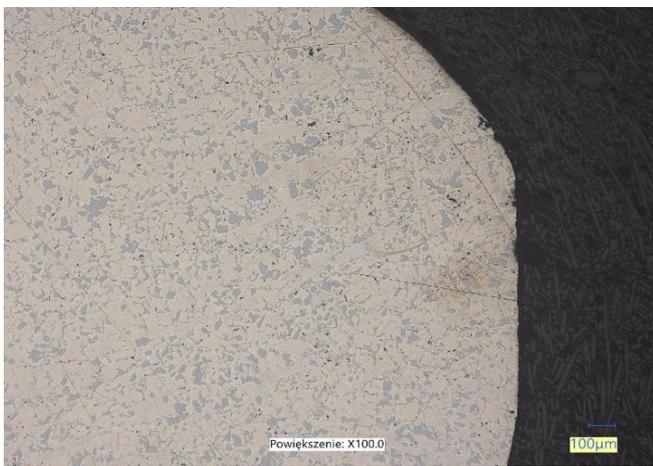
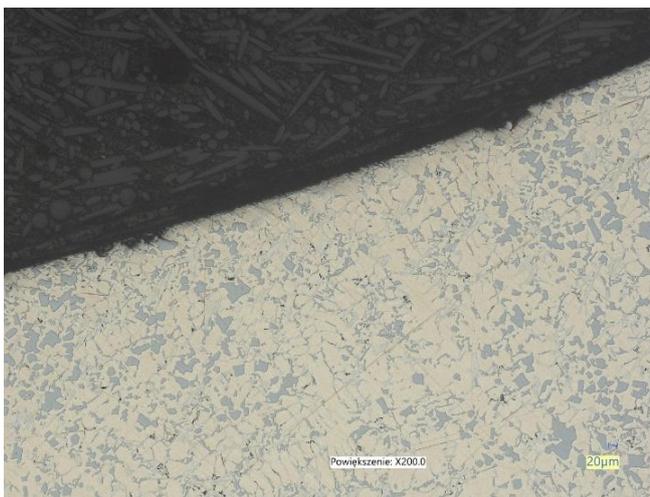
The metallographic specimen included the ring land area, piston crown, and combustion chamber region. Figure 17a shows the new piston with the selected areas marked for analysis. Four zones were examined: the piston crown, the combustion chamber edge, and two locations within the combustion chamber. All examined edges in the new diesel engine piston were continuous, uniform, and free of any irregularities. The microstructure in these areas was fine-grained and consistent across all analyzed zones. Figure 18a shows the edge of the combustion chamber in the new piston, while Fig. 18b presents the same area in the used piston. In the used piston, burn marks and localized edge degradation up to 0.04 mm deep were observed. These thermal erosions are numerous and distributed across the entire surface of the combustion chamber.

Fig. 18. View of typical burn marks on the surface of a used piston: a) combustion chamber edge, b) combustion chamber

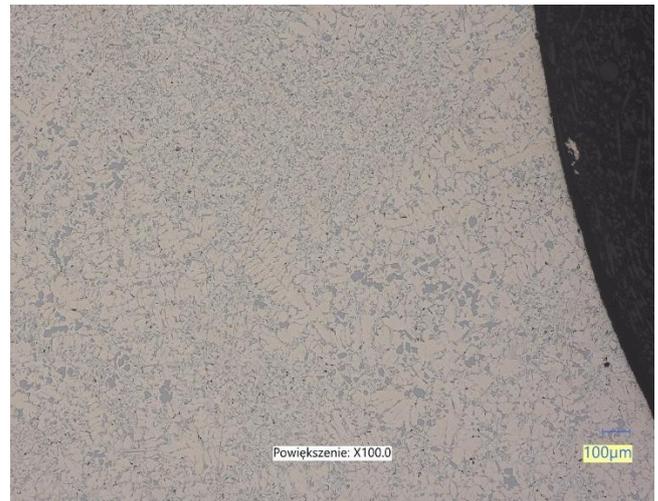
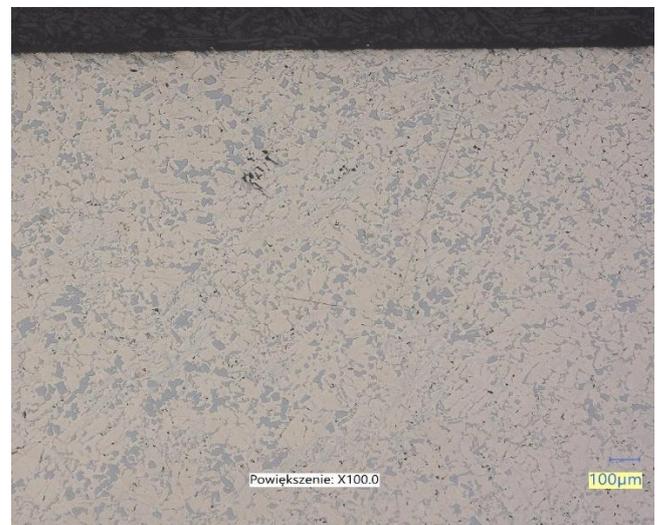
Analysis of the microstructure of the used internal combustion engine piston in various regions revealed grain refinement in the combustion chamber area adjacent to the piston's internal cooling channel, as shown in Fig. 19a. When compared to the microstructure near the piston crown

(Fig. 19b), the difference in grain size is clearly noticeable. This effect was not observed in the new piston. The analyzed region is subjected to both high temperatures and pressures generated during combustion, as well as thermal gradients caused by the cooling channel extracting heat from the combustion chamber. The presence of the cooling channel may have contributed to the observed local microstructural refinement in this area.

Fig. 19. Metallographic cross-section of the upper part of the piston pin bore in the used piston
