Investigation of the effect of engine running time on the material characteristics of a piston

ARTICLE INFO

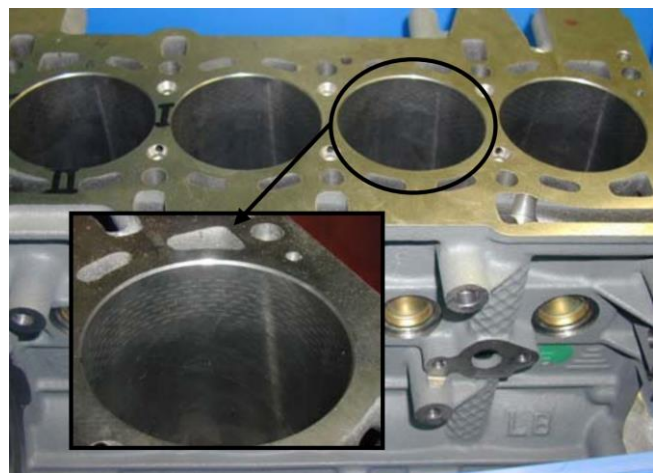
Fig. 1. Photograph of a four-cylinder passenger car engine block [16]

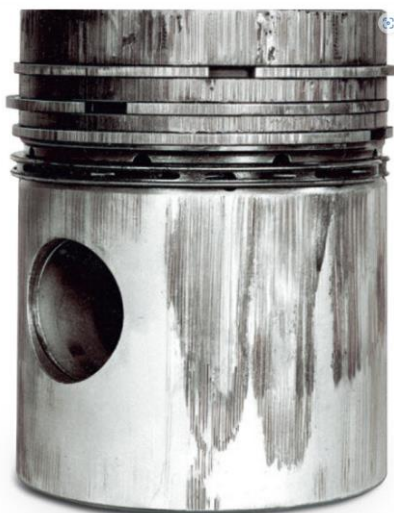
Fig. 2. Photograph of a piston damaged by seizure [21]

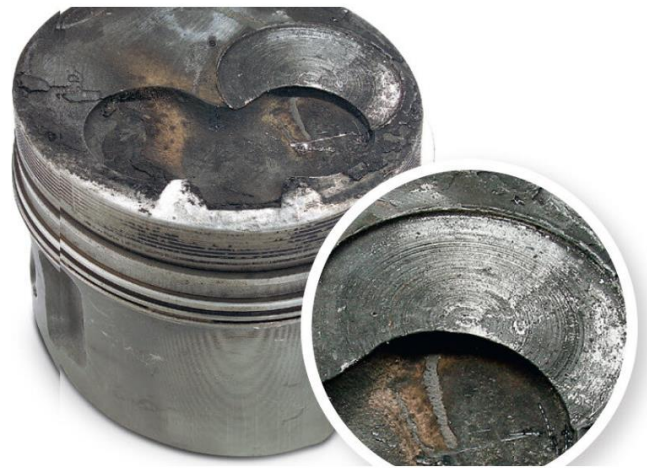
Fig. 3. Photograph of a piston with a damaged crown [21]

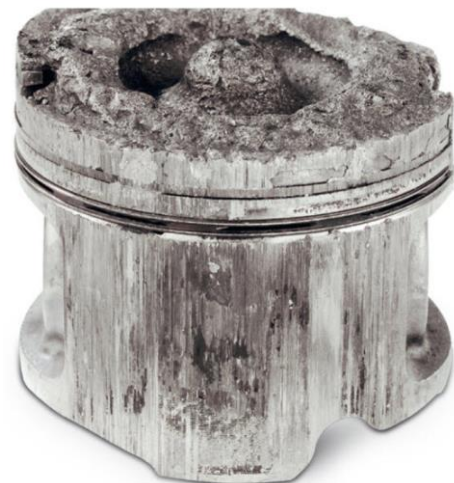
Fig. 4. Photograph of a piston damaged by crown melting [21]

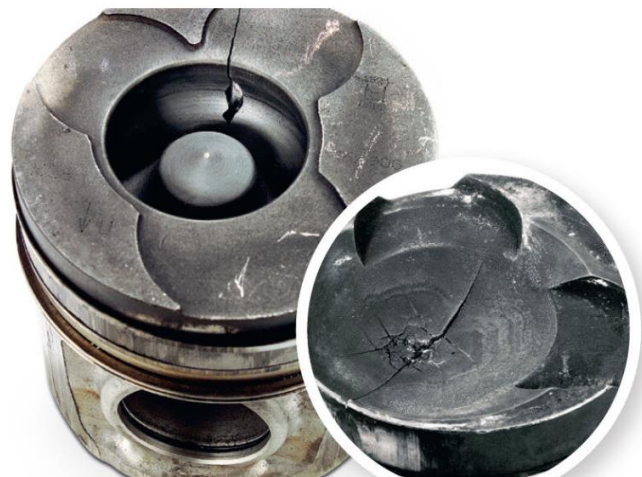
Fig. 5. Photograph of a piston damaged by cracking in the combustion chamber [21]

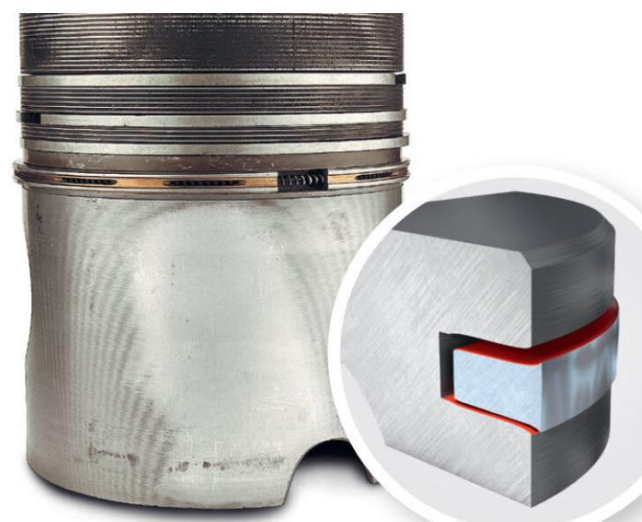
Fig. 6. Photograph of a piston damaged by dirt intrusion [21]

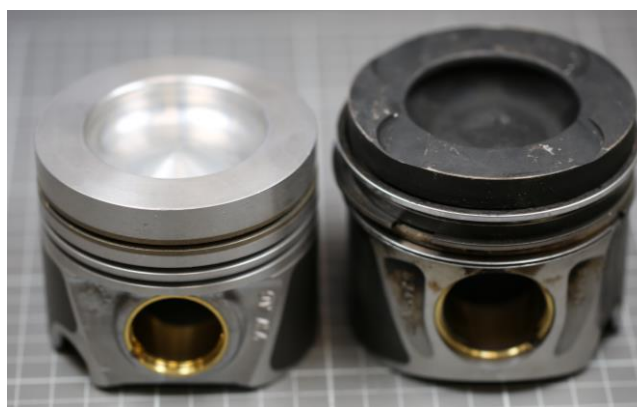
Fig. 7. Analyzed pistons from diesel engines

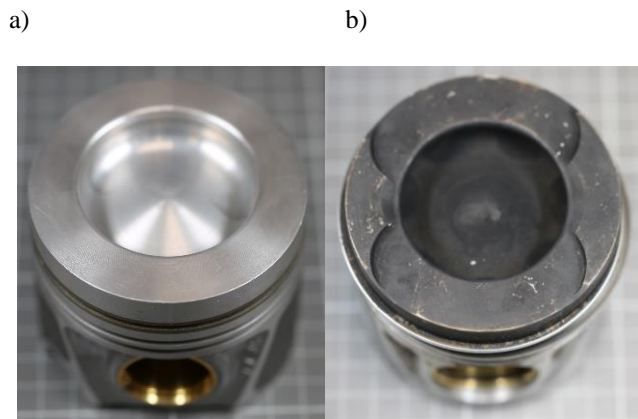
Fig. 8. Piston crown with combustion chamber: a) new diesel engine piston, b) piston after approximately 200,000 kilometers of operation

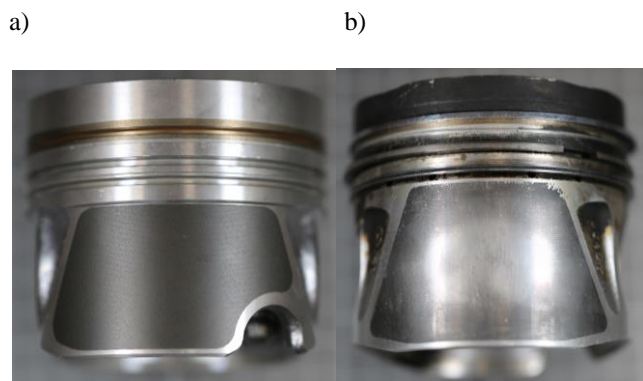
Fig. 9. View of the piston skirts from internal combustion engines: a) unused piston, b) used piston

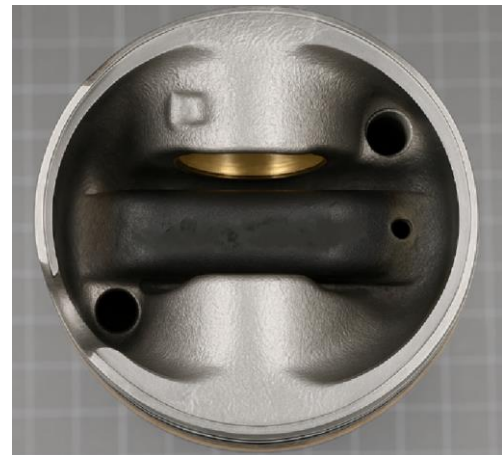
Fig. 10. View of the overheated internal area of a used internal combustion engine piston

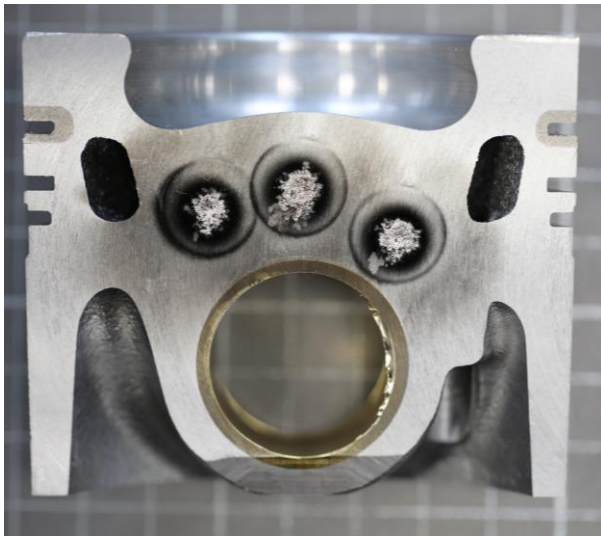
Fig. 11. Chemical composition measurement points on a new internal combustion engine piston

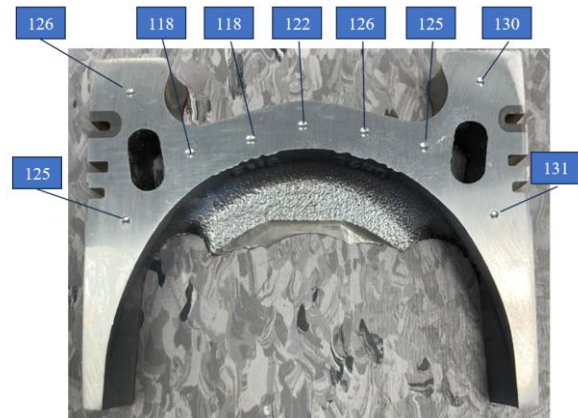
Fig. 13. Unused diesel engine piston with marked hardness measurement points and HB values

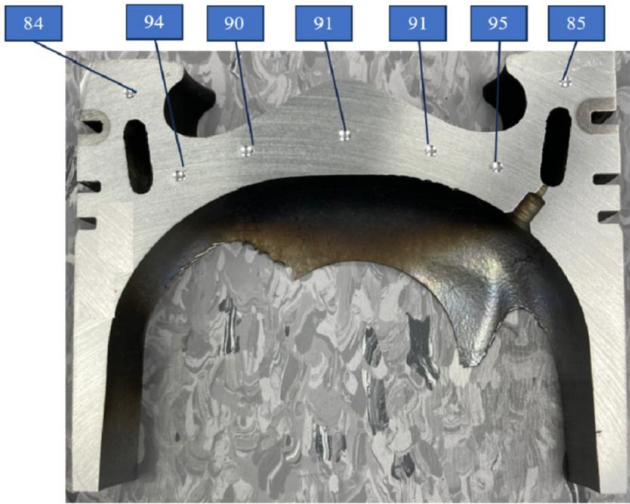
Fig. 14. Used diesel engine piston with marked hardness measurement points and HB values

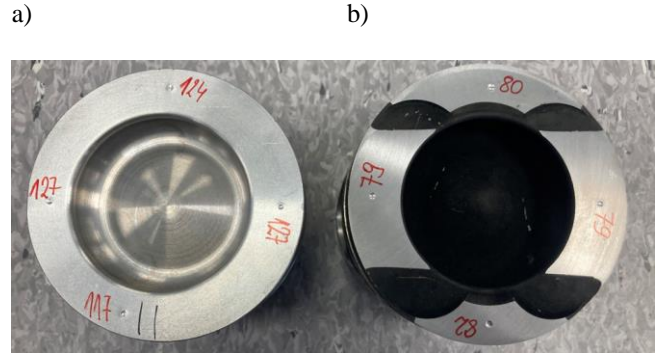
Fig. 16. Hardness measurement of the piston crown: a) new piston, b) used piston

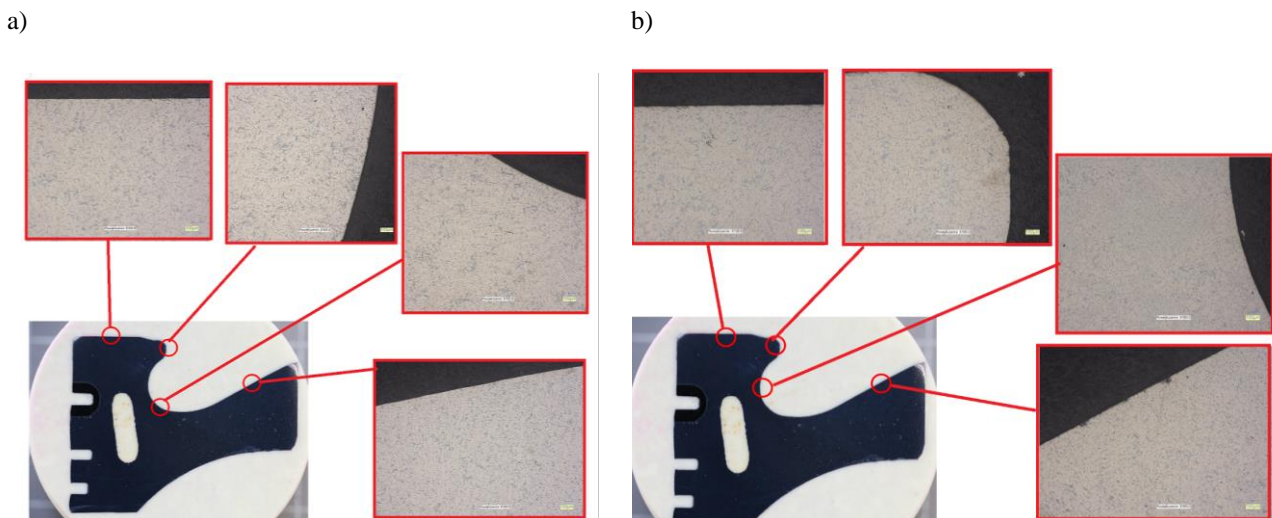
Fig. 17. Microstructure analysis locations: a) new piston, b) used piston

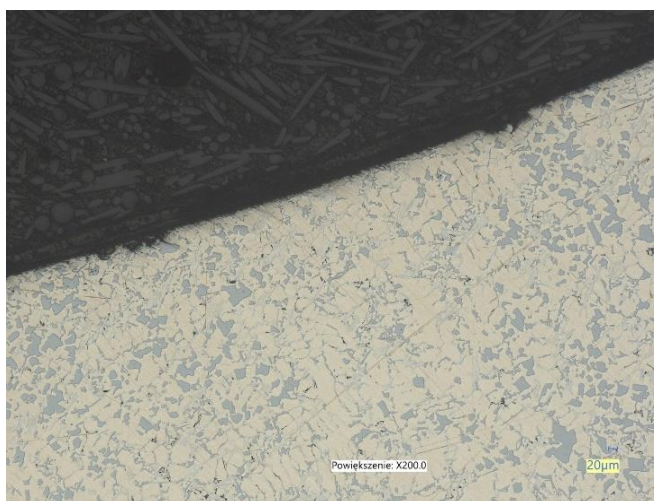
Fig. 18. View of typical burn marks on the surface of a used piston: a) combustion chamber edge, b) combustion chamber

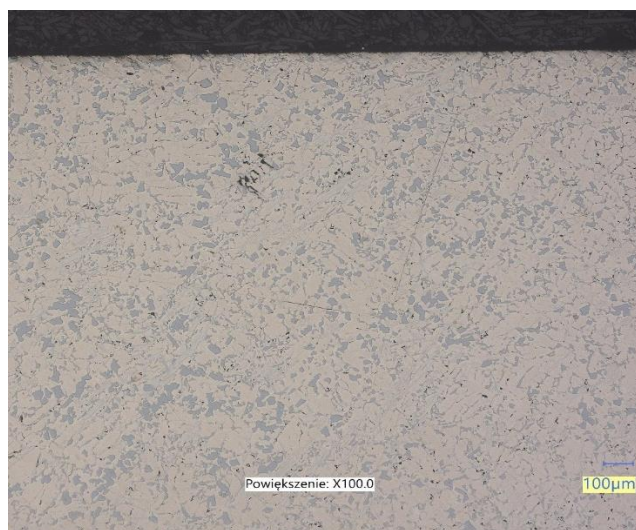
Fig. 19. Metallographic cross-section of the upper part of the piston pin bore in the used piston

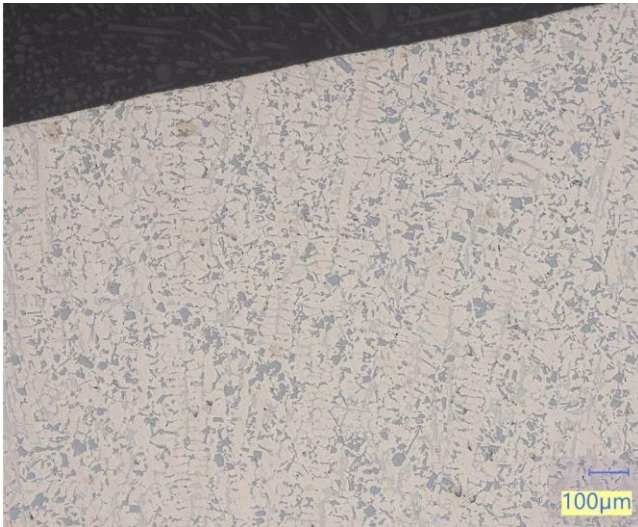
Fig. 20. Metallographic cross-section of the combustion chamber of a new internal combustion engine piston
