The effectiveness of fault detection in common rail injectors examination methods

The article presents the effectiveness tests of fault detection in common rail injectors. 40 injectors with different wear levels were tested. Testing was made on two test benches of a completely different design. Research includes comparison of accuracy, reproducibility and testability to detect specific defects. A device was created for visualization of the fuel injector spraying steam.

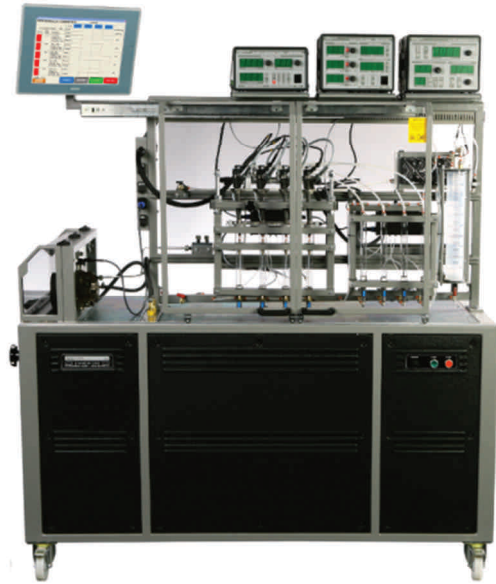
Fig. 2. STPiW 3

STPiW 3 is designed for testing pumps, injectors, pressure sensors and control valves which occur in common rail systems and systems with distributor pump. Construction of the test bench allows simultaneous testing of four injectors. Figure 3 shows the layout of the device. The fuel system has all the elements that can be found in a system of a car. The electric feed pump (1) supplies calibration fluid through the filter (2) to the high pressure pump (PO1). This is the 3-plunger radial-piston pump Bosch CP1H. It is driven through toothed belt by the induction motor (SIL). The motor is powered by the inverter (FAL) that provides smooth and precise speed control. The pump is controlled by the cut-off valve (ZAW2) and the pressure regulator valve (ZAW3). The rail (K) is equipped with the pressure sensor (CC1) and the pressure control valve (ZAW1). Pressure value in a high pressure system is controlled by the electronic module (D2) which controls all valves on the basis of a sensor reading. Tested injectors connected by flexible cables are placed in

the injected fuel quantity measuring cylinders (H). On the right side, there are cylinders that measure the return quantity (I). All return pipes are connected to the return collector (9) from which the liquid flows into the main tank (4). Injectors control the pulse generator (D1), which is set by the software on the computer connected to the device. In order to maintain accuracy of the tests and comparability of the results, it is necessary to keep the fluid temperature constant. This is done by the system, marked by dotted line, consisting of the heater (6), the electric pump (7) and the cooler with the fan (WEN1).

Quantity measurement begins with the measurement of hydrostatic pressure of the liquid in the measuring cylinders (H). Subsequently, the motor driving the pump is started. When the pump speed is stabilized, the pressure is adjusted to the setpoint. In the next stage, the injectors start injecting the calibration fluid into the measuring cylinders. The standard measuring cycle is set to 1000 injections. At the end of the series of injections, the hydrostatic pressure is measured again. Based on the pressure difference, before and after a test, the software calculates the amount of liquid that has increased during the test. Afterwards the volume is divided by the amount of injections which determines the injected fuel quantity.

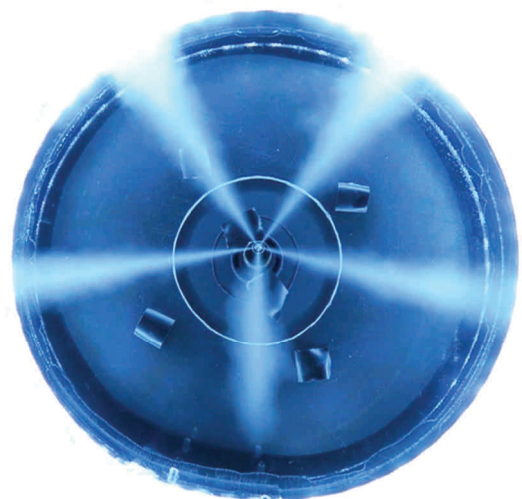
Fig. 20. Fuel spray pattern of a damaged injector

In addition, the spray pattern of the injector number 1 was documented (Fig. 20). The streams formed by the two upper holes are characterized by a larger cone angle than the others. Considering the amount of reflected light from these streams it can be inferred that they contained a higher injected fuel quantity. The spraying from the lower hole is

severely opened from the beginning, while the sprayed droplets have not yet reached the wall of the visualization chamber. This means that spreading speed of the droplets flowing from the lower hole is smaller than those from the remaining holes. The reason for such phenomenon is because the flow through this channel is disturbed by the unevenness of its geometry, which may be due to internal sediments.
