Comparative analysis of construction materials used for fastening elements of six-point safety belts in rally cars

Key words: *six-point safety belt, failure, motorsport, passive safety*

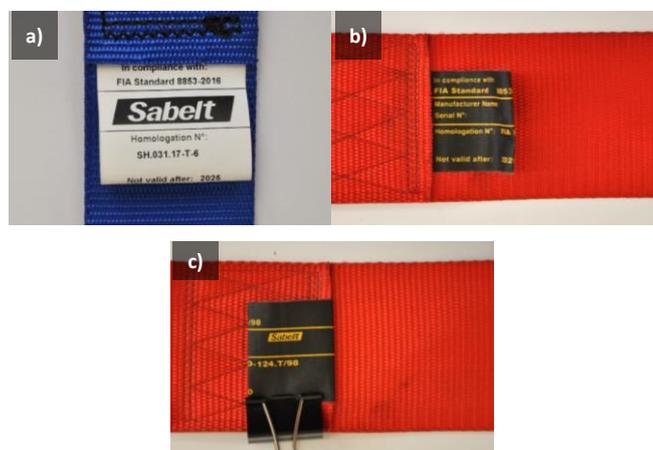
Fig. 1. Manufacturers' labels sewn onto the six-point harnesses containing information regarding compliance with the FIA standard and temporary homologation: a) original belt; b) c) imitations of the original belt

imitations of the same company's product. Each harness tested (original or imitation) had an appropriate label with the information required by FIA Standard 8853-2016 (Fig. 1): (1) the FIA standard number; (2) the manufacturer's name, which may be replaced by a logo; (3) the unique serial number of the harness; (4) the homologation number; (5) the year of the expiry date; (6) (optionally) the information about adaptation to the FRH system.

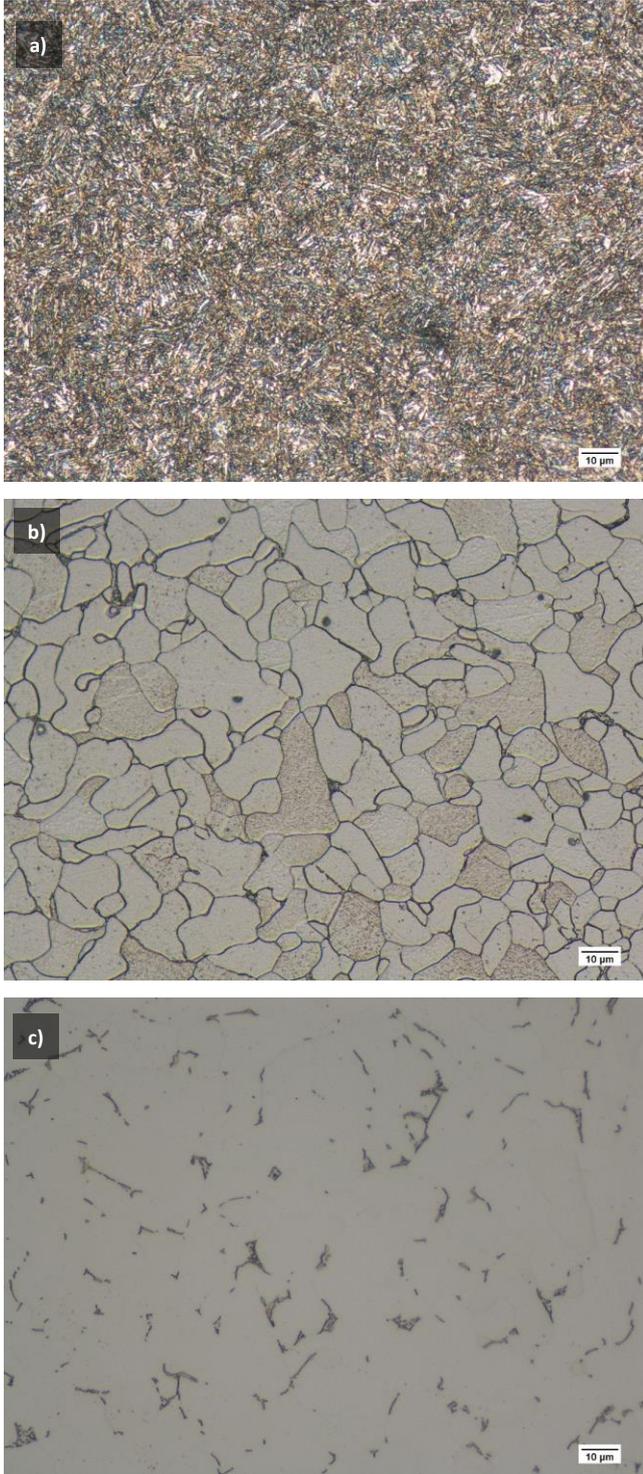
Fig. 2. Snap hook: a) original with tempered martensite microstructure; b) imitating original with ferritic microstructure with minor amount of pearlite colonies and presence of tertiary cementite at grain boundaries (micrograph c) in picral-etched state to visualize the extensive amount of cementite)

It was found that the snap hooks were made of two different grades of steel with various microstructure morphology and hardness. The original component was made of medium-carbon steel of grade C50 according to PN-EN ISO 683-1:2018-09. At the same time, it is characterized by the microstructure of tempered martensite, which indicates that the heat treatment process was carried out (Fig. 2a, Fig. 3a).

In case of the snap hook coming from the belt imitating the original one, it was made of low-carbon steel for cold forming of DC04 grade according to PN-EN 10130:2009 standard. It is characterized by a ferritic-pearlitic microstructure with locally occurring precipitations of tertiary cementite at grain boundaries (Fig. 2bc, Fig. 3bc). According to PN-EN 10130:2009, the mechanical properties of such steel are guaranteed for only six months after the product is made at the factory available to the customer, which is due to the aging processes occurring in this type of steel. The presence of tertiary cementite in excessive amounts reduce the toughness of steel, especially if it is located at the ferrite grain boundaries [2, 18]. For this reason, its amount, size and morphology are strictly controlled in the automotive low carbon steels in order to achieve a precipitation strengthening effect instead of a deterioration of the mechanical properties (mainly decrease in toughness) [4, 16, 24, 27].

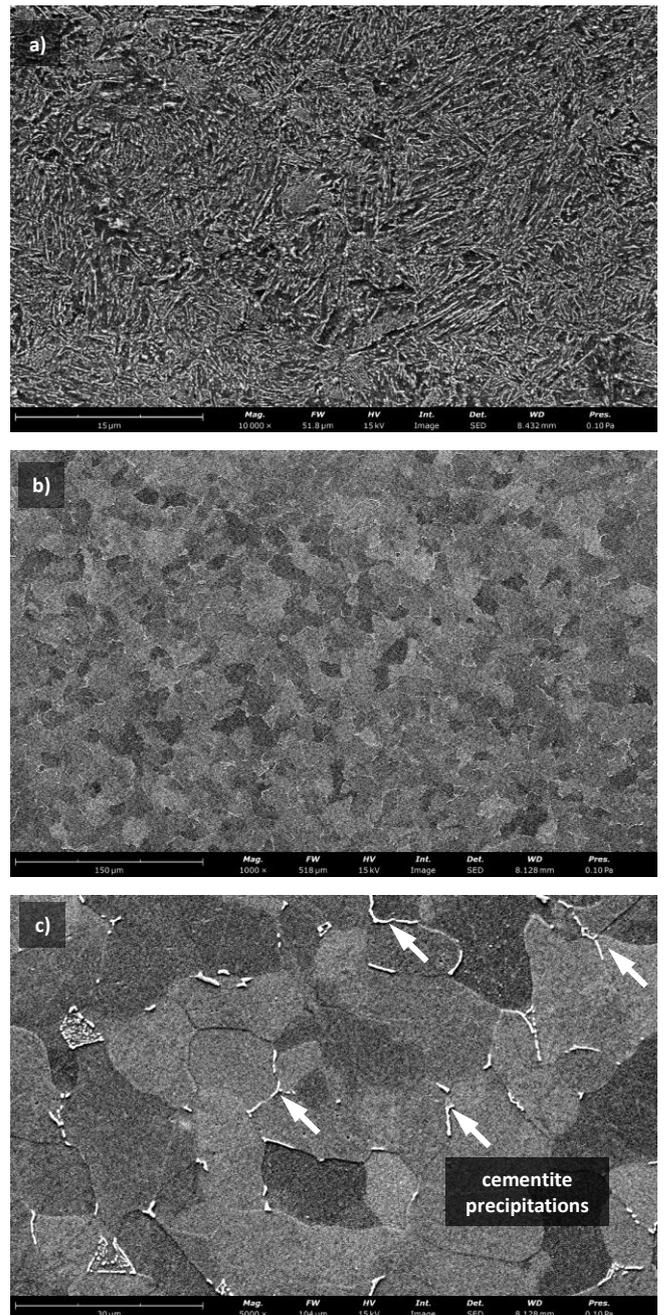
Fig. 3. Snap hook: a) original with tempered martensite microstructure; b) imitating original with ferritic microstructure with minor amount of pearlite colonies; c) numerous tertiary cementite precipitations visible at grain boundaries (indicated by arrows); SEM (BSE)

- the degree of refinement of the microstructure of the compared elements, which results in a different grain boundary strengthening effect of the material in favour of the original snap hook (Fig. 3a vs Fig. 3c);
- the presence of undesirable precipitations of tertiary cementite at grain boundaries in DC04 steel, which locally forms a continuous network, thus providing a privileged site for accelerated crack growth and propagation;

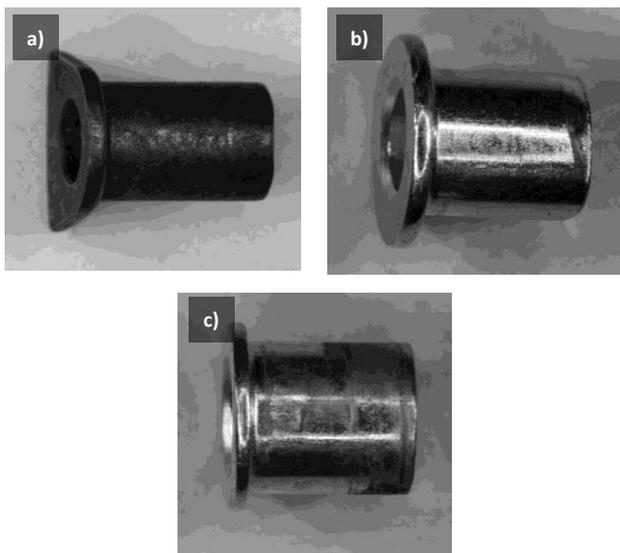
Fig. 4. The central fastening sleeve, which causes the mechanism to jam in the event of an accident, making it difficult to release the safety belts: a) original belts; b) c) imitation of original belts

A recurring defect of imitation seat belts is the tendency for the central fastening mechanism to jam, making it extremely difficult for the driver and/or passenger to safely and quickly exit the vehicle. The reason for this phenomenon is the deformation of the set of locking sleeves of the seat belt tongues in the central mechanism (Fig. 4). Their size and construction make it impossible to perform chemical composition analysis by GDS methods.

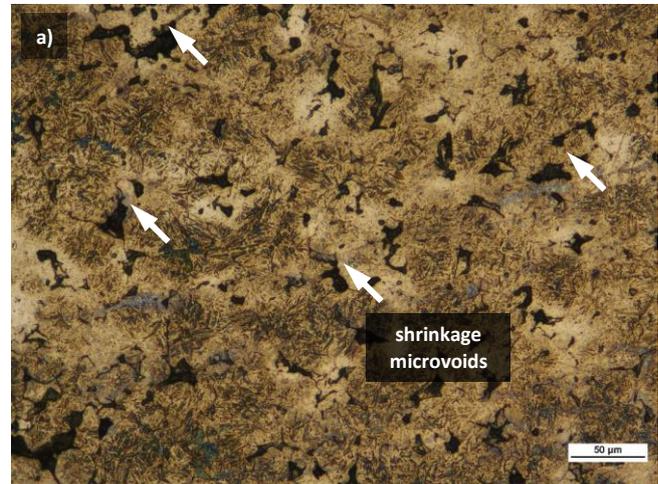
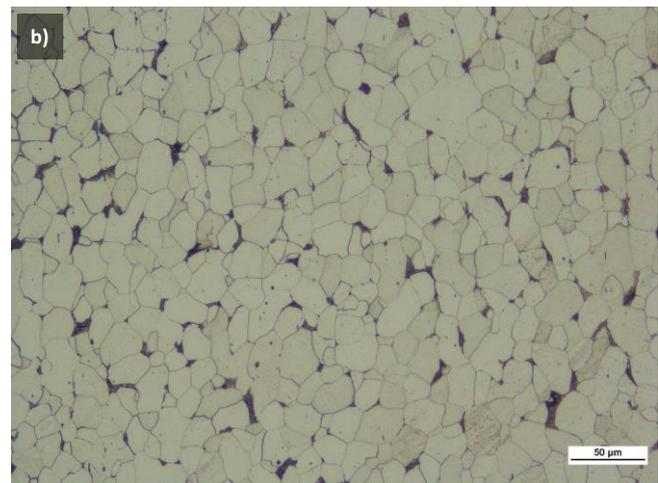
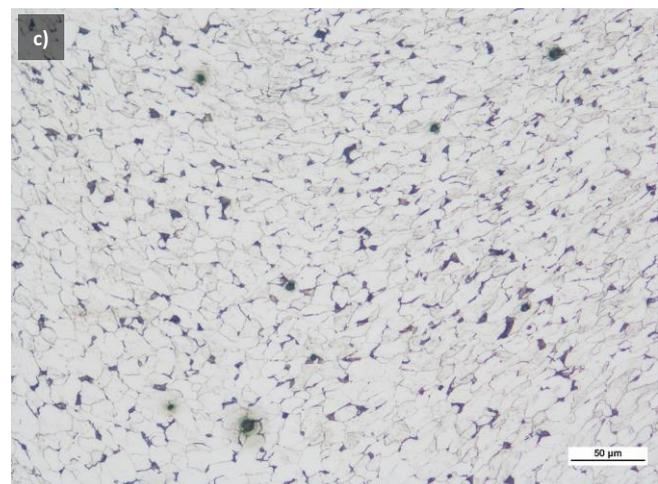
Fig. 5. Sleeve of the central fastener: a) the original with tempered martensite microstructure with visible numerous porosities and shrinkage microcavities; b) c) an imitation of the original with ferritic-pearlitic microstructure with visible locally occurring deformation grain texture resulting from the metal forming process of the workpiece

The original sleeve is characterised by a tempered martensite microstructure with numerous visible porosities and shrinkage microcavities (Fig. 5a). Their presence is an evidence of the casting nature of sleeve production. However, the number and distribution of voids reduce the quality of the material. They provide an easy path for crack propagation. Due to the morphology of the microstructure, the material can be classified as a medium carbon steel for heat treatment.

The sleeves installed in the central fasteners of the belts imitating the original ones are characterised by a microstructure of ferritic-pearlitic morphology with a locally visible deformation texture resulting from the plastic forming process of the workpiece

cess of the details. This texture translates into anisotropy of the mechanical properties of the sleeve. The number of pearlite colonies is relatively small and their distribution is not band-shaped. The ratio of the proportion of pearlite to ferrite grains makes it possible to classify the material in the family of low-carbon steels for metal forming.
