## Case study of accelerated wear of brake discs made of grey cast iron characterized by increased thermal stability

*In this paper, the subject of the analysis is Rotinger High Performance brake disc, characterized by increased thermal resistance, which is a result of adequate design and material solutions. However, despite declared performance, the analyzed discs suffered accelerated wear over a period of about 20 months. The aim of this study was to assess the causes of the disc failure. As a result, it was showed that the applied material solution still does not differ from standard ones. According to the authors of this paper, an appropriate procedure to improve resistance to thermal fatigue is, among others, changing the shape of graphite precipitates from flake to spheroidal.*

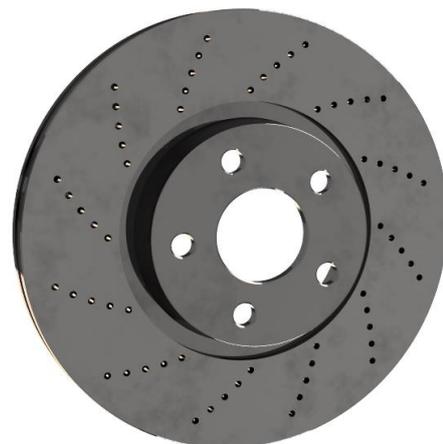
Fig. 1. Ventilated and drilled brake disc

Drilled brake discs (Fig. 1) have numerous vent-holes, which continually expel the hot gases generated between disc and linings, eliminating the phenomenon of friction decay (fading). The risk of the entire braking system overheating is greatly reduced, as the hot air escapes from the surface faster. The likelihood of disc damage due to sudden temperature changes is also lowered, whereby they are used in high performance cars [1, 8]. Moreover, friction dust is channelled through the holes and then removed by centrifugal force.

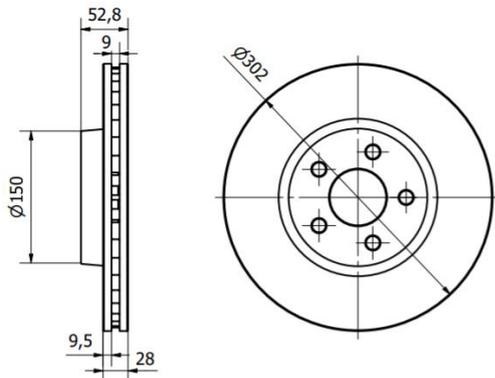
Fig. 2. Basic dimensions of the analyzed brake disc

A fragment of a worn Rotinger High Performance brake disc was used for tests. It was exploited for about 20 months, mainly in urban conditions (approximately 60%) and the rest accounts for motorway. The total mileage during that period equals to 16,800 km. The brake disc was cut out using a high-energy abrasive water-jet. Its basic geometric data are shown in Fig. 2. Moreover, additional worn out brake discs were taken for tests. Their working conditions are not specified, as they were taken from the garage to carry out comparative metallographic analysis.

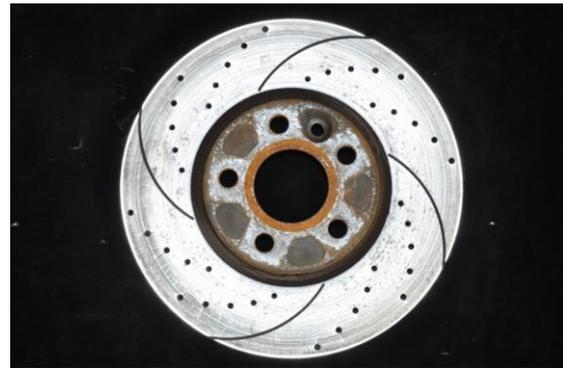
Fig. 3. Macroscopic image of the analyzed brake disc; visible venting and gas removal system through notches and holes distributed in a characteristic radial-axial manner; unetched state

A macroscopic image of the brake disc is shown in Fig. 3. Its degree of degradation as a result of corrosion or tribological changes is relatively low, however there are charac-

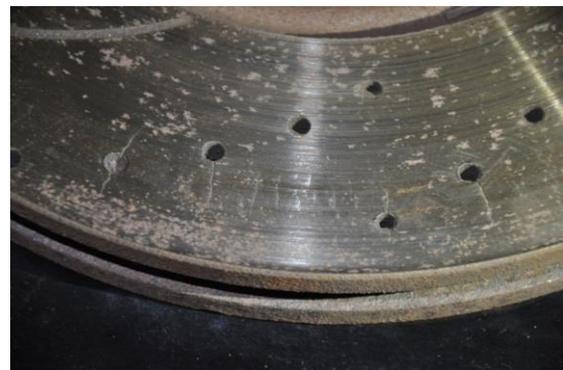
Fig. 4. Magnified section of the brake disc surface shown in Fig. 3; there can be observed radial cracks on the friction surface, which are initiated mainly at the vent-holes; unetched state

teristic radial cracks on the friction surface, whose main source are vent-holes (Fig. 4, 5). These types of cracks are formed when variable thermal loads occur during frequent and intensive braking, resulting in formation of internal stresses in the material. When the material is heated, its dimensions are increased as a result of thermal expansion caused by vibrations of atoms, simultaneously generating compressive stresses. Exceeding the yield point of the material due to excessive loading results in tensile stresses, which ultimately cause a break in the continuity of the material. This type of damage can cause the disc to fracture, reducing its stability and causing excessive pad wear.

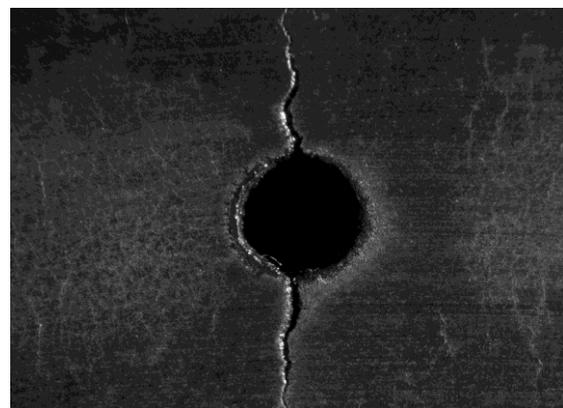
Fig. 5. Magnified section of the brake disc surface shown in Fig. 4 in the vent-hole area; visible cracks arranged in a radial way; unetched state

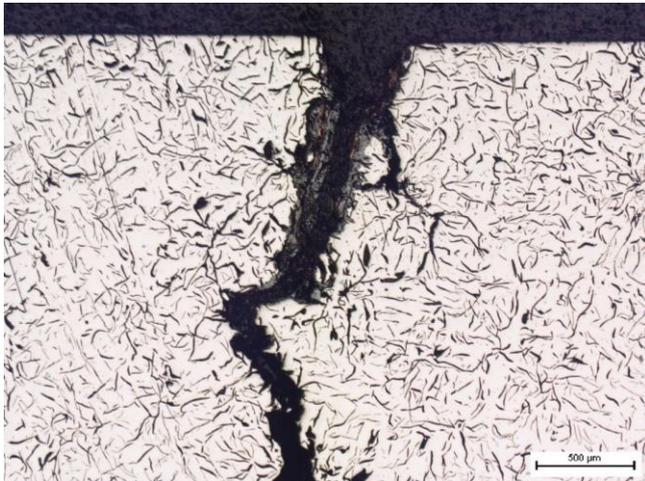
Fig. 6. Microscopic image of the analyzed brake disc. The visible crack spreads along the entire cross-section of the disc; unetched state, light microscopy

Macroscopic examination of the material in the unetched state (Fig. 6, 7) indicated the occurrence of unmodified flake graphite precipitates, corresponding to the standard no. I, according to PN-EN ISO 945-1:2019-09. The graphite distribution is consistent with the A standard and locally C, while the size of the precipitates lies in the range of 2–4, in compliance with the eight-stage scale. It should be noted here that this shape of precipitates is the most unfavorable one in terms of mechanical properties, since the sharp ends act as stress concentrators in the contact with metal matrix. This implies a significant deterioration of plastic and strength properties, including tensile strength  $R_m$ , flexural strength  $R_g$  and torsional strength  $R_s$ . In fact, flake graphite has a complex three-dimensional structure and its separations violate the continuity of the cast iron metal matrix to a great extent, while not transferring any stresses. Thus, the effective cross-sectional area of the disc structure is reduced. Moreover, the longer and thinner the flakes are, the more material's internal stresses are increased. What is more, cracks running along the entire cross-section can be also observed (Fig. 6).

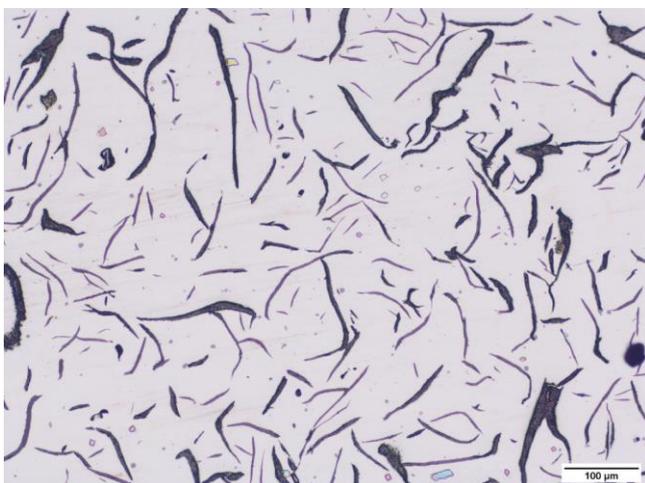
Fig. 7. Magnified image of the material structure of the analyzed brake disc shown in Fig. 6; visible flake inclusions of unmodified graphite; unetched state, light microscopy

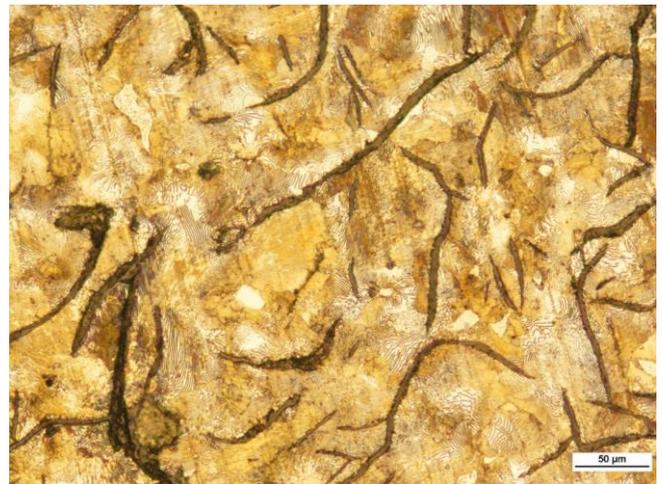
Fig. 8. Microstructure of the analyzed brake disc; visible flakes of graphite on the background of perlite matrix; precipitations of phosphite eutectic and manganese sulfides are also observed locally; light microscopy, etched with  $HNO_3$

Microscopic examination of the material in the as-etched state (Fig. 8, 9) indicated the presence of a perlite matrix. The theoretical strength of perlite is approximately  $R_m = 750$  MPa and by binding in the matrix the highest possible content of carbon ( $C_{zw} = 0.77\%$ ), it provides relatively the highest tensile strength. At the same time, the ductile properties are reduced – for comparison, ferrite's elongation  $A = 40\%$  and its KCU impact strength is  $260$  J/cm<sup>2</sup>. In the case of pearlite, these values are  $A = 10\%$  and  $KCU = 40$  J/cm<sup>2</sup>, respectively.

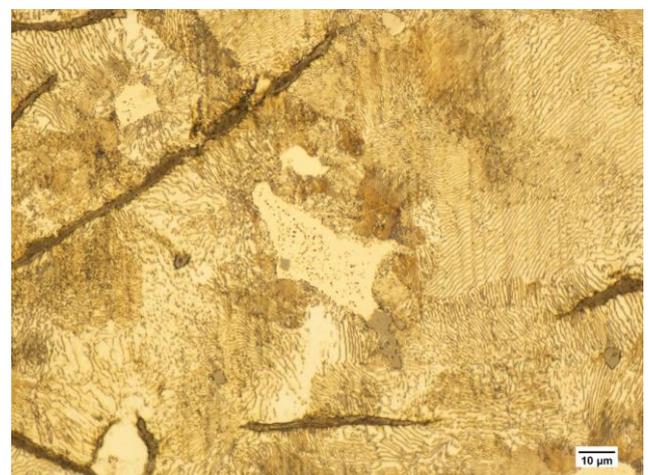
Fig. 9. Magnified image of the microstructure shown in Fig. 8; visible flakes of graphite on the background of perlite matrix; precipitations of phosphorus eutectic and manganese sulfides are also observed locally; light microscopy, etched with  $HNO_3$

Phosphite eutectic precipitations are visible in Fig. 9. Their shape is limited by the concave surface of previously solidified austenitic matrix. When the percentage share of phosphorus is zero, ledeburite, being a mixture of austenite and cementite, begins to crystallize at  $1147^\circ C$ . As its content increases, the solidification temperature is lowered to about  $950^\circ C$ , and the resulting eutectic consists of cementite, iron phosphide, and austenite, which then desintegrates into pearlite at  $745^\circ C$ .

This structure is called steadite and its occurrence may be desirable. Steadite has hardness of over 500 HBW, so that its uniform distribution in the matrix provides an increase in wear resistance. In comparison, the hardness of perlite is approximately 200–250 HBW. Steadite appears already for the content of 0.1% P in the form of individual precipitates, and for the content above 0.7% P it forms a continuous lattice.

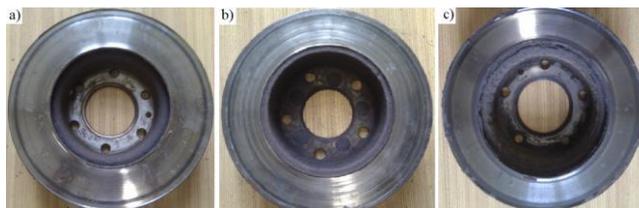
Fig. 10. Macroscopic images of comparative brake discs: a) numerous gouges occurring circumferentially on both friction surfaces, whose darker color indicates overheating; b) wear of the disc manifested by a decrease in thickness; c) wear of the disc due to corrosion changes

Comparative material testing of a set of monolithic ventilated brake discs showed that they were made of grey cast iron and their microstructure consisted of unmodified flake graphite precipitates and a perlite matrix. Slight microstructural differences were manifested only by the size of graphite precipitates. The discs were characterized by hardness in the range of 180–206 HBW. On this basis, it can be concluded that the applied material solution for the brake discs in question does not go beyond the generally applied (standard) construction and material solutions. Figure 10 and 11 presents macroscopic images of the analysed brake discs and their microstructure in the unetched state.

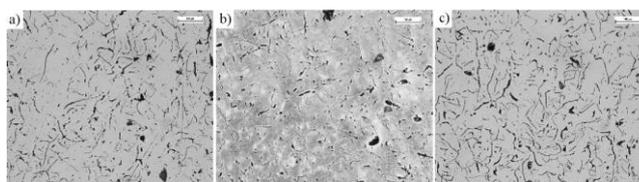
Fig. 11. Microscopic images of the analyzed brake discs shown in Fig. 10; in all cases flake precipitations of unmodified graphite are visible; they are characterized only by the variation of the size of the precipitates, and their shape and way of distribution are similar to each other; unetched state, light microscopy
