Problems of regeneration of modern piezoelectric fuel injectors

Key words: common rail system, piezoelectric fuel injector, diagnostic tests, regeneration process

The tests were carried out on a Bosch CRI3-16 piezoelectric fuel injector, which was removed from the 3.0 TDI (Turbo Direct Injection) engine of a Volkswagen Touareg passenger car with an operational mileage of 262 thousand km.

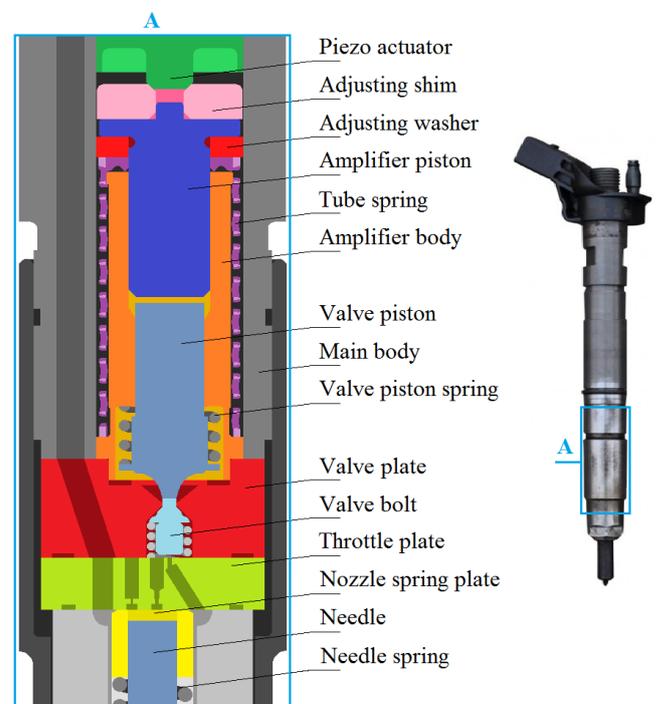
Fig. 1. Bosch CRI3-16 fuel injector design: own study based on [20]

ing pressure up to 160 MPa [9]. Figure 1 shows the most important elements of the internal structure, specifying the control valve assembly and the hydraulic amplifier. Other characteristic features include the triangular cross-section of the needle in the guiding part, providing space for free fuel flow. Moreover, compared to solenoid solutions, the high pressure feed connector is positioned centrally rather than laterally, which simplifies the upper part of the main body. For this reason, the overflow connector is located next to the flange with the electrical connection [12].

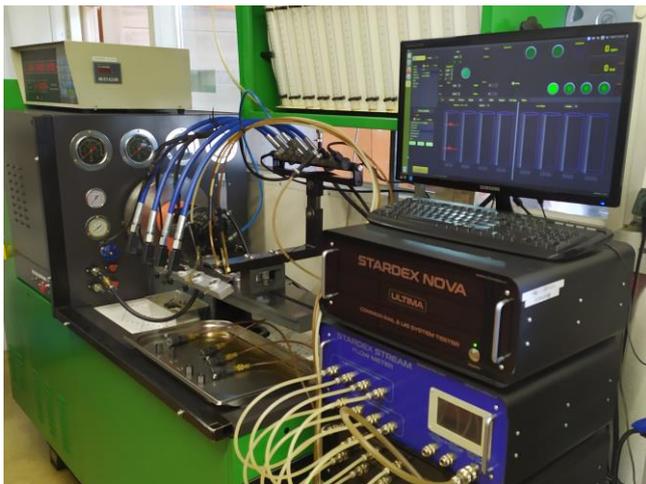
Fig. 2. 12PSB test bench with Stardex kit

- 12PSB test bench with a complete Stardex kit (Fig. 2),
- Mega Tester V3 piezoelectric actuator tester,
- Bass BP-3605 fuel injector pressure tester,
- Yizhan 13MP HDMI VGA microscope camera,
- Polsonic Sonic 9, Bene YesWeCan 3L ultrasonic cleaners,
- IP54 electronic micrometer,
- Facom E.316A200S electric torque wrench,
- GRS Tools POWER HONE diamond grinder,
- vices, grips and workshop tools.

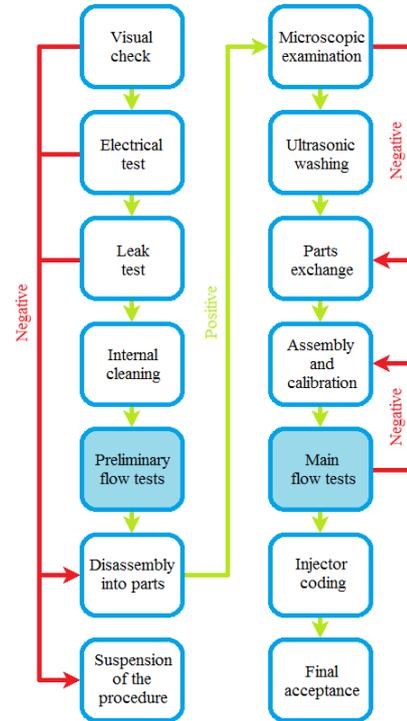
Fig. 3. Research plan

Figure 3 shows an in-house test plan which only partially overlaps with Bosch's procedures. Due to the available equipment, checking the piezoelectric actuator and the state of tightness can be carried out in the initial stages. The detection of a failure results in the suspension of the regeneration process or the exclusion of the fuel injector from thermochemical cleaning and preliminary flow measurements on the test bench. In addition, washing in ultrasonic baths takes place after microscopic inspection and applies only to those components that will not be replaced. Differences may also apply to the correction of fuel dosage, as the manufacturer assumes top-down adjustment by means of coding or by earlier disassembly of the nozzle and changing the thickness of the needle washer (not shown in Fig. 1). The latter method results from the frictional wear of the plunger and barrel assembly, which is one of the most fre-

quently detected failures in common rail fuel injectors [2, 3, 8]. However, this process can be extended in the situations when other irregularities are found during the tests.

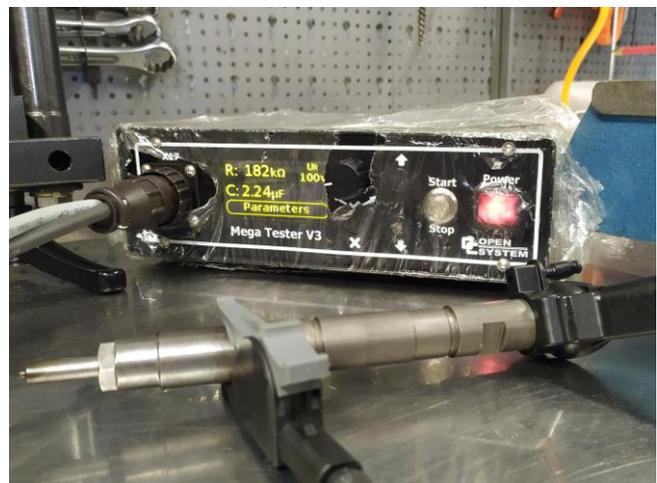
The inspection of the tested fuel injector did not reveal any external defects or incompleteness of its components. Therefore, electrical measurements were performed using the Mega Tester V3 (Fig. 4). The data presented in Table 1 show that the piezoelectric actuator was functional, as the values of all parameters were within the nominal ranges. The main difference compared to Siemens VDO Continental products is the lack of necessity to control GAP, i.e. the size of the gap between the crystal stack and the hydraulic valve lifter [15].

Fig. 4. Testing piezoelectric actuator with the Mega Tester V3

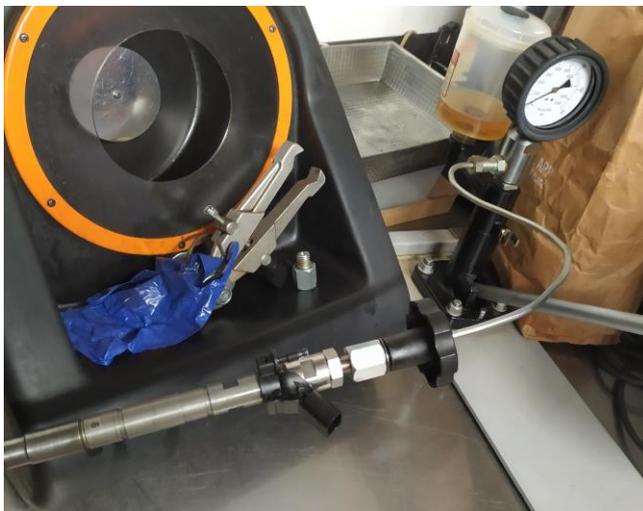
In the next step, the tightness of the fuel injector was checked on the Bass BP-3605 tester (Fig. 5). At a pressure of 40–50 MPa, no leaks were found in the area of the nozzle and the overflow connector. This proves that the nozzle and the nut are kept tight, as well as the valve assembly. At this stage, it is possible to test the quality of fuel atomisation, but it is necessary to provide a control impulse from an additional diagnostic device, e.g. AZ0222-CRR, SRN.101.540, AZ0134-13. This test is carried out optionally, mainly in the case of suspected obstruction of the exit holes, changes in their geometry, bad condition of the tip, etc.

Fig. 5. The fuel injector leak test on the Bass BP-3605 tester

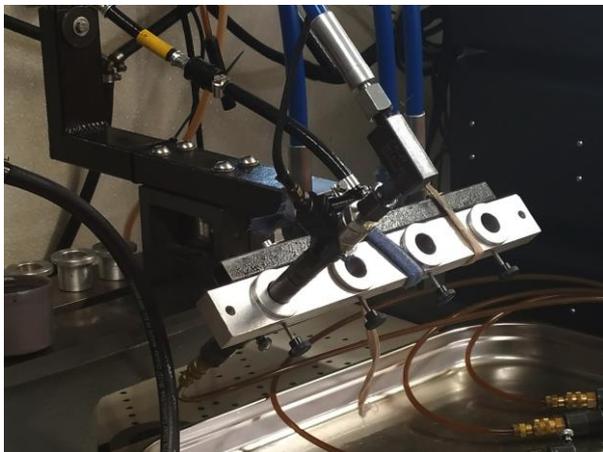
In accordance with the adopted test plan, the CRI3-16 fuel injector was subjected to thermochemical cleaning. In this process, as in the preliminary flow measurements, a 12PSB test bench with a Stardex kit was used (Fig. 6).

Fig. 6. View of the fuel injector during flow measurements

The results presented in Table 2 show that a negative result of the measurements was obtained at full load. A disturbance in the fuel supply after the maximum pressure and control time have been set, may suggest a problem in the operation of the actuator group. Despite the fact that the criteria specified by the manufacturer were met for the remaining operating points, the values of fuel injection doses also seem to be slightly underestimated. It would be premature to indicate possible causes, at least until the fuel injector is disassembled and the individual components are inspected. Nevertheless, improper cooperation of the plunger and barrel assembly should be ruled out, as wearing of the needle in the nozzle would be visible in the idle and pre-injection tests [10, 25].

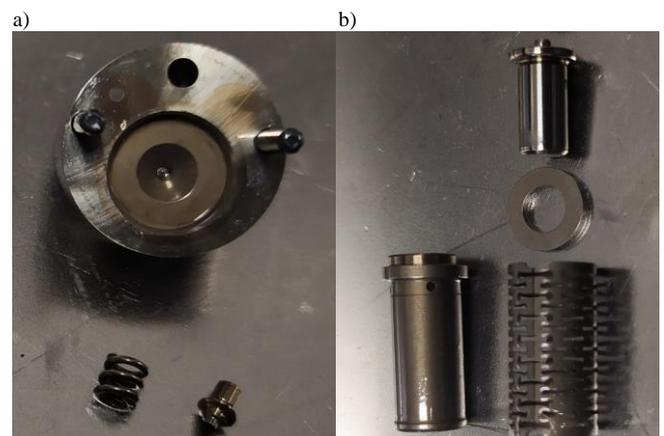
In organoleptic tests and under high microscopic magnification, corrosion centres were revealed on parts that were in direct contact with the fuel, e.g. on the throttle and valve plates (Fig. 7a). Traces of frictional wear were also observed on some working surfaces, in particular on those from the hydraulic booster (Fig. 7b). As a result, it was decided that the the above actuator assemblies would be replaced completely. Moreover, taking into account the operational mileage over 200,000 km, a new nozzle was used, similarly to the regeneration of fuel injectors from other manufacturers [23]. It should be emphasised, however, that the technical condition of the needle and the nozzle did not raise any major objections (Fig. 8). The remaining components were bathed in ultrasonic cleaners and then thoroughly dried with compressed air.

Fig. 7. Exemplary parts of the valve group a) amplifier module b)

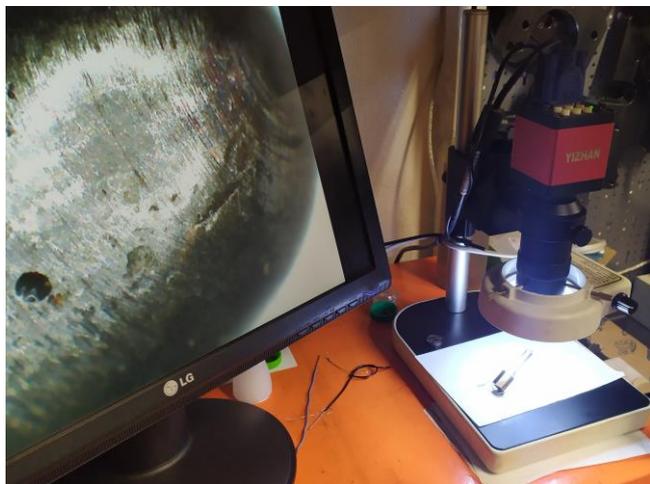
Fig. 8. Microscopic inspection of the nozzle tip

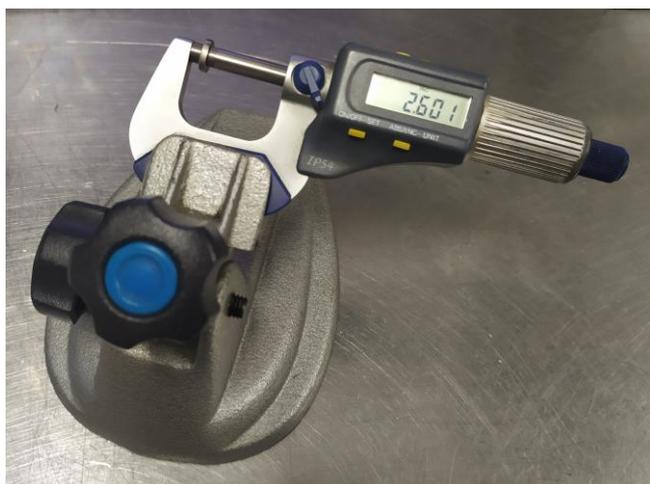
Fig. 9. Measurement of the adjusting shim thickness after grinding

Taking into account the results of preliminary tests, it was decided that the stack length compensation would be ensured by grinding the front surface of the adjusting shim of the hydraulic booster by 0.2 mm (Fig. 9). In turn, the assembly of this assembly required venting and pressing in the presence of oil (Fig. 10 and 11). In this way, falsification of the measurements on the test bench, i.e. the occurrence of the so-called zero doses, is prevented.

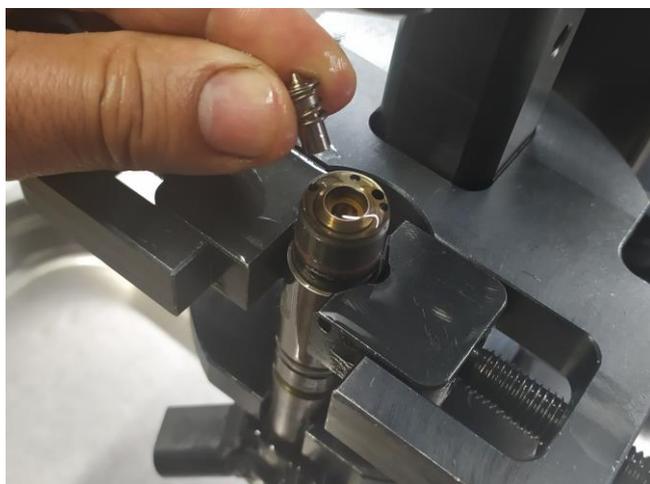
Fig. 10. Assembly of the hydraulic booster

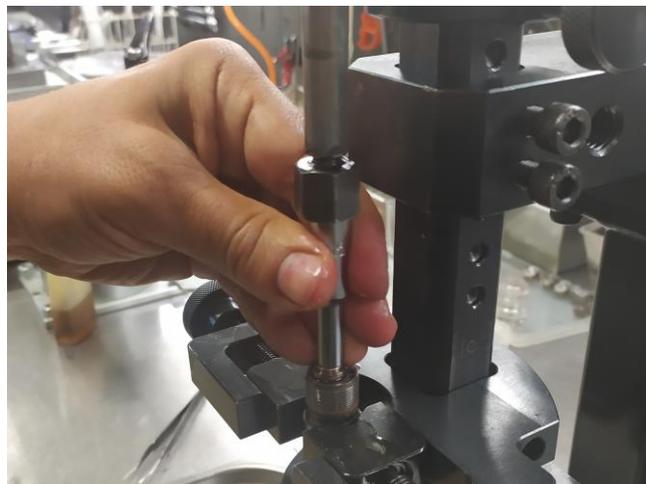
Fig. 11. Pressing step in the presence of oil
