Repair methodology of a piezoelectric injector utilizing components obtained from selective decomposition

Key words: common rail system, piezoelectric fuel injector, selective decomposition, regeneration process

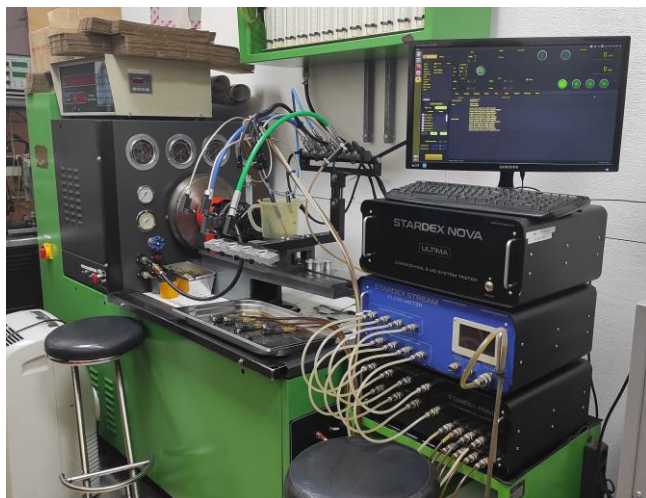
Fig. 2. 12PSB test bench with a Stardex test kit

The Stardex test kit included the Nova Ultima simulator, the Stream flow meter and the Prima cooling, filtering and damping module. The system was complemented by a PC computer with the Ubuntu Linux system, equipped with the necessary peripheral devices (Fig. 2). Its connection to the 12PSB test bench allowed for a comprehensive fuel injector check in automatic mode. Other control, repair and maintenance activities, including additional calculations, were carried out at separate laboratory stations.

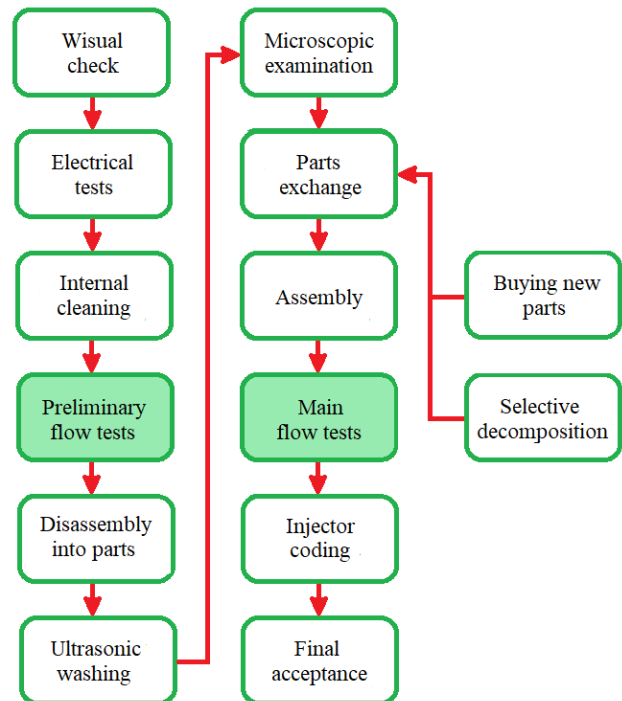
Fig. 3. The research plan for Denso fuel injector

Figure 3 shows the test plan, the course of which is analogous to the standard procedures used in the maintenance of fuel injectors. Differences may result from the access to specific diagnostic equipment, as well as the type

of irregularities found. For example, electrical tests are usually conducted on the main test bench [17]. However, their isolation makes it possible to detect damage to the crystal stack already at the initial stage, which makes further actions pointless. In the absence of a dedicated tester, a universal multimeter with a capacitance measurement function can be used [2, 4]. In turn, the suspicion of the presence of metal filings entering the fuel injector from a faulty pump will result in an earlier microscopic examination. In this way, they will not be removed during cleaning in an ultrasonic cleaner.

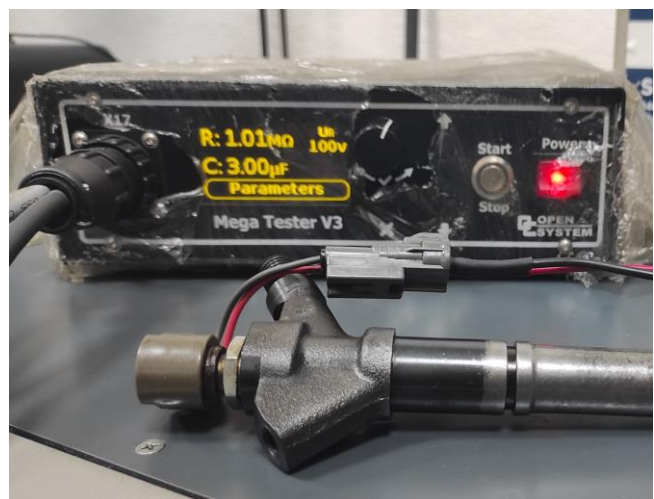
Fig. 4. Testing of the electrical parameters of the fuel injector

In the next step, electrical measurements were started, which were carried out using the Mega Tester V3 tester (Fig. 4). There was no breakdown of insulation between the actuator and the main body ($R_i = \infty$). In addition, almost exemplary results were obtained for the remaining parameters, as shown in Fig. 4. The capacitance of the crystal stack was $C = 3.00 \mu\text{F}$, and its resistance $R = 1.01 \text{ M}\Omega$, which is characteristic only for piezoelectric fuel injectors from this manufacturer. This value remained unchanged in the continuous R_C load test.

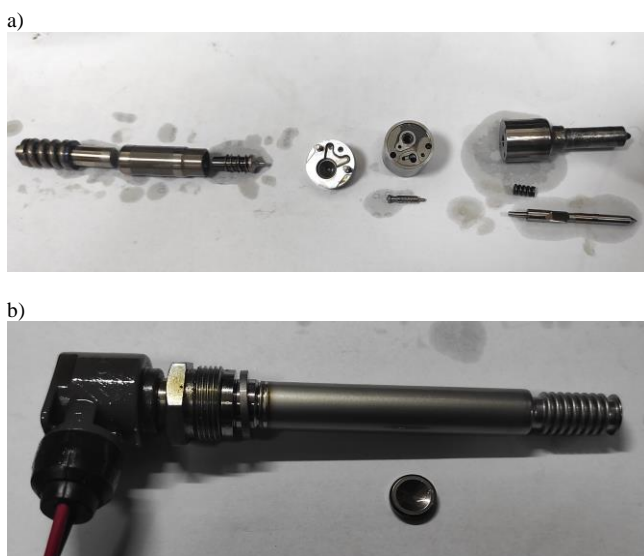
Fig. 5. Examples of assemblies after disassembly: a) hydraulic booster, valve, nozzle, b) piezoelectric actuator

Figure 5 shows the view of exemplary fuel injector components after disassembly. At this stage, it is possible to inspect the individual components in detail, as well as to carry out simple tests, e.g. checking the patency of the nozzle openings. The easiest way is to use the WD-40 multi-purpose spray directly (Fig. 6). This test should be regarded as optional, usually performed when the nozzle tip is heavily coked or contaminated.

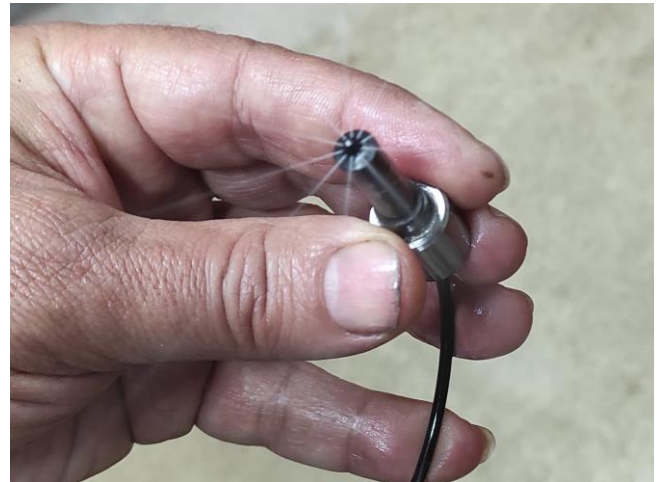
Fig. 6. Checking the patency of the nozzle openings
