## Issues in the conservation and restoration of powertrains as engineering art monuments

The article discusses issues related to the behavior of powertrains understood as monuments of engineering art. The theoretical part analyzed the most important issues related to the maintenance and renovation of vehicles, their share in Poland in the age category, as well as the regulations regarding the classification of historic vehicles. The next part of the article presents the renovation process of two powertrains – the K-750 motorcycle and the Volkswagen Type 117 passenger car, along with a short production history. Then, recommended procedures for unique objects were discussed in the context of their state of preservation and occurrence based on the authors' experience.

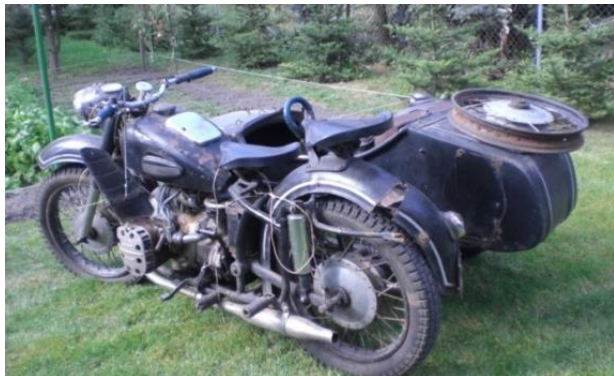
Fig. 1. Object undergoing renovation: K-750 motorcycle produced in Kiev in 1962

The subject of the renovation was a two-cylinder boxer combustion engine, Soviet production, with a displacement of 750 cm<sup>3</sup> (Table 2). It was used to power motorcycles M-72, MW-750, K-750, and all their varieties from factories in Moscow, Irbit, and the Urals (Fig. 1). The engine design was taken from the German BMW R-71 military motorcycle in 1939. Due to its use, the engine had to be characterized by high durability and power because it powered a machine equipped with a sidecar, where the total weight of the vehicle, including equipment and weapons, exceeded 450 kg (Fig. 2). After the war, the production of motorcycle harnesses was not discontinued; their design was slightly changed to make them more suitable for urban driving, for example, the gear ratios in the gearbox were changed.

In accordance with conservation and engineering guidelines, the drive system was dismantled, and parts were verified. Previous users have not modified the engine and gearbox and have never thoroughly overhauled them, as evidenced by the condition of individual parts. It was also interesting to discover traces of foundry sand inside the engine block (in the upper parts) in hard-to-reach places, which remained after the production process. This made it possible to conduct a thorough analysis of component wear and obtain information about the weakest nodes in the engine. Examples include cracked pistons and uneven wear marks caused by the rings in the liners. This data contributed to improving the axial positioning of the elements in the cylinders and ensuring proper lubrication. However, severe wear of the camshaft slide bearing prompted a deeper analysis of this system and the implementation of material

changes in the node. Scratches on the pistons indicated that the filter in the power supply system and the mechanical oil filter should be checked frequently.

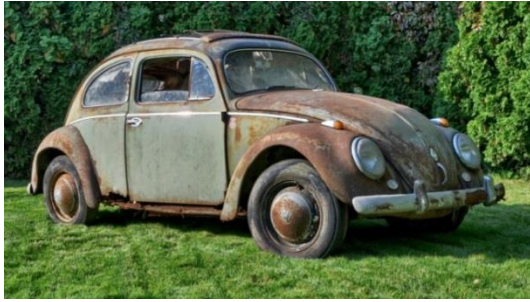
Fig. 3. Object undergoing renovation: Volkswagen Type 117 car produced in Wolfsburg in 1954

Another object undergoing renovation was a four-cylinder boxer combustion engine, made in Germany, with a displacement of 1,192 cm<sup>3</sup> (Table 3, Fig. 3). Its history began in 1934, when Ferdinand Porsche began design work on a vehicle intended to motorize post-war Germany. Unfortunately, the ambitious plans were interrupted by the outbreak of World War II, during which most of the units produced were used for military vehicles, such as the 4-seater Kübelwagen light off-road vehicle or the Schimmwagen floating all-wheel drive vehicle, as well as for power generators. After World War II, the engine was used in vehicles such as the Volkswagen Type 1 "Beetle", Type 2 "Transporter" and Type 14 "Karmann-Ghia" [7]. The latter, based on the "Beetle" chassis, had a special, sports body manufactured at the plant in Osnabrück. In the following years, this unit underwent several modifications aimed at improving efficiency. The most important changes included: the addition of a Bosch L-Jetronic injection system with electronic control in 1974 and the introduction of a liquid cooling system in 1982, used in the third-generation Transporter model [3].

The renovation process of the presented engine began with disassembly, carried out in accordance with conservation and engineering guidelines, based on the service manual from the vehicle's production period. The visual assessment revealed advanced corrosion of metal covers designed to increase engine cooling efficiency. Apart from typical signs of use of the piston-cylinder assembly, such as moderate abrasion, no signs of excessive wear were found, so after cleaning, these components were reassembled. The upper cylinder covers required the use of an appropriate reconstruction technique. Knowledge from the literature and information from brand enthusiasts revealed that from January to July 1954, these covers were assembled from three separate pieces, formed by cold forming and then joined by a spot welding process. Due to the advanced corrosion of the original covers, three copies were purchased from the secondary market, based on which a set was prepared for use. All covers were covered with thermosetting black polymer-based paint with a gloss similar to the varnish originally used (based on metal oxides).

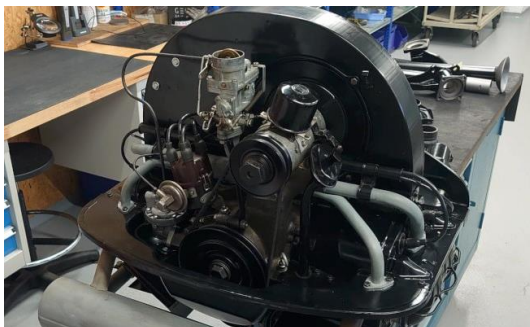
Fig. 4. The engine of a Volkswagen Type 117 car at the assembly station

In parallel to the engine renovation, renovation works on the gearbox were carried out. The vehicle's transmission was equipped with synchronizers and helical gears for 2<sup>nd</sup>, 3<sup>rd</sup>, and 4<sup>th</sup> gear for easier operation and lower noise emission. During conservation work, it was found that the synchronizers had visible damage on the surface, which may indicate that the material was too plastic or that the impact load was too high. The element that could not be replaced due to lack of availability was the shaft transmitting torque from the engine to the transmission. Pitting occurred around the sealant, so it was decided to apply several layers of technical chrome to the damaged surface and then reduce the diameter to the nominal diameter in the process of abrasive machining. The last stage was the final assembly with the addition of lubricating liquid (Fig. 4).

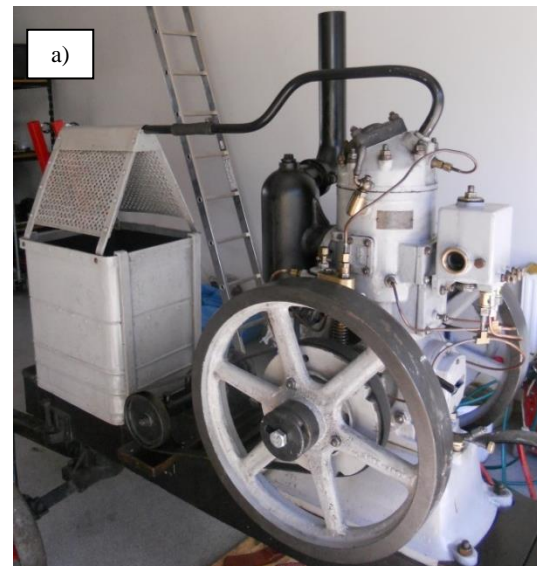
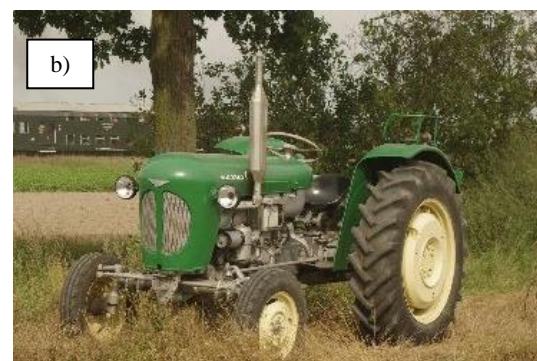
Fig. 5. Unique monuments of engineering art in the collections of the National Museum of Agriculture and Food Industry in Szreniawa: a) Motor Polski produced in Żnin in 1930, b) Ursus C-342 produced in Warsaw in 1965

Based on the authors' experience and in consultation with conservators, certain guidelines for the protection of unique objects have been formulated (Fig. 5). During conservation work carried out by both enthusiasts and conservators, it is very important to create documentation of the progress of the work. This not only has a positive impact on

When referring to monuments of engineering art, unique in their existence or related to historical figures, the conservation process and possible renovation should be considered individually. For objects in a poor state of preservation, renovation means replacing most of the parts with new ones. In such a case, a better solution is to preserve the remnant and create a vehicle modeled on what remains of its original structure. Operation (even for demonstration purposes) is also not recommended for unique objects because each start-up of, e.g., a heat engine, involves its destruction. Examples of such objects that require special conservation care include a two-stroke stationary engine manufactured by "Motor Polski" from Żnin (1930, Fig. 5a), the prototype Ursus C-342 (1965, Fig. 5b), or the concept Polish car FSM Beskid. All objects have been preserved in fewer than 10 pieces, which makes them unique in the world. They are all in museums.
