The analysis of temperature disintegration on the body of fuel injector during research on test bench

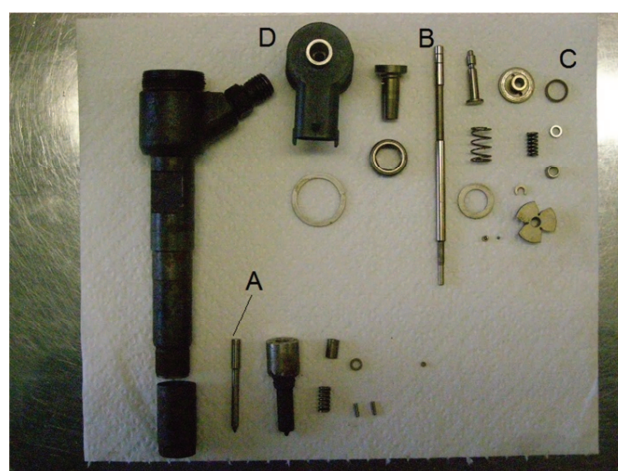
Fig. 1. Electromagnetic Bosch fuel injectors. A – precision element on injector needle, B – fuel injector steering valve, C – valve sealer, D – fuel injector coil

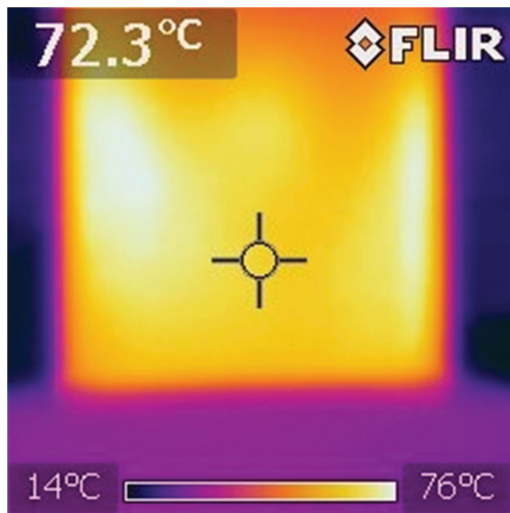
There is possibility to analysis temperature injected fuel (Fig. 3) using infrared camera. Fuel temperature influences on corrosion, cavitation, erosion and friction phenomena. This parameter could be useful to determine phenomena inside injector nozzle.

Fig. 3. Temperature of injection fuel

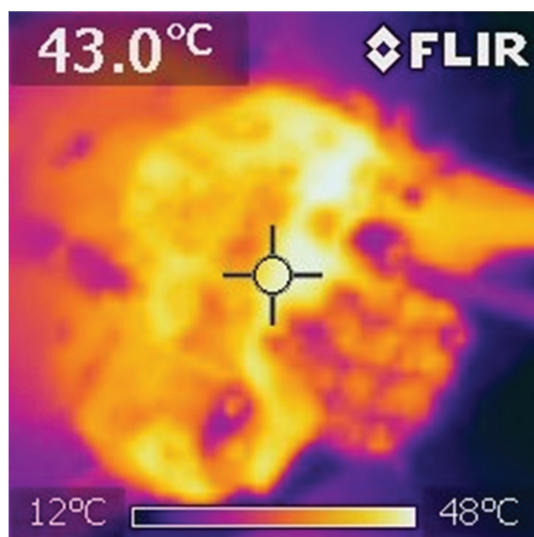
There is opportunity to research fuel injection pump especially high pressure section. If there are leaks it would be visible using infrared camera. Figure 4 presents the picture of high pressure injection pump during research on the bench.

Fig.4. Temperature of fuel injection pump

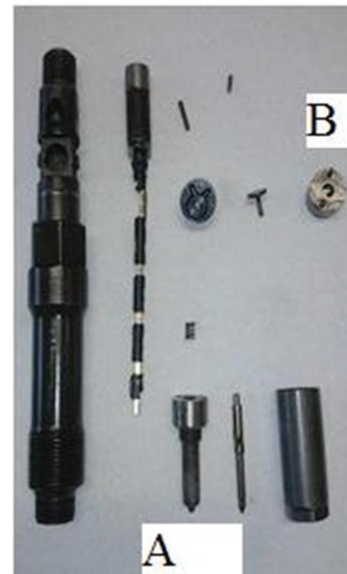
During laboratory tests has been used electromagnetic Delphi fuel injectors. Figure 5 presents researched injector disassembled on spare parts. There has been sectioned two areas. The first injector nozzle (A) and the second steering valve and electromagnetic coil areas (B). This areas determine fuel injector work parameters (injection and return dosages and injection delay). Catalogue number researched fuel injector were EJBR02201Z [6]. Researches has been made on STPiW 3 test bench (Fig. 7) by using infrared

Fig. 5. Electromagnetic Delphi fuel injector dismantled on spare parts: A – injector nozzle area, B – steering valve and electromagnetic coil area
