## Comparative study of aftermarket and OEM DPFs for Periodic Technical Inspections (PTI) compliance with new PN emission limits

*This study evaluates the performance of aftermarket and OEM diesel particulate filters (DPFs) using a particle number counter (PNC) during stationary Periodic Technical Inspection (PN-PTI) tests. Several European countries have already implemented regulations requiring this test to ensure that vehicles equipped with DPFs meet the stringent particle number (PN) emission limits. In this work, measurements were conducted on various vehicles with new and conditioned DPFs. The results revealed significant variability in PN emissions, with some filters failing to meet the required limits. Key contributors to elevated PN levels were identified, including filter aging and inadequate conditioning procedures. Based on the findings, the paper proposes practical recommendations and diagnostic approaches to support compliance with PN-PTI test requirements.*

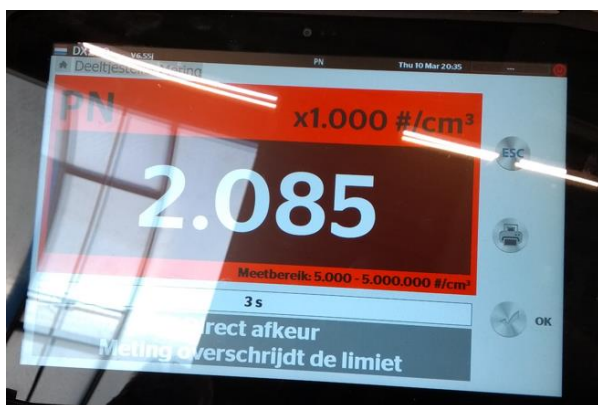
Using the Continental DX280 DC particle number counter, measurements of PN were conducted on vehicles compliant with Euro 3 to Euro 6 emission standards. The PNC used for testing was equipped with software calibrated for the Dutch market, where the limit is set at 1 000 000  $\#/cm^3$ . The device was borrowed courtesy of the director of Wijs-Air. Prior to testing, the PNC underwent a standardized warm-up procedure. Once ready, idle PN emissions were measured for all tested vehicles (Fig. 7). The result of each measurement was displayed on a wireless monitor approximately 15 seconds after the sampling began (Fig. 8).

Fig. 8. PN measurement result on the Continental PNC display for the Peugeot 308 and for old OEM DPF

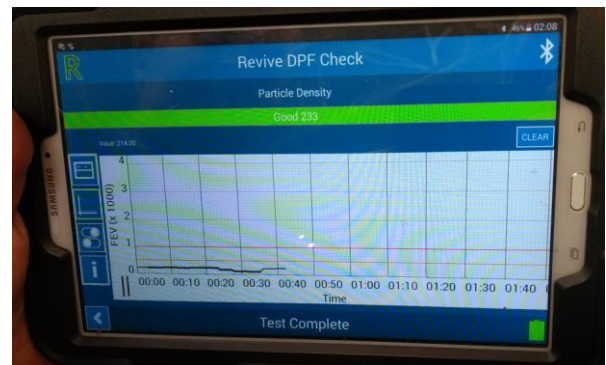
In addition, the same vehicles were also assessed for particulate matter emissions by measuring the exhaust smoke opacity using a DPF100 PM tester, which was also borrowed. For this device, results were categorized as follows: good (0–500  $\mu g/m^3$ ), marginal (500–1000  $\mu g/m^3$ ), and poor (above 1000  $\mu g/m^3$ ). Measurement results were visually indicated both by a corresponding LED on the tester's housing and on a wireless display (Fig. 9), which presented a real-time graph with horizontal limit lines for easy interpretation.

Fig. 9. PM measurement result (density) on the DPF100 tester display for the Peugeot 308 and for the old OEM DPF

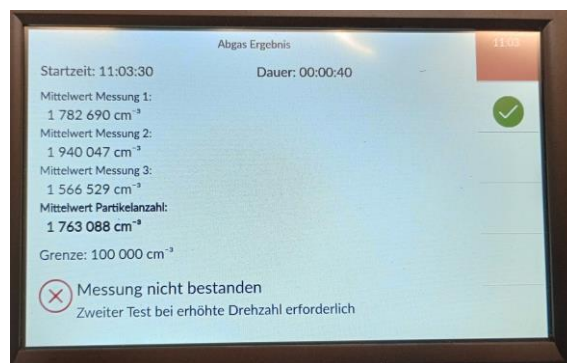
Fig. 13. PN measurement result on the Bartec nEC PNC display for the Peugeot 308 and for the cordierite DPF of competitor 8

Referring to the results shown in Fig. 14, none of the aftermarket DPFs tested (representing eight different competitors) passed the particle number emission tests, regardless of substrate type (SiC or cordierite). The average particle number for these aftermarket parts was significantly high, reaching approximately 1.6 million  $\#/\text{cm}^3$ . Only the OEM DPF remained within the acceptable upper limit, achieving a value of 137,280  $\#/\text{cm}^3$ .

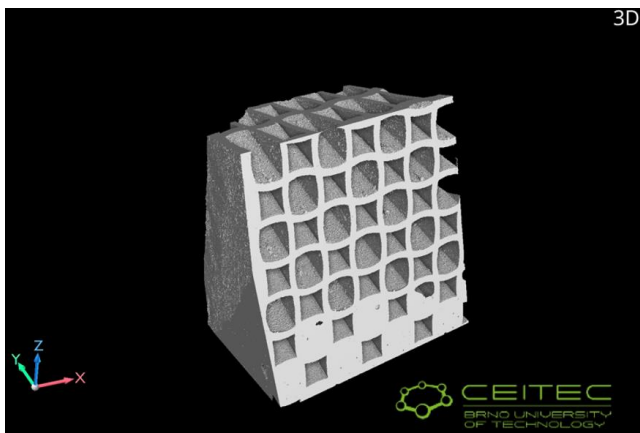
Fig. 18. 3D scan of a section of an OEM filter

In addition to the DPF filter that exhibited high PN emissions, a small cubic sample from both an OEM (SiC) filter (Fig. 18) and an aftermarket (cordierite) filter (Fig. 19) was sent to the CTLAB X-ray Computed Tomography facility at the Central European Institute of Technology. The purpose of this supplementary analysis was to examine the internal structure of the filters (wall thickness and porosity). This investigation aimed to explain why the OEM filter exhibited compliant PN emission levels immediately after installation in the vehicle, whereas the aftermarket DPF required initial conditioning to reach acceptable emission levels.

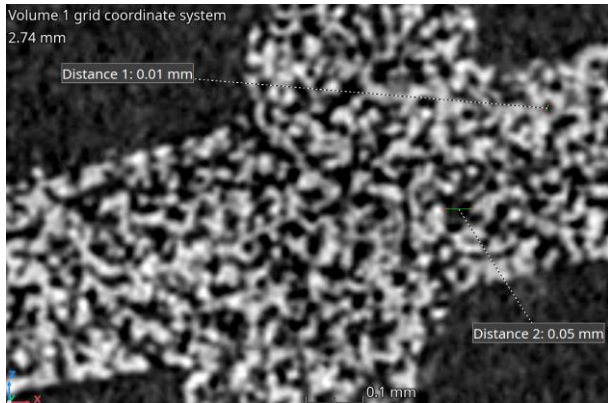
Figure 22 (OEM filter) and Fig. 23 (aftermarket filter) show magnified CT scan images of the filter walls and their pores. Several representative pore diameters are indicated, ranging from small pores of approximately 0.01 mm to larger ones around 0.06 mm. A visual comparison shows that the OEM filter contains a greater number of smaller pores, whereas the aftermarket filter exhibits larger pores.

Fig. 22. OEM filter wall – magnified pore structure

The OEM filter exhibits a more homogeneous pore structure, characterized by a narrower pore size distribution and reduced variability in pore diameters. In contrast, the aftermarket filter shows a broader pore size distribution, including a noticeable presence of larger pores. Such characteristics may suggest reduced efficiency in capturing fine particulate matter, although they could also result in lower flow resistance (i.e., lower pressure drop) across the filter.

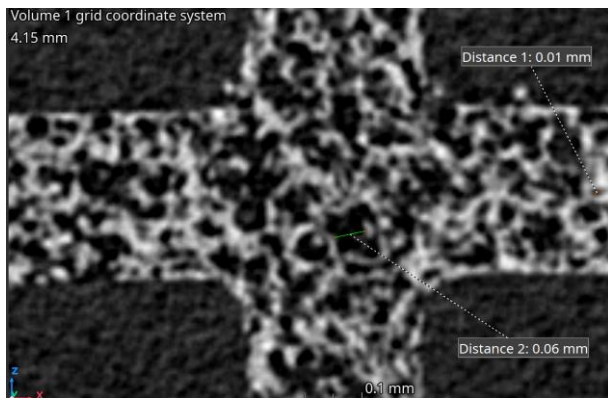
Fig. 23. Aftermarket filter wall – magnified pore structure

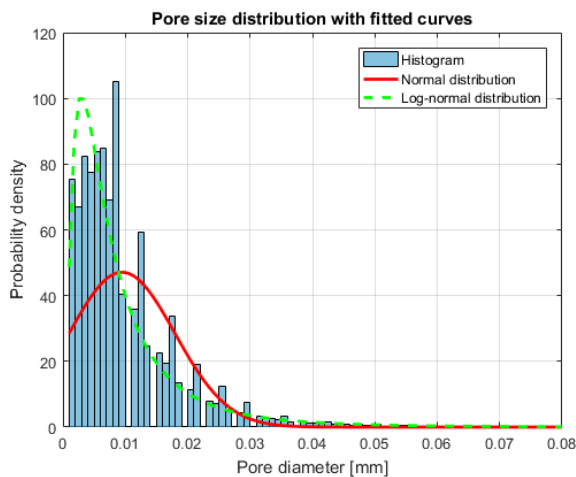
Figures 24 and 25 present the pore diameter distributions for the OEM and aftermarket filters, respectively. Each histogram illustrates the frequency of pore sizes observed in the samples. The red solid line represents the fitted normal distribution, while the green dashed line cor-

Fig. 24. Pore size distribution – OEM filter section

Based on this analysis, the mean pore diameter was calculated to be 9.5  $\mu\text{m}$  for the OEM filter and 11.1  $\mu\text{m}$  for the aftermarket filter. The porosity of each filter was determined by calculating the ratio of total pore volume to total sample volume, expressed as a percentage. According to this approach, the OEM filter exhibited a porosity of 39.5%, while the aftermarket filter showed a higher porosity of 45.5%.

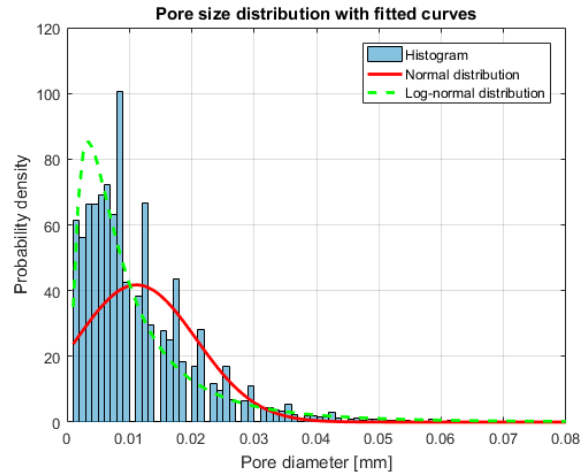
Fig. 25. Pore size distribution – aftermarket filter section
