## Comparative study of aftermarket and OEM DPFs for Periodic Technical Inspections (PTI) compliance with new PN emission limits

**Key words:** Periodic Technical Inspections, particle number counter, PN-PTI test, DPF

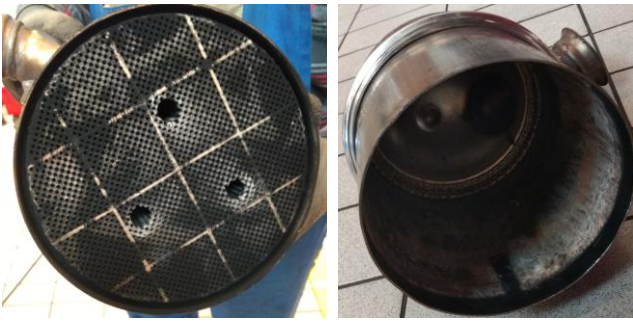
Fig. 4. Tested DPF filters with 3 holes and empty

Figure 11 presents the results obtained from a series of controlled modifications performed on the DPF of a Peugeot 308. Initially, three 10 mm diameter holes were drilled into the existing DPF. In this configuration, the PNC immediately detected abnormally high PN emissions exceeding 10 million  $\#/cm^3$ , indicating severe filter damage. However, the DPF100 PM tester reported a “marginal” result of 653  $\mu g/m^3$ , suggesting that the filter was not in optimal condition.

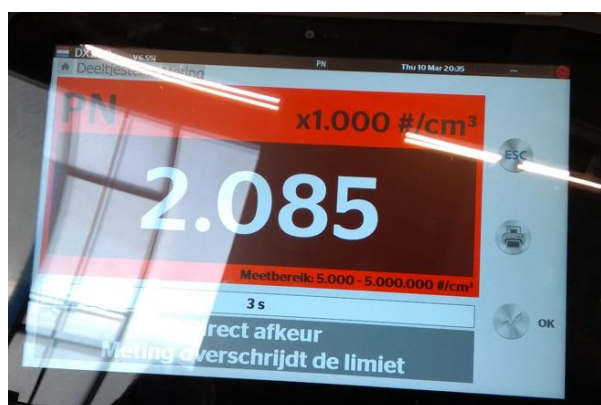
Fig. 8. PN measurement result on the Continental PNC display for the Peugeot 308 and for old OEM DPF

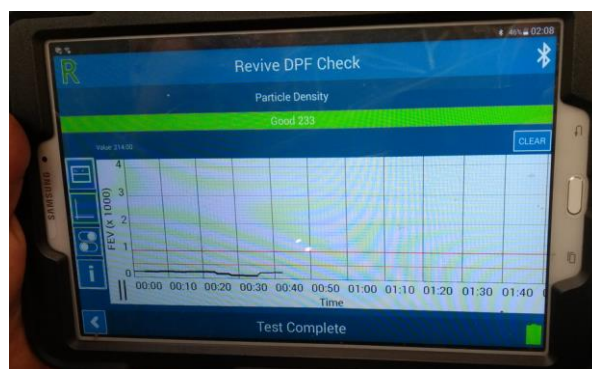
Fig. 9. PM measurement result (density) on the DPF100 tester display for the Peugeot 308 and for the old OEM DPF

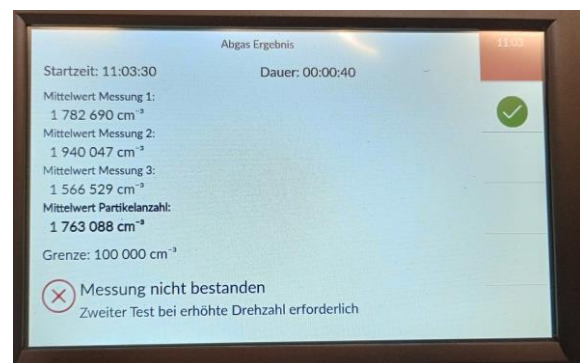
Fig. 13. PN measurement result on the Bartec nEC PNC display for the Peugeot 308 and for the cordierite DPF of competitor 8

Referring to the results shown in Fig. 14, none of the aftermarket DPFs tested (representing eight different competitors) passed the particle number emission tests, regardless of substrate type (SiC or cordierite). The average particle number for these aftermarket parts was significantly high, reaching approximately 1.6 million  $\#/\text{cm}^3$ . Only the OEM DPF remained within the acceptable upper limit, achieving a value of 137,280  $\#/\text{cm}^3$ .

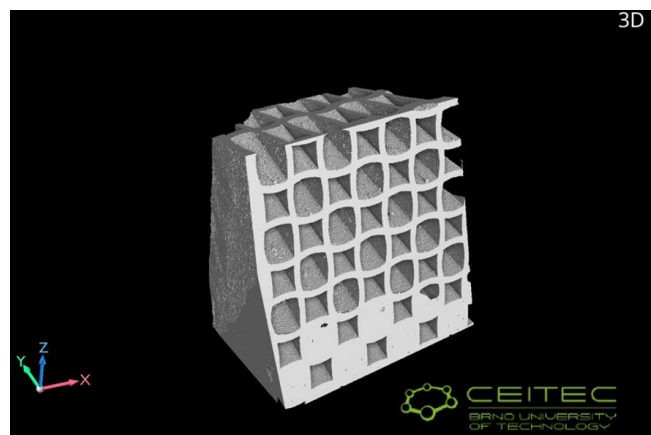
In addition to the DPF filter that exhibited high PN emissions, a small cubic sample from both an OEM (SiC) filter (Fig. 18) and an aftermarket (cordierite) filter (Fig. 19) was sent to the CTLAB X-ray Computed Tomography facility at the Central European Institute of Technology. The purpose of this supplementary analysis was to examine the internal structure of the filters (wall thickness and porosity). This investigation aimed to explain why the OEM filter exhibited compliant PN emission levels immediately after installation in the vehicle, whereas the aftermarket DPF required initial conditioning to reach acceptable emission levels.

Fig. 18. 3D scan of a section of an OEM filter

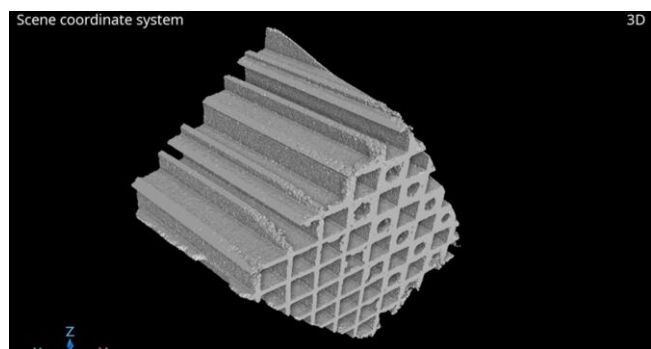
Fig. 19. 3D scan of a section of an aftermarket filter

As a result, the new aftermarket filter shows higher PN emissions during the initial phase. However, after a short conditioning period, the larger pores begin to fill with particulate matter, which enhances the filter's ability to trap particles and reduces emissions to levels compliant with regulatory limits.

New aftermarket DPFs require initial conditioning before they can reliably meet the PN limits during MOT testing using PNC devices. PN measurements should not be conducted immediately after DPF installation, as unconditioned filters may not yet be effective in trapping particulate matter.
