## Investigation of the effect of engine running time on the material characteristics of a piston

Regardless of the class of passenger car, manufacturer, or type of internal combustion engine, vehicle owners strive to ensure the longest possible period of reliable engine operation. The reliability and performance of an internal combustion engine are key indicators of its quality and prestige. Numerous research and development studies have focused on optimizing piston design and identifying the causes of piston failure. However, to better understand degradation mechanisms and trends in modern piston design, it is necessary to investigate the phenomena affecting the piston during typical engine service life. Thermomechanical stresses, friction, elevated and fluctuating temperatures, and contaminants all contribute to piston wear and reduce its service life. In this study, a new aluminum piston was compared with a piston extracted from an engine after approximately 200,000 kilometers of operation. The influence of engine operating time on piston surface condition, hardness, microstructure, and surface quality was analyzed. These parameters provide insight into the impact of friction

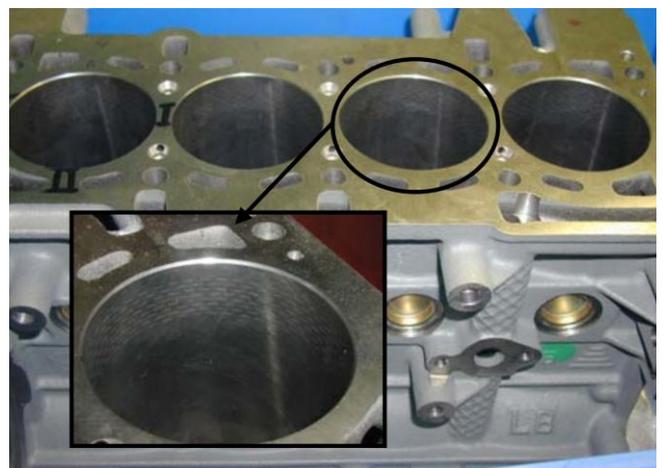
During its operating cycle, the piston undergoes deformation due to gas pressure and contact forces acting along its working plane. The lateral and angular movement of the piston causes impacts between the piston skirt and the cylinder liner, leading to dynamic fluctuations in hydrodynamic forces. The maximum impact force occurs in diesel engines during the compression stroke and is concentrated at the upper ends of the piston skirt. An increase in clearance between the piston skirt and the cylinder liner results in greater lateral displacement and a larger tilt angle, which, in turn, increases the piston's lateral acceleration and intensifies impact forces [9]. An example of engine block damage caused by this phenomenon is shown in Fig. 1.

Fig. 1. Photograph of a four-cylinder passenger car engine block [16]

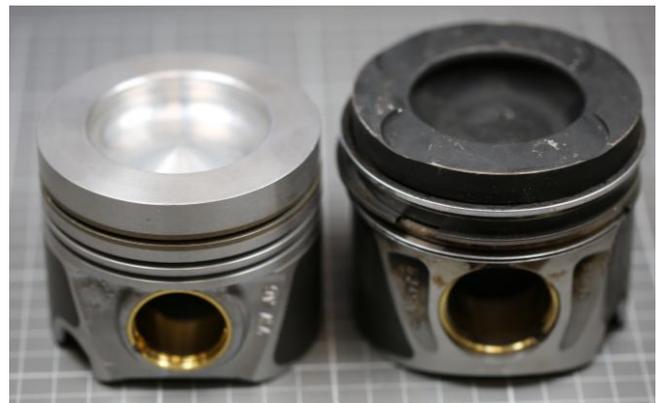
To investigate the influence of engine operating time on the mechanical and tribological properties of a piston, a comparative analysis was conducted between a new diesel engine piston and a piston from an engine with approximately 200,000 kilometers of mileage. The analyzed pistons are shown in Fig. 7. Both pistons share an identical design and components. The diameters of both pistons are identical, and they are manufactured from the same material. The operating conditions of the engines from which the examined pistons were taken are comparable. The only structural difference is the presence of valves in one piston. However, it should be emphasized that the present analysis focuses on the influence of engine operation on the properties and microstructure of the piston material, rather than on design differences. The first piston ring groove contains a reinforcing cast iron insert, designed to increase the mechanical strength of the piston. This insert is made of spheroidal graphite iron, subjected to alfin treatment, and subsequently cast with molten aluminum to form a durable metallurgical bond. Additionally, both pistons are equipped with an internal cooling channel to protect the piston crown and combustion chamber from overheating caused by the high thermal loads generated during combustion.

Fig. 7. Analyzed pistons from diesel engines

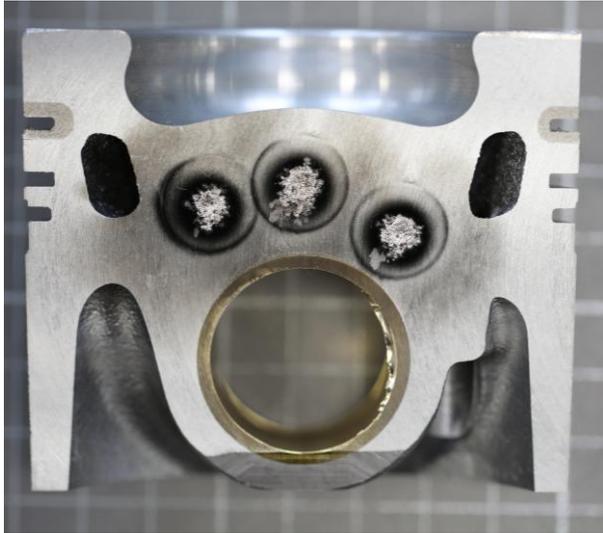
To determine the chemical composition, the analyzed pistons were sectioned along their axis, perpendicular to the piston pin bore. The measurements were carried out using a spectrometer. Measurement points are marked in Fig. 11 for the new piston and in Fig. 12 for the used piston. Three measurements were taken on the new piston and four on the used piston.

Fig. 11. Chemical composition measurement points on a new internal combustion engine piston

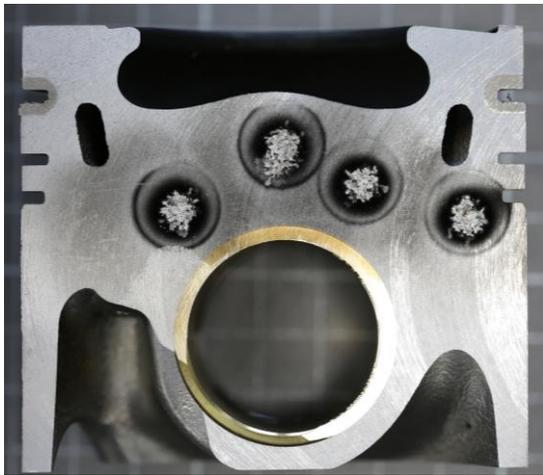
Fig. 12. Chemical composition measurement points on a used internal combustion engine piston

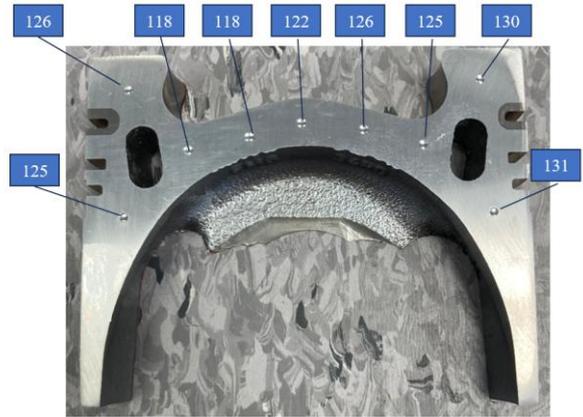
The operating cycle of a piston in an internal combustion engine involves repeated heating and cooling. The temperature dependence of material strength presents a significant limitation for both increasing engine efficiency and extending service life. To evaluate the effect of the engine's thermal cycles on mechanical properties, both a new piston and a used piston (with approximately 200,000 kilometers of service) were sectioned longitudinally along the axis, in a plane perpendicular to the piston pin bore. Hardness measurements were performed using the Brinell hardness scale (HB). The measurement points for the new piston are shown in Fig. 13. The hardness values ranged from 118 to 131 HB, with an average value of 124.6 HB and a measurement spread of 13 HB.

Fig. 13. Unused diesel engine piston with marked hardness measurement points and HB values

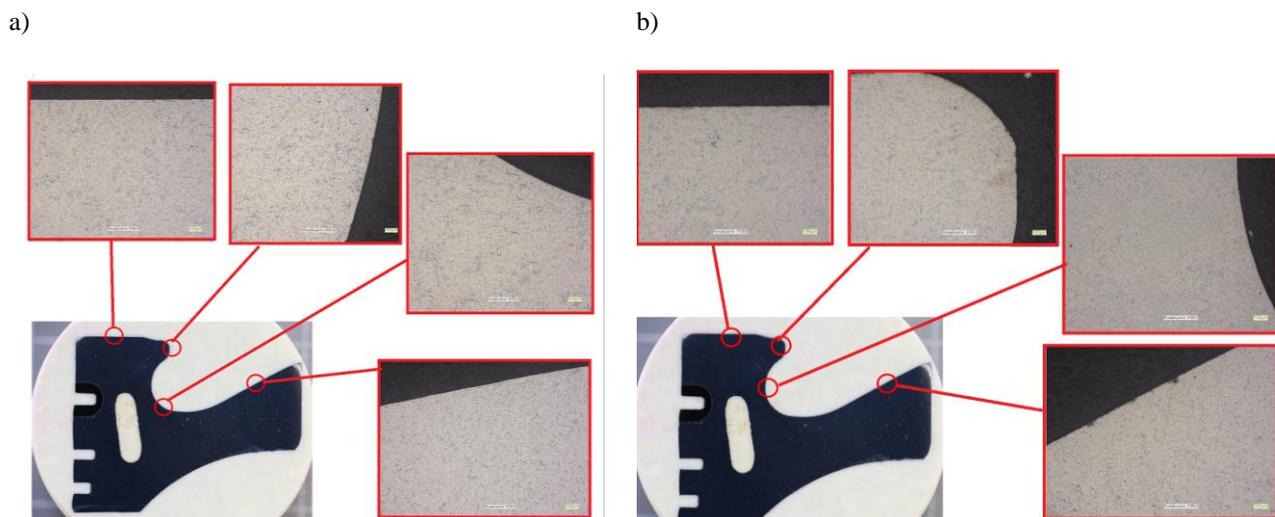
High temperatures, along with cyclic heating and cooling, affect the material's hardness and mechanical properties. To determine whether these factors influenced the surface condition and microstructure, metallographic cross-sections were prepared for both the new and used pistons, as shown in Fig. 17a and 17b, respectively.

Fig. 17. Microstructure analysis locations: a) new piston, b) used piston

The metallographic specimen included the ring land area, piston crown, and combustion chamber region. Figure 17a shows the new piston with the selected areas marked for analysis. Four zones were examined: the piston crown, the combustion chamber edge, and two locations within the combustion chamber. All examined edges in the new diesel engine piston were continuous, uniform, and free of any irregularities. The microstructure in these areas was fine-grained and consistent across all analyzed zones. Figure 18a shows the edge of the combustion chamber in the new piston, while Fig. 18b presents the same area in the used piston. In the used piston, burn marks and localized edge degradation up to 0.04 mm deep were observed. These thermal erosions are numerous and distributed across the entire surface of the combustion chamber.

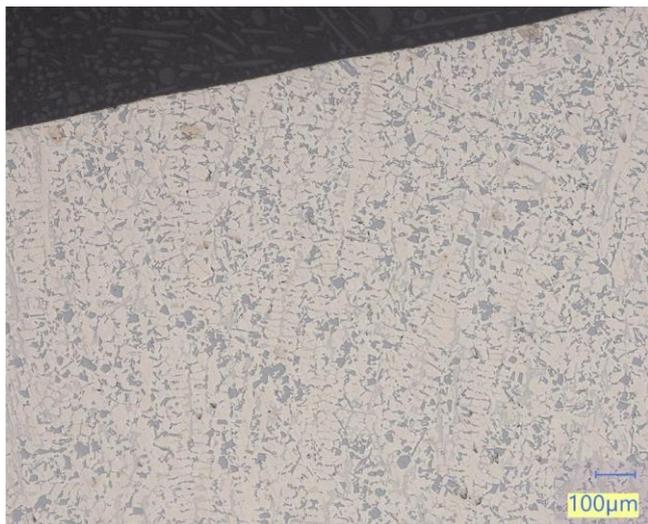
For comparison, Fig. 20 presents the microstructure of the new piston in the combustion chamber region. The structure is homogeneous, with clearly visible solidification lines typical of the silumin casting process. A distinct difference can be observed between the microstructures of the new and used pistons. The edge in this area is smooth, uniform, and free of any discontinuities.

Fig. 20. Metallographic cross-section of the combustion chamber of a new internal combustion engine piston
