Evaluation of materials used for coatings of electrical connectors used in the electrical harness of passengers cars

Key words: *automotive electrical connectors, metal coatings, anodic protection, cathodic protection, corrosion*

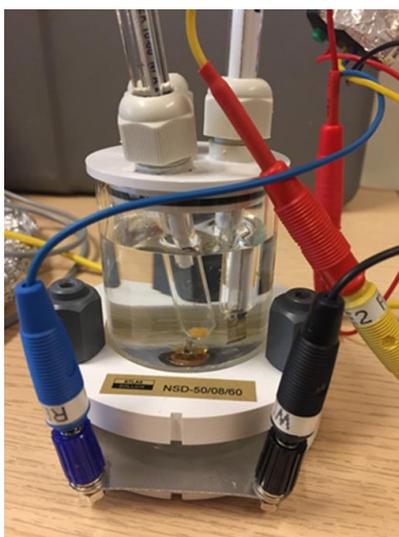
Fig. 1. The measurement site for corrosion tests

Two samples, one coated with tin and one coated with gold, were selected for the topography examination. The roughness of each connector was measured according to PN-87/M-04256/02. The topography picture was prepared via SEM. The corrosion resistance of these two samples was examined. Two tests, open circuit potential and potentiodynamic polarization, were performed on an automated measurements site (Fig. 1), which consisted of a vessel, a potentiostat ATLAS 0531 – ELECTROCHEMICAL UNIT&IMPEDANCE ANALYSER, computer controller and three electrodes: calomel electrode as a reference electrode, platinum electrode as a counter electrode and connector as a working electrode. The open-circuit test in 3% sodium chloride solution lasted 40 minutes and took place at room temperature. This test was performed in order to find a resting potential of a system, which is necessary for the second test. During potentiodynamic polarization measurement, potentiodynamic curves were registered and a pitting susceptibility of material was evaluated.

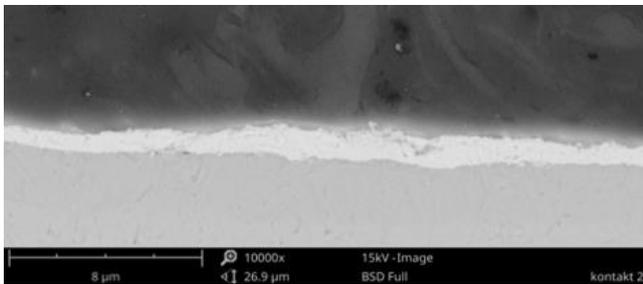
Fig. 2. Scanning microscope image of sample number 2 – a continuous, well-made coating of variable thickness, a substrate for coating application well prepared

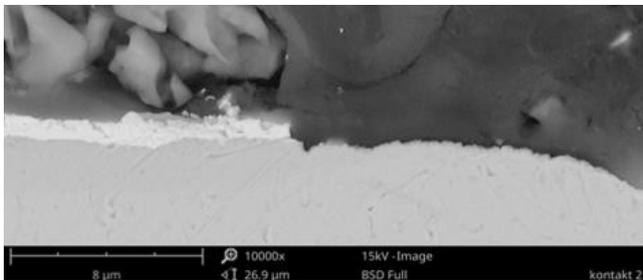
Fig. 3. Scanning microscope image of sample number 2 – the place of the beginning of coating application – visible layer break

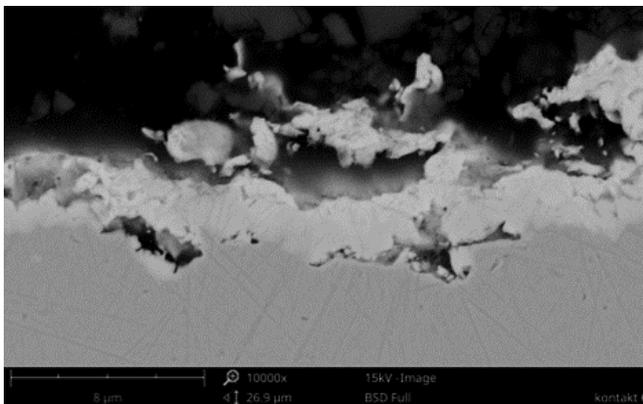
Fig. 4. Scanning microscope image of sample number 3 – a continuous layer, uneven coating thickness, visible delamination

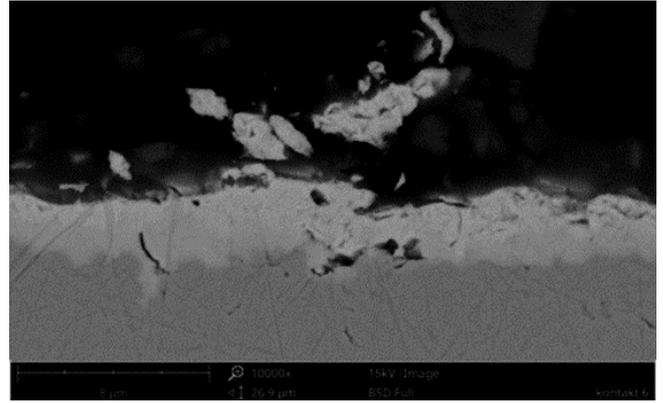
Fig. 5. Scanning microscope image of sample number 3 – differences in coating thickness with continuity, visible delamination at the border of coating and core material

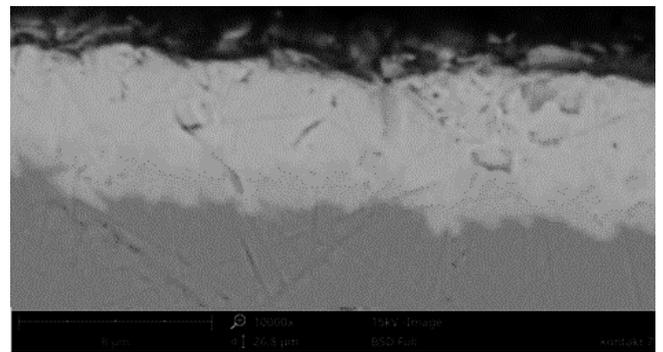
Fig. 6. Scanning microscope image of sample number 4 – a continuous layer with even coating thickness, visible impurities in the coating

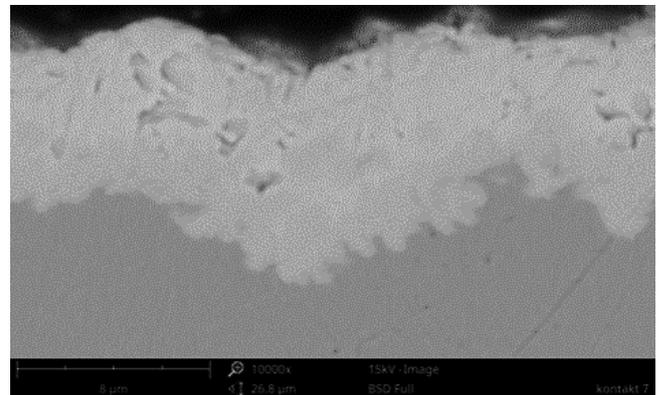
Fig. 7. Scanning microscope image of sample number 4 – a continuous layer with uneven coating thickness. Coating material with numerous irregularities

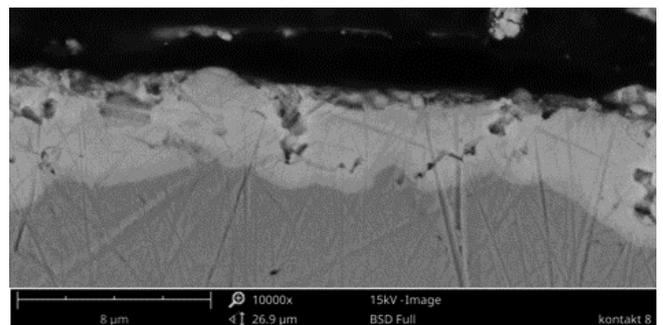
Fig. 8. Scanning microscope image of sample number 5 – a continuous layer, with varied coating thickness, numerous impurities

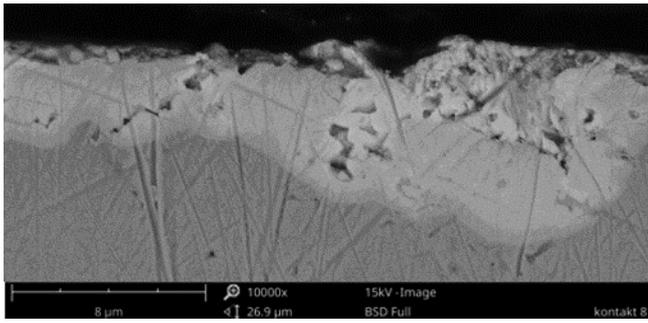
Fig. 9. Scanning microscope image of sample number 5 – a continuous layer, with uneven coating thickness, and numerous impurities

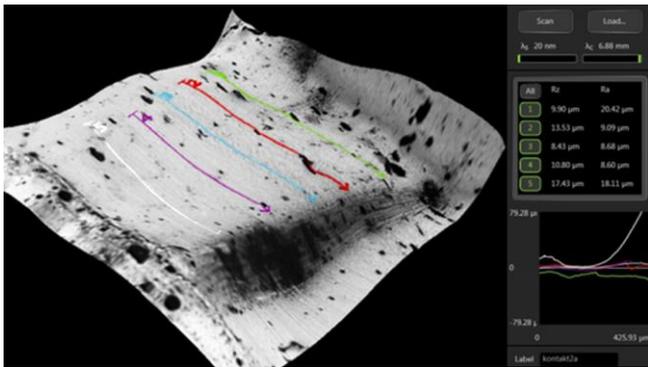
Fig. 10. Sample number 2, measurement 1 – 3D view of the test surface

Observations of the material of sample number 2 indicate a high presence of surface contaminants of various sizes but regular round shapes. Longitudinal cracks can be observed. In places of inclusions on the roughness profile, large differences in height appear (Fig. 11). In places without inclusions, the roughness profile shows very small differences in height. In the results for measurement 1 – line 5 (white) has a clearly increasing shape (Fig. 10). After

analyzing this shape, this result is not considered a roughness measurement because the differences in profile height are too large – 79.3 µm – to qualify this shape irregularity as roughness. It is also not taken into account when calculating the average roughness value for the sample, which is for parameter Rz = 8.03 µm and for parameter Ra = 7.89 µm. The Ra value for gold coating is higher than that found in the literature, where it was 0.5715 µm and 0.3827 µm. The surface of the samples examined by Ren et al. was also less wavy and did not have large cracks and inclusions, which translates to lower roughness parameters [15].

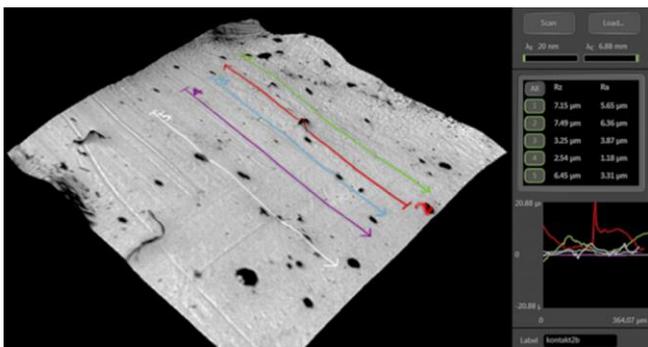
Fig. 11. Sample number 2, measurement 2 – 3D view of the test surface

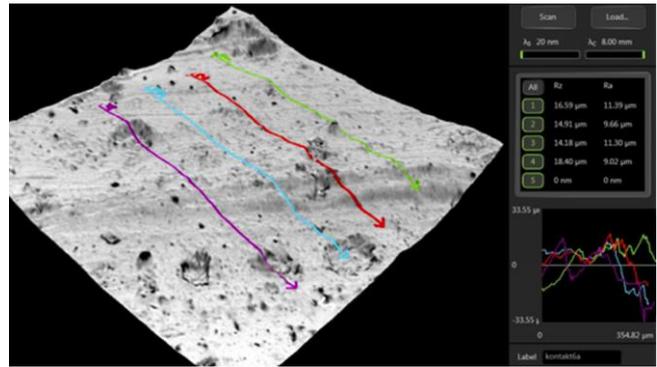
Fig. 12. Sample number 3, measurement 1 – 3D view of the test surface

The surface irregularities observed in the material of specimen number 3 are predominantly concave depressions – dark grey patches with irregular shapes visible in Fig. 12. and Fig. 13. A small number of convex, fine surface contaminations (black dots) with regular shapes and a small (several or even several times smaller) size compared to the depressions can also be observed. The sample has visible longitudinal scratches occurring in one direction. On the 3D image in places of surface roughness (convex and concave) on the roughness profile appear large differences in height. The indices of surface roughness for sample number 3 are for the parameter Rz = 13.58 µm and for the parameter Ra = 13.24 µm. Narayanan et al. examined the roughness of tin-coated connectors after 20000 fretting cycles at various temperatures. The Ra value they measured ranged from 1.71 to 2.77. This indicates that the samples they examined had lower roughness, despite being subjected to destructive testing, than sample number 3 [16].

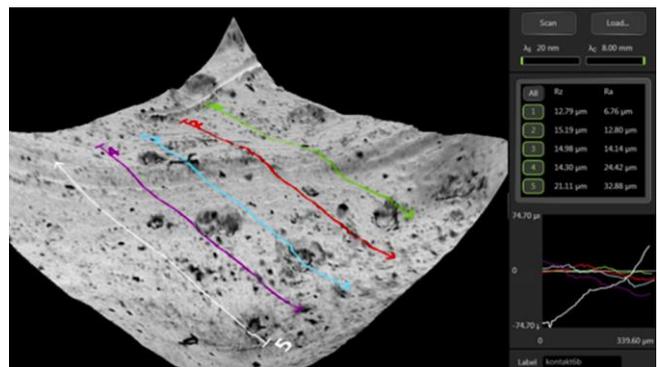
Fig. 13. Sample number 3, measurement 2 – 3D view of the test surface

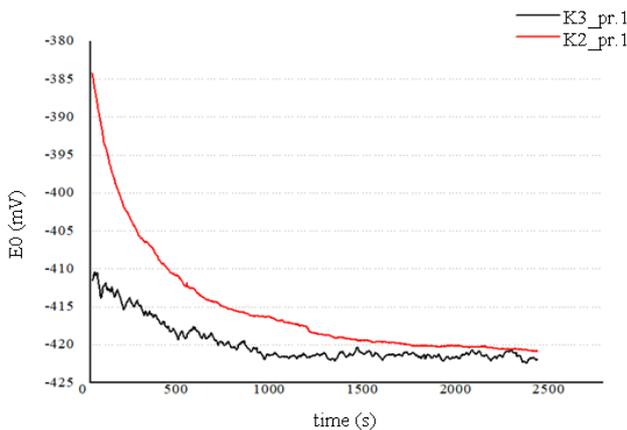
Fig. 14. Open circuit stationary potential as a function of time for samples number 2 and 3

The corrosion resistance tests were carried out on two samples, number 2 and 3. The measurement of the stationary potential as a function of time for the open circuit of both samples showed that after 40 minutes both samples had very similar potential. The sample coated with gold, showed a potential $E^0 = -421$ mV, while the sample coated with tin, showed a potential $E^0 = -422$ mV – the result is shown in Fig. 14.
