Causes of the powerplants failures installed on Polish civil aviation aircraft

Key words: powerplant, aircraft engine failure, safety risk

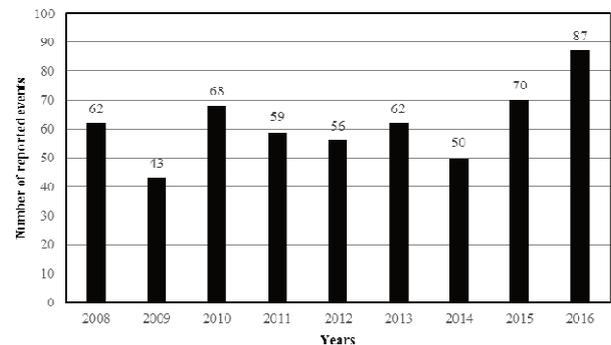
Figure 1 shows an annual number of reported aviation events caused by powerplant types considered in this article.

Fig. 1. Number of reported aviation events caused by powerplants installed on Polish registered aircraft

There was 557 reported events between 2008 and 2016 caused by all engine types installed on Polish registered aircraft.

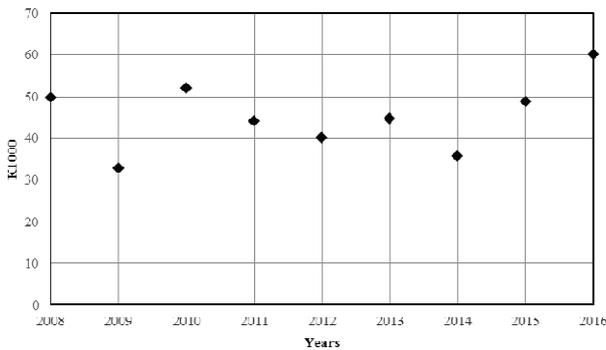
Figure 2 shows changes of the coefficient K_{1000} for aviation events occurred within 2008-2016, for all powerplant types. The below presented figures are showing increased trend of the reported aviation occurrences per 1000 registered aircraft for last two years. Such a situation

is different considering various engine types. Next four chapters contains detailed information of aviation events have occurred for each of the powerplant type since 2008.

Fig. 2. Changes of the coefficient K1000 for SCF-PP aviation occurrence categories

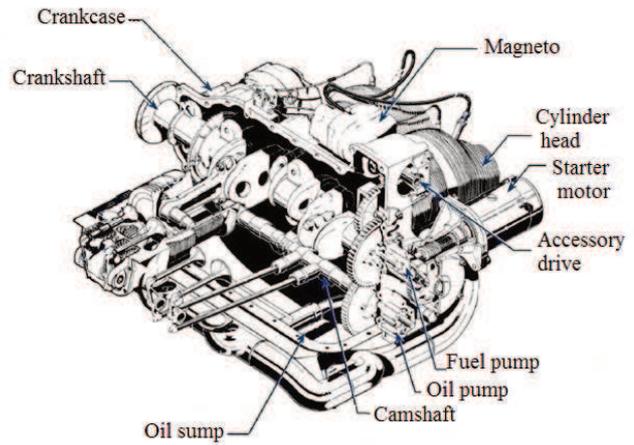
Figure 3 shows view of the contemporary utilized typical aviation piston engine with description of its main parts [3].

Fig. 3. Four cylinders, horizontally opposed, air cooled aviation piston engine

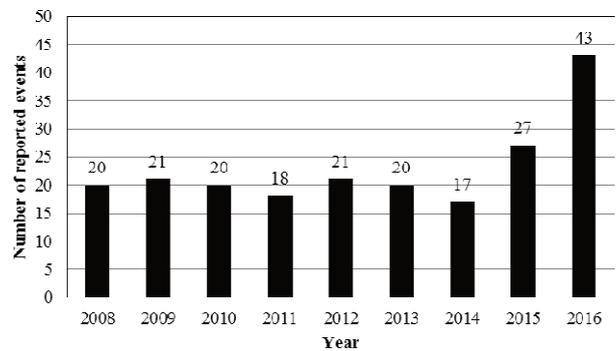
Figure 4 shows an annual number of reported aviation events caused by piston engines. Figure 5 shows changes of the coefficient $K_{1000pist.}$ between 2008-2016.

Fig. 4. Number of events caused by piston engines installed on Polish registered aircraft between 2008-2016

It has to be pointed out that for last two years sudden, significant increase in number of events caused by this

engine type is observed. From 17 in 2014 to 43 in 2016 – more than twice.

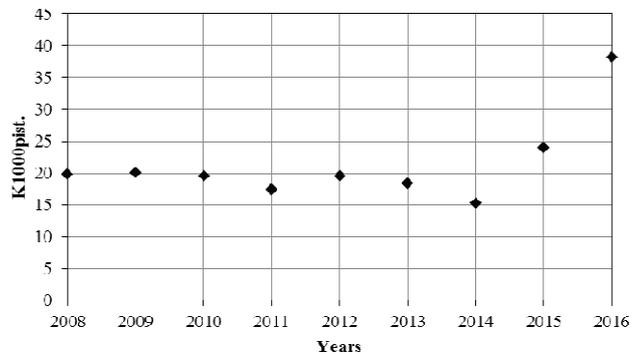
Fig. 5. Changes of the coefficient $K_{1000pist.}$

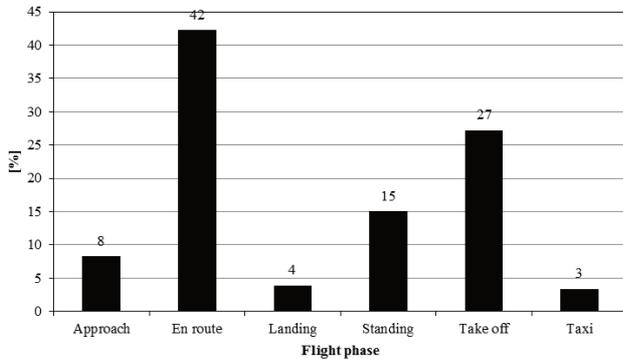
Figure 6 gives (in percent) information during which aircraft maneuver and how often reported event caused by piston engine took place in 2008-2016. It is unacceptable that the vast amount of the powerplant reported failures occurred during aircraft movement. Only 15% of them were detected during routine maintenance tasks.

Fig. 6. Flight phases share when piston engine malfunction took place

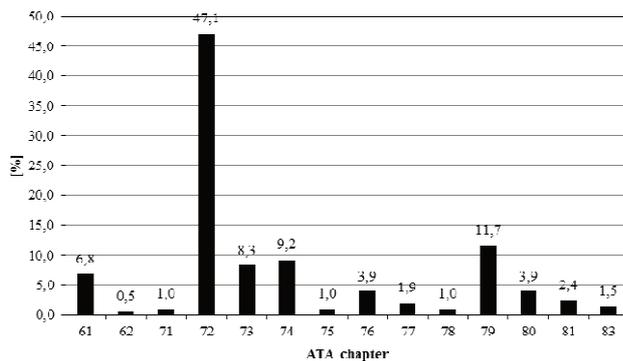
Figure 7 shows reported system defects frequency in percent assigned to the certain ATA chapter for the piston engines in the 2008-2016.

Fig. 7. Share of each powerplant system events coded by ATA 100 chapter between 2008 and 2016

The above Fig. 7 shows “share” of the certain ATA chapter in percent in the total volume of the piston engines reported events. It was assumed that the most frequently occurred event – ATA chapter 72 has occurrence probability level equal 5. Next 79, 74 and 73 level 4, 61 level 3, 76 and 80 level 2 and the remaining 62, 71, 75, 77, 78, 81 and 83 level 1. According to the methodology described in the introduction (Tab. 1, Tab. 2 and Tab. 3) to each from the above ATA chapters safety risk severity was assigned, based on events consequences described in the ECCAIRS reports. Then safety risk assessment matrix was developed for piston engines operated in Poland. Results of the analysis are presented in the Tab. 5.

Almost 50% out of the total (207) occurrences caused by powerplants can be assigned to the engine itself (see Fig. 7). Most of the events are connected with powertrain and cylinder systems. The events were caused by cracked exhaust valves. Also carbon deposit was observed on them. Other occurrences were caused by different failures of the cylinders. It can be presumed that those damages were mainly due to engines overheating that resulted from an improper exploitation.

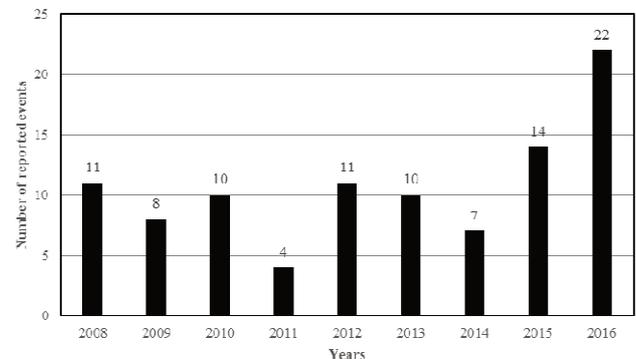
There were 97 reported aviation events in the ATA 72 chapter between 2008-2016. Figure 8 shows an annual number of reported events as a result of piston engine failures coded in that chapter.

Fig. 8. Number of events caused by piston engines installed on Polish registered aircraft in the ATA 72 chapter between 2008-2016

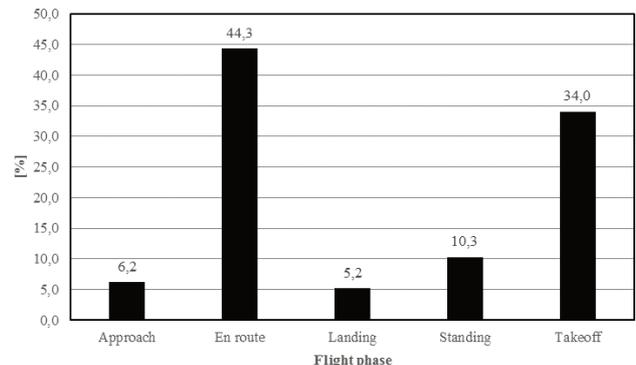
Figure 9 gives (in percent) information during which aircraft maneuver and how often failure of the piston engine in the ATA 72 chapter took place between 2008-2016.

Fig. 9. Flight phases share when powerplant malfunction ATA chapter 72 took place

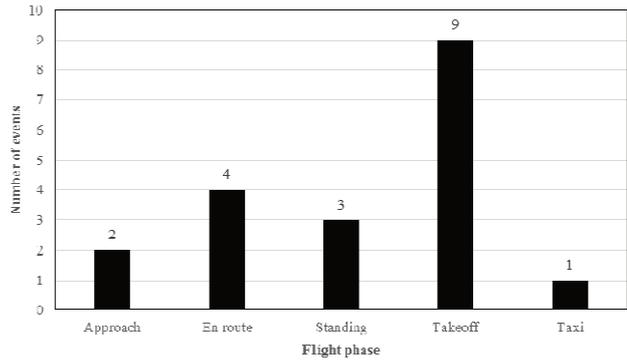
Figure 10 gives information during which aircraft maneuver a failure in the ATA 74 chapter took place within 2008-2016. The Tab. 7 shows in numbers result of the engine ignition system malfunctions, symptoms observed and precursors of the powerplant defects, where it was confirmed.

Fig. 10. Flight phases share when powerplant malfunction in the ATA 74 chapter took place

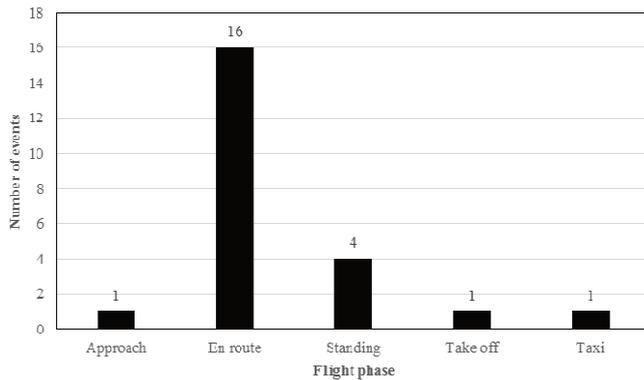
Between 2008-2016 there was 23 events caused by engine oil system. Figure 11 gives information during which aircraft maneuver a failure coded in the ATA 79 chapter took place within 2008-2016.

Fig. 11. Flight phases share when powerplant malfunction in the ATA 79 chapter took place

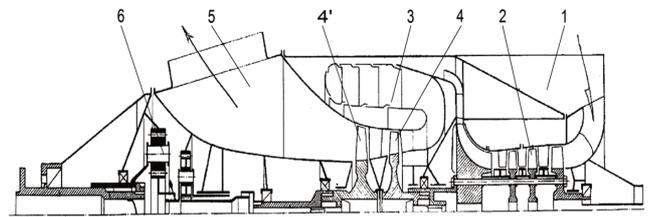
Figure 12 shows scheme of the contemporary utilized popular Pratt & Whitney PT6 turboprop engine with description of its main parts, covering the power range between 430 and 680 shaft kilowatts [8, 9].

Fig. 12. Design scheme of PT6 turboprop engine: 1 – air inlet, 2 – compressor, 3 – combustor chamber, 4 – compressor powered turbine, 4' – power turbine 5 – exhaust, 6 – reduction gearbox

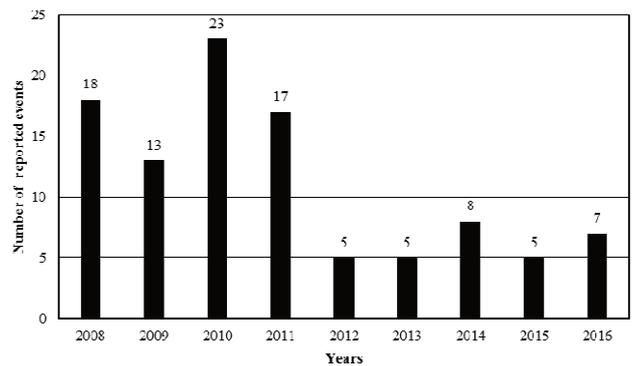
Figure 13 shows an annual number of reported aviation events caused by turboprop engines. Figure 14 shows changes of the coefficient $K_{1000\text{tprop}}$ during 2008-2016.

Fig. 13. Number of events caused by turboprop engines installed on Polish registered aircraft between 2008-2016

Above pictures are showing sudden decrease in number of events as well as coefficient $K_{1000\text{tprop}}$ from 2012 without turboprop aircraft fleet size changes. Reason for such level of safety increase is one of the operators aircraft fleet a

change to another turboprop aircraft type powered by different engine model.

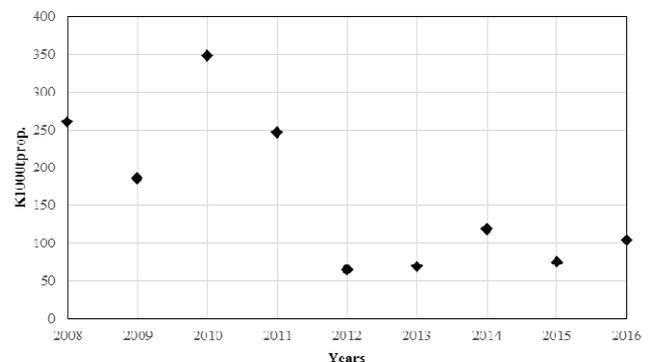
Fig. 14. Changes of the coefficient $K_{1000\text{tprop}}$

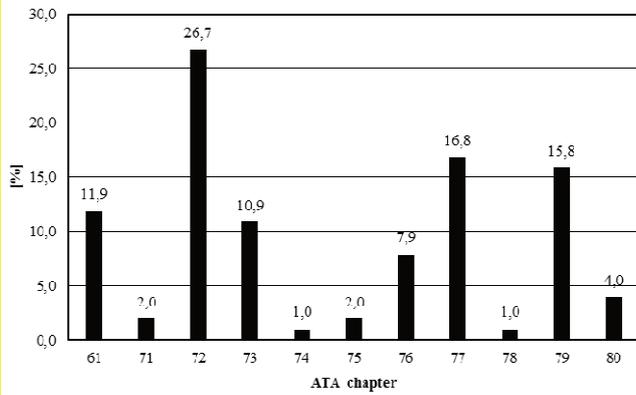
Figure 15 shows reported system defects frequency in percent assigned to the certain ATA chapter for the turbo-prop engines in the years 2008-2016. Figure 16 gives (in percent) information during which aircraft maneuver and how often reported event caused by turboprop engine took place within 2008-2016.

Fig. 15. Share of each powerplant system events coded in the ATA 100 chapter between 2008 and 2016

Figure 15 shows in percent “share” of the certain ATA chapter in the total volume of the turboprop engines reported events. It was assumed that the most frequently occurred event – ATA chapter 72 has occurrence probability level equal 5. Next, 77 and 79 level 4, 61, 73, 76 level 3, 80 level 2 and the remaining 71, 74, 75, 78, level 1. According to the methodology described in the Introduction

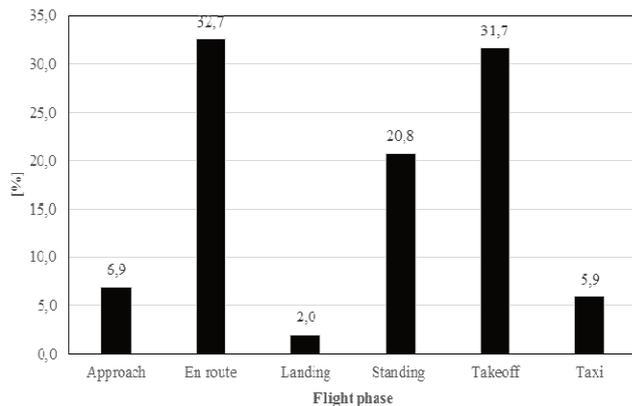
Fig. 16. Flight phases share when powerplant caused event took place

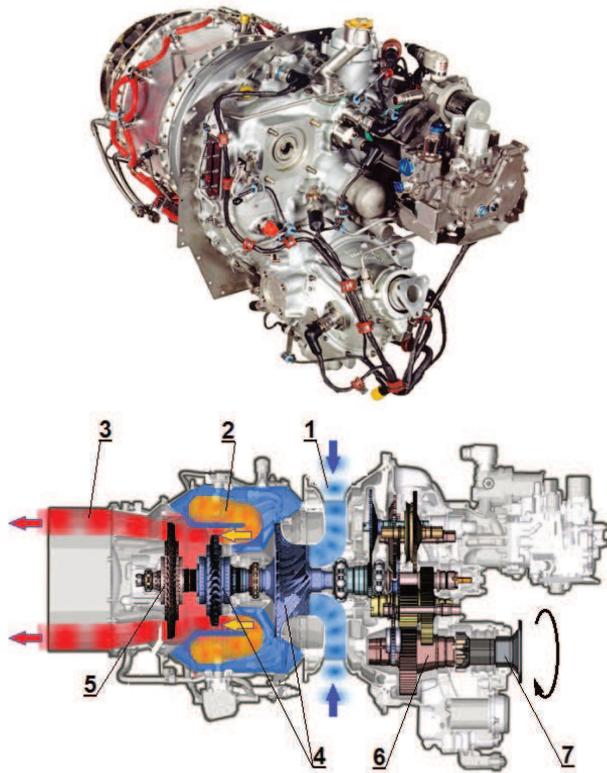
Fig. 17. View and cross-section of the PW 206 turboshaft engine: 1 – air inlet, 2 – combustor chamber, 2 – compressor, 3 – exhaust, 4 – radial compressor and turbine, 6 – reduction gearbox, 7 – shaft [17]

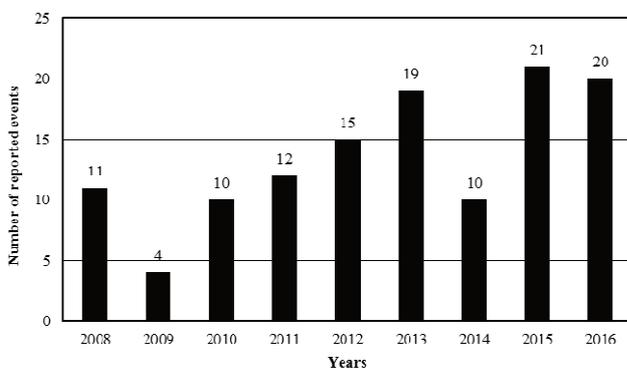
Fig. 18. Number of events caused by turboshaft engines installed on Polish registered aircraft between 2008-2016

With the constant number of helicopters, the number of events reported to the ECCAIRS database have increased since 2008 (Fig. 18), as a consequence also coefficient $K_{1000\text{ts shafts}}$ proportionally has increased (Fig. 19).

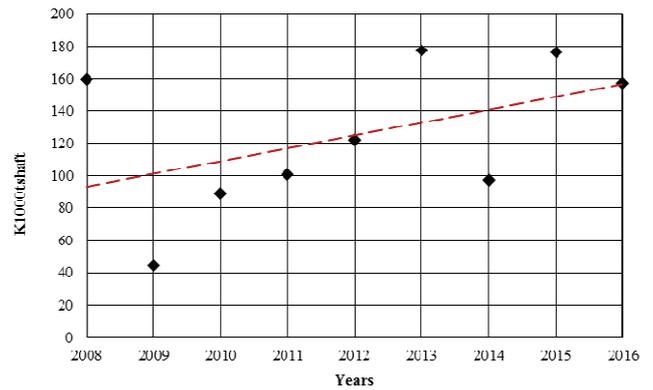
Fig. 19. Changes of the coefficient $K_{1000tshaft}$ and the trend line

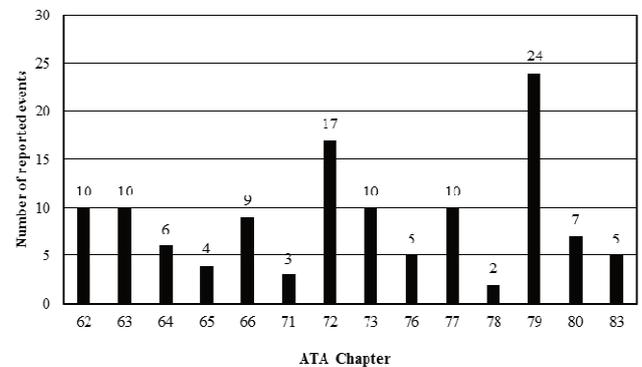
A more accurate analyzes of the events shows that most of them concerns engine oil system (ATA 79 chapter) and ATA 72 chapter. This order is preserved both in terms of number of events and percentage share (see Fig. 20 and 21).

Fig. 20. Number of the turboshaft engine system events coded in ATA 100 chapter between 2008 and 2016

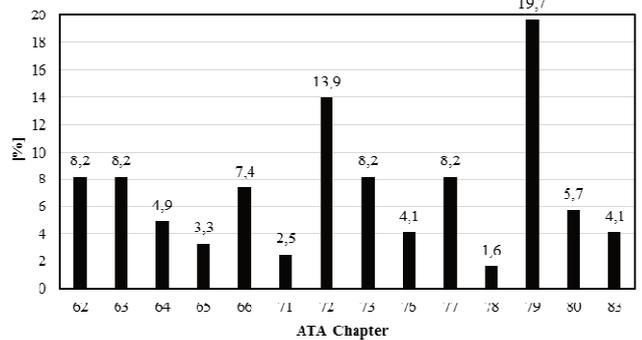
Fig. 21. Share of turboshaft engine system events coded in ATA 100 chapter between 2008 and 2016

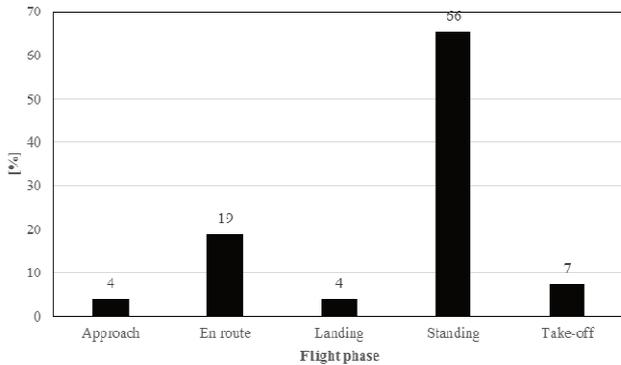
The positive thing is that as many as 2/3 of all turboshaft malfunctions were detected during routine maintenance checks and less than 1/5 during flight, which shows Fig. 22.

Fig. 22. Flight phases share when turboshaft engine malfunction took place

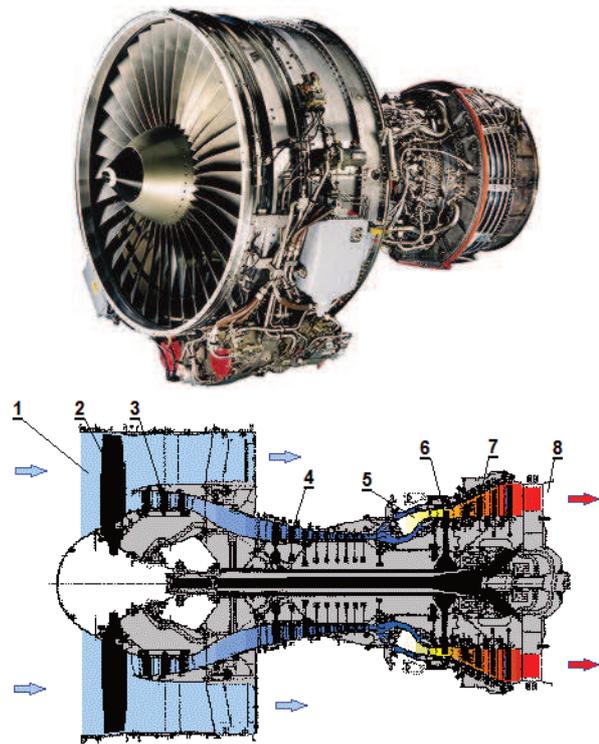
Currently there are 94 Polish registered aircraft powered by jet engines, 80 of them fall into MTOM > 5700 kg class [16]. Details are shown in the Tab. 15. Figure 23 presents representative of the most popular worldwide turbofan engine family CFM56.

Fig. 23. Basic features of modern turbofan engine [18]: 1 – engine inlet, 2 – fan, external duct, 3 – low pressure compressor internal duct, 4 – high pressure compressor air, 5 – combustion chamber, 6 – high pressure turbine, 7 – low pressure turbine, 8 – exhaust

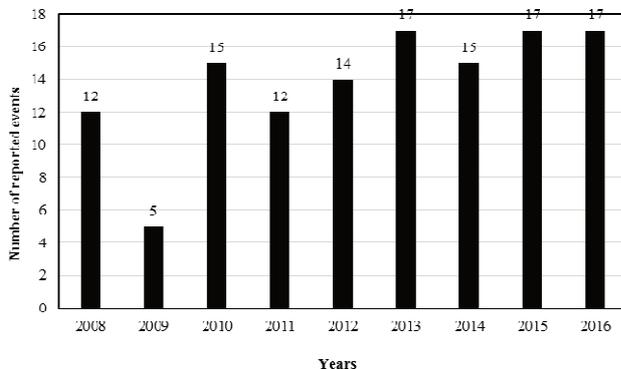
Number of reported events as well as factor $K_{1000jet}$ since 2011 have stabilized (Fig. 24 and 25).

Fig. 24. Number of events caused by turbojet engines installed on Polish registered aircraft between 2008-2016

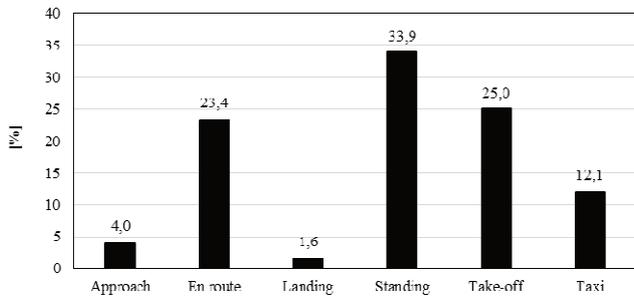
Fig. 28. Flight phase share when turbojet engine malfunction took place

Figure 26 presents number of reported events in each ATA 100 chapter dedicated to powerplant systems. Fig. 27 shows reported system defects frequency in percent assigned to the certain ATA chapter for the turbojet engines in the years 2008-2016. Fig. 28 gives (in percent) information during which aircraft maneuver and how often reported event caused by turbojet engine took place between 2008-2016.

It has to be taken into consideration for those involved in the SMS that more than 60% of the reported events have occurred during different aircraft flight phases (Fig. 28). Some organizational projects has to be undertaken in order to increase failures detectability level during maintenance.
