Diagnostic method for a piezoelectric injector using the Newton-Cotes formula

The article presents a method for regenerating common rail injectors, which involves extending the standard diagnostic procedure with a phase of analytical calculations. The closed-type Newton-Cotes formula (referred to as the trapezoidal rule) was employed to estimate the resulting fuel spray patterns and compare them with the manufacturer's reference. In the discussed example, it was demonstrated that the proposed solution is particularly useful in challenging situations where a definitive assessment of the injector's technical condition remains difficult. Several other advantages were also highlighted, making this method suitable for application in laboratory and workshop conditions.

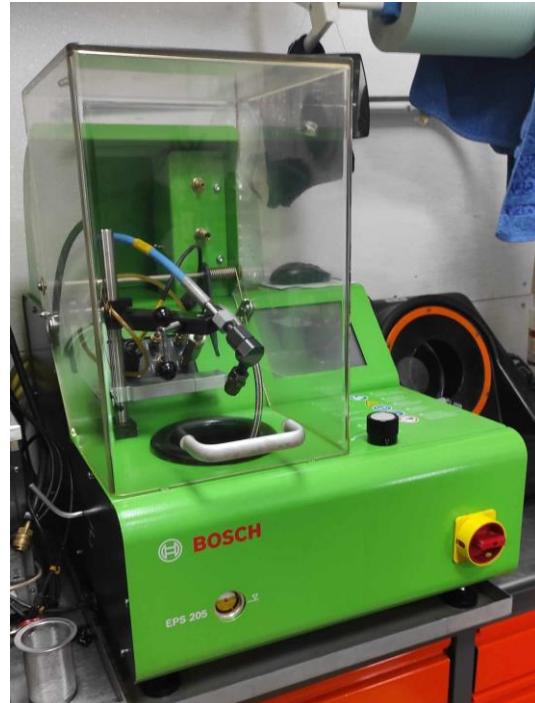
Fig. 1. View of the Bosch EPS 205 test bench

This is a versatile diagnostic device with a single measurement tower, allowing for automatic testing, coding, and internal cleaning of injectors. The results are compared with the manufacturer's database, which is accessible from the control screen and subsequently saved and printed as a final report. The functionality of the tester has been significantly enhanced compared to previous versions (EPS 200/200A), as the manufacturer has installed sets (attachments, adapters, connectors) and software adapted for testing piezoelectric injectors. Due to its compact size and affordable price, the device is very popular in the service market.

The research was conducted on a test bench equipped with a Bosch EPS 205-type table (Fig. 1).

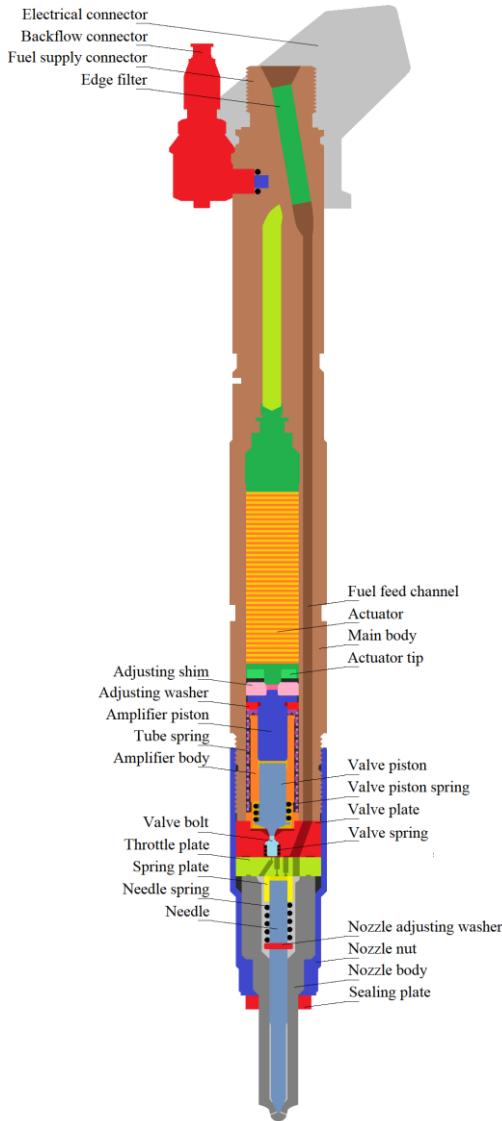
Fig. 2. Structure of the Bosch CRI3-18 injector: a proprietary development based on [16, 19]

Injectors of this type are classified as third-generation systems, operating at maximum pressures up to 180 MPa [15]. Figure 2 illustrates the internal structure, detailing the components of the hydraulic amplifier group, control valve, and nozzle. A characteristic feature is the absence of a lateral fuel supply channel in the nozzle, resulting in the central delivery of fuel in the spaces around the needle. Consequently, this component has a triangular cross-section in the guiding part, which is essentially unique among other manufacturers. The sealing of the tip is achieved solely through the valve assembly [11].

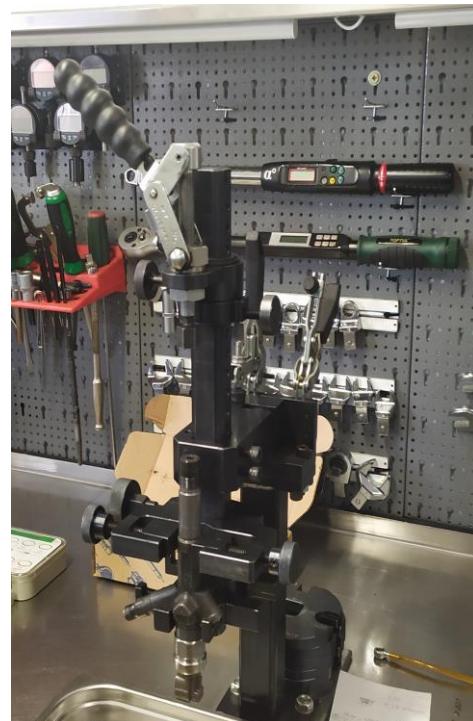
Fig. 3. General view of the tool station

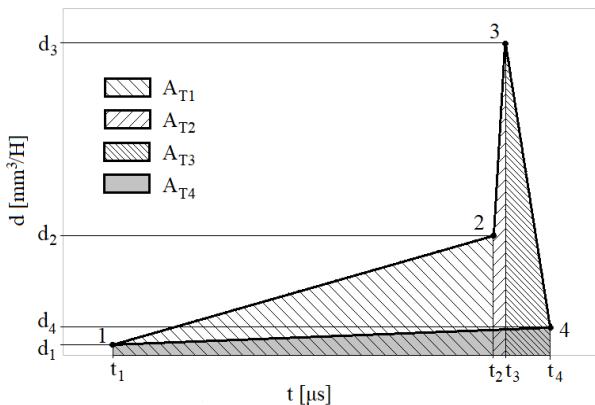
By connecting them, a non-rectangular quadrilateral with vertices 1-2-3-4 was obtained (Fig. 4). Subsequently, trapezoids were extracted, and their surface areas were calculated using the closed Newton-Cotes formula [2]:

Fig. 4. Graphical interpretation of the trapezoidal method for the discussed example

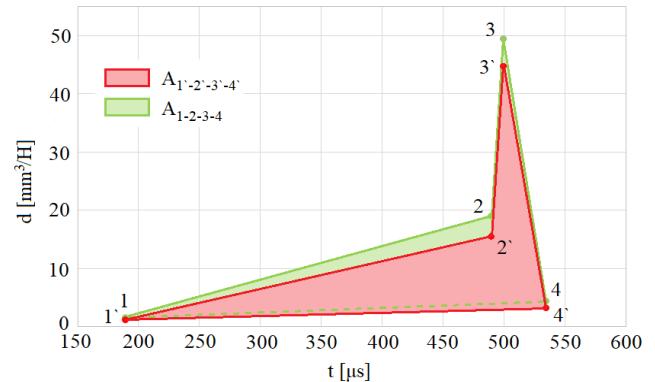
Fig. 5. Graphical interpretation of the results of preliminary tests

From the data presented in Tables 3 and 4, it can be observed that the injection process disturbance caused a displacement of the quadrilateral 1`-2`-3`-4`. Although the fuel doses met the requirements of the test procedure, their values were significantly underestimated compared to the reference. This was especially true for points 2` and 3`, which corresponded to engine operating conditions at half and full load. As a result, the surface area for the tested injector was 18.5% smaller (Fig. 5). The cause should be attributed to the improper functioning of the valve group, which should be replaced after disassembly. A similar decision was made regarding the precision pair (nozzle, needle). In this regard, the decisive factor was the relatively high mileage of the vehicle rather than the nature of any dysfunction.

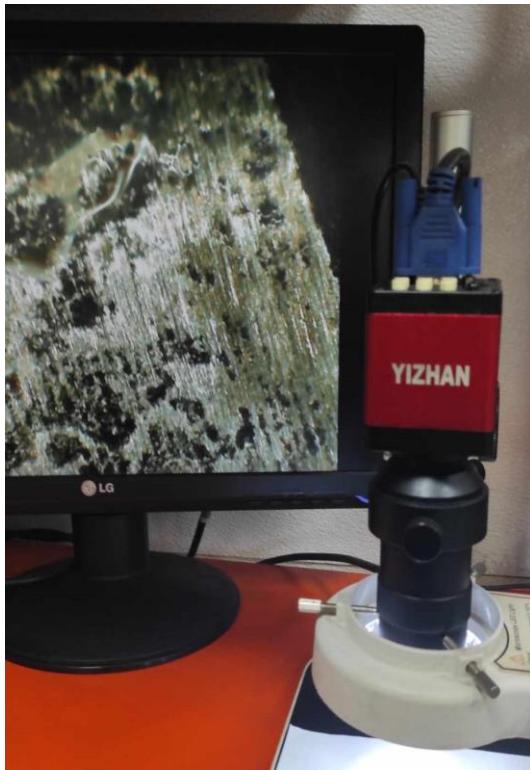
During the inspection under high magnification, corrosion was observed on most components that had direct contact with fuel, such as the needle, valve plate, throttle, and the hydraulic amplifier body (Fig. 6). This process had an adverse effect on the dynamics of individual assemblies, and the resulting contaminants further polluted the interior of the injector, leading to accelerated wear of interacting surfaces. It should be noted that corrosion intensification is a commonly encountered phenomenon in injectors operating at such high working pressures. This occurs despite the structural and material modifications employed by manufacturers [1, 5, 10].

Fig. 6. Observation of corrosion on the hydraulic amplifier body

Consequently, it was decided that restoring full functionality would only be possible by replacing all executive and control groups, except the piezoelectric actuator.

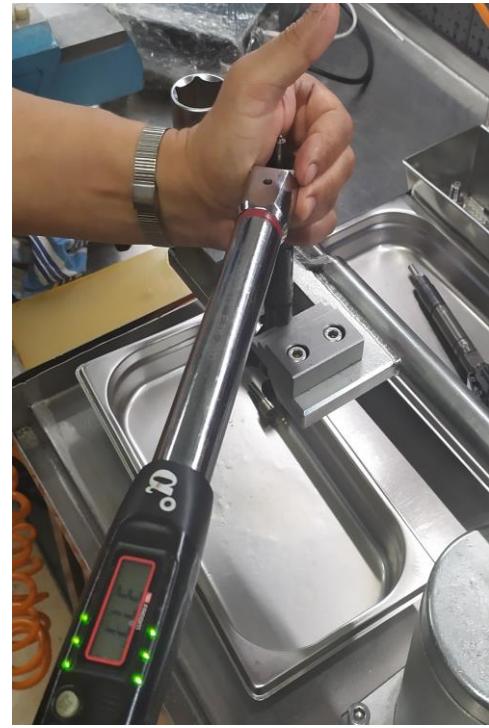
During the injector assembly process, it is essential to purge the hydraulic amplifier by assembling its components in diesel oil and then compressing them using a specially dedicated press. This step is of fundamental importance for ensuring accurate fuel delivery during primary investigations, as it eliminates the possibility of result distortion, namely, zero doses. Subsequently, the nozzle assembly (nozzle, needle, spring, washer) is assembled and securely fastened to the main body using a nut. Throughout this operational procedure, strict adherence to the manufacturer's guidelines is crucial, utilizing a torque wrench for this purpose (Fig. 7).

Fig. 7. Tightening the nut with a torque wrench

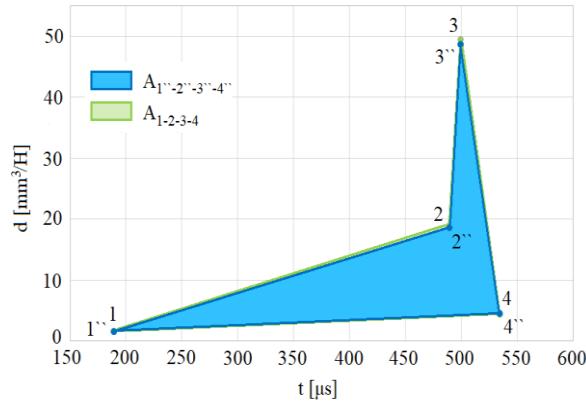
Fig. 8. Graphical interpretation of the results of the main tests

It can be observed that the replacement of key components yielded favorable results. There was an increase in the values of all fuel doses compared to the preliminary tests. As a result, the surface area of the quadrilateral 1"-2"-3"-4" almost completely overlapped with the reference, with a difference of only 2.8% (Fig. 8). This suggests that the factory settings of the tested injector have been restored. Of course, new codes were assigned before installation in the engine. This process was carried out automatically on the same test bench where fuel dosing measurements were taken.
